Covell's Beach and Bath House

ADA Transition Plan

October 2021

Institute for Human Centered Design

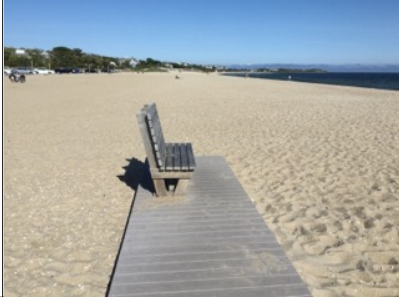
Exterior route < 36" wide	25"	Ensure that a clear width of 36" min. is maintained at the accessible route.	1	-	\$0
2	Wooden Path to Beach	Ext.		Exterior Access Route	Exterior

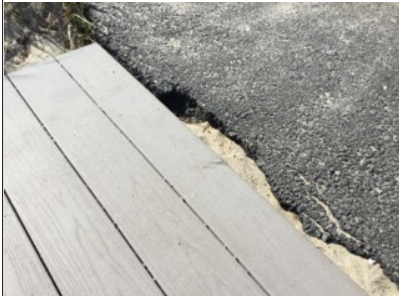
Surface openings > 1/2"	3.5" -	See ID #3.	1	-	\$0
3	Wooden Path to Beach	Ext.		Exterior Access Route	Walkway

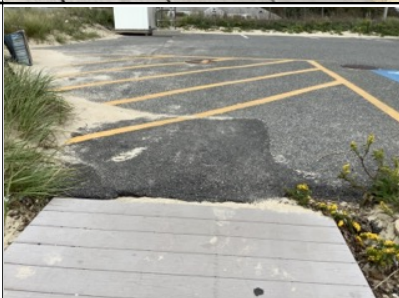
Surface openings > 1/2"	3.5"	Repair surface to ensure that opening is 1/2" max. Cost for a 4'x4' concrete patch.	1	256	\$256
4	Women's Toilet Room	Ext.		Exterior Access Route	Exterior

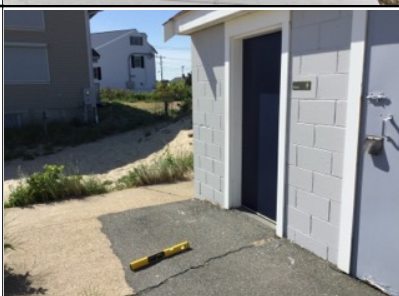
Cross slope > 1:50 (2.00%)	9.2%	Reduce cross slope to be no steeper than 1:50 (2.00%).	1	-	\$0
5	Men's Toilet Rooms	Ext.		Exterior Access Route

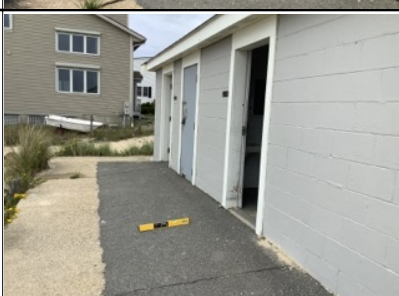
Cross slope > 1:50 (2.00%)	9.2%	Reduce cross slope to be no steeper than 1:50 (2.00%).	1	-	\$0

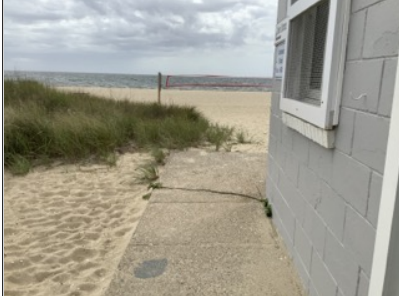
Cross slope > 1:50 (2.00%) Route not maintained in operable working condition	4.7% -	Reduce cross slope to be no steeper than 1:50 (2.00%). Ensure the accessible route is maintained in operable working condition.	1	-	\$0
7	Route to Toilet Rooms	Ext.		Exterior Access Route	Exterior

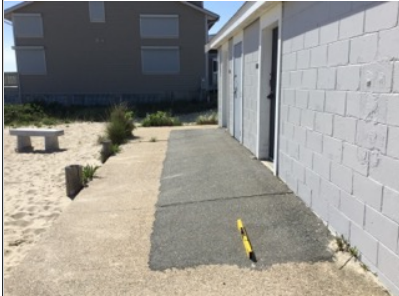
Running slope > 1:20 (5%)	6.4%	Reduce running slope to be no steeper than 1:20 (5%).	1	-	\$0
8	Route to Beach	Ext.		Exterior Access Route	Walkway

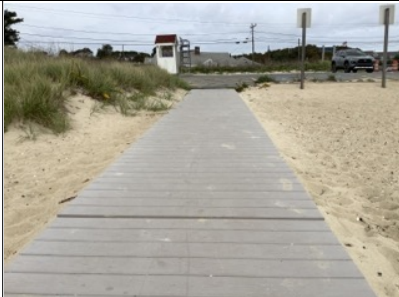
Level changes > 1/4"	0.5"	Alter change in level to be 1/4" high max.	1	-	\$0
9	Entrance to Beach From Accessible Parking Space	Ext.		Exterior Access Route	Exterior

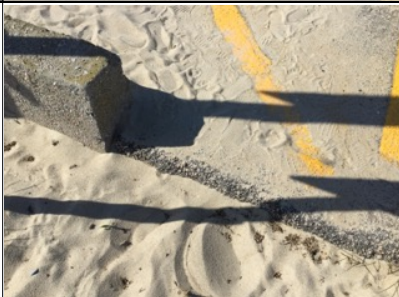
Level changes > 1/4" Route not maintained in operable working condition	4.5" -	Alter change in level to be 1/4" high max. Ensure the accessible route is maintained in operable working condition.	1	-	\$0

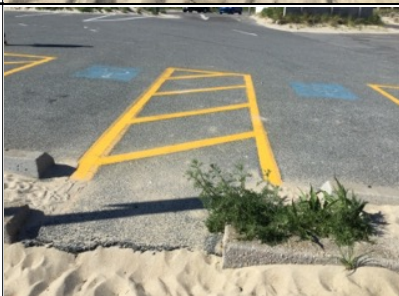
10	Entrance to Beach From Accessible Parking Space	Ext.		Exterior Access Route	Walkway

Route not maintained in operable working condition	-	Ensure the accessible route is maintained in operable working condition.	1	Labor	\$0

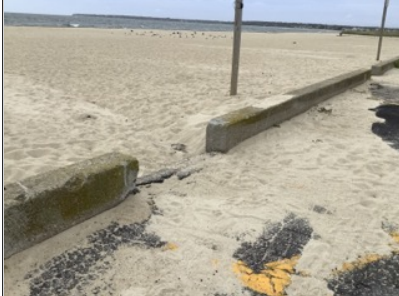
Route not maintained in operable working condition	-	Ensure the accessible route is maintained in operable working condition.	1	Labor	\$0
12	Route to Bathhouse	Ext.		Exterior Access Route	Walkway

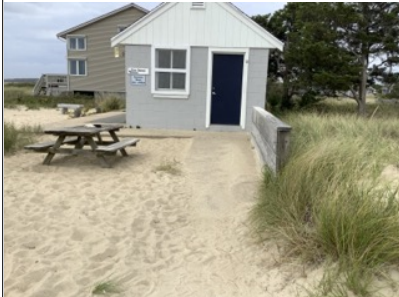
Route not maintained in operable working condition	-	Ensure the accessible route is maintained in operable working condition.	1	Labor	\$0
13	Route to Volleyball	Ext.		Exterior Access Route	Exterior

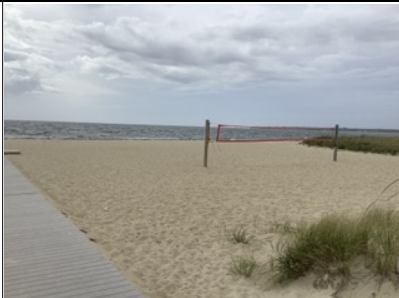
Accessible route not provided	-	Ensure an accessible route is provided. Cost for a 5 ft. wide by 30 ft. long beach mat.	1	1379	\$1379
Beach Access Routes												
14	Beach Access			Beach Access Routes	Removable

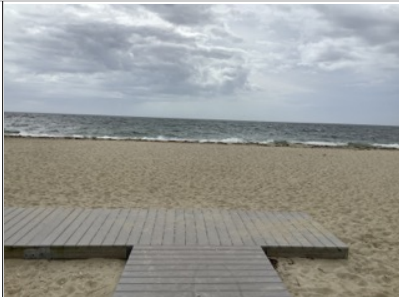
Beach route not provided	-	Provide an accessible route that is firm and stable. Ensure the accessible route extends to the high tide level. Cost for a 5 ft. wide by 50 ft. long beach mat.	1	1999	\$1999

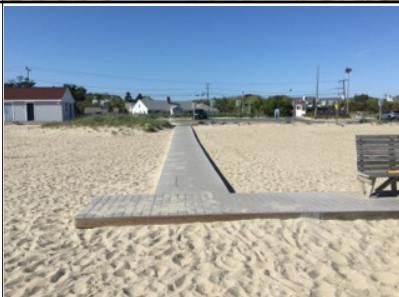
15	Beach Access	Ext.		Beach Access Routes	Removable

Level changes > 1/4"	7"	Ensure change in level is 1/4" high max.	1	-	\$0

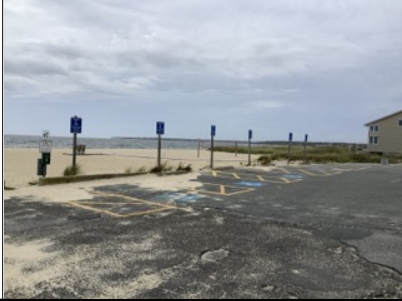
Parking lot not maintained in operable working condition	-	Ensure the parking lot is maintained in operable working condition.	1	Labor	\$0
Entrance												
17	Women's Toilet Room	Ext.		Entrance	Main Entrance

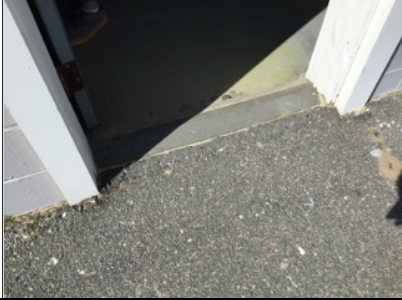
Threshold not beveled	-	Bevel threshold.	1	150	\$150
18	Men's Toilet Room	Ext.		Entrance	Main Entrance

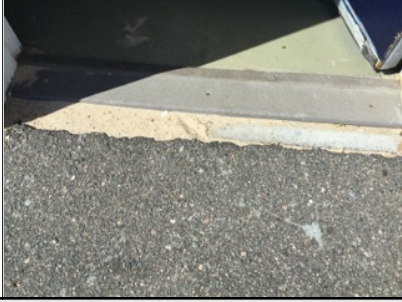
Threshold not beveled Threshold is > 1/2" high	- 1.25"	Bevel threshold. Alter threshold to be 1/2" high max.	1	300	\$300
Access to Goods and Services												
Doors, Doorways, & Gates												
19	Men's Toilet Room	1		Doors, Doorways, & Gates	Toilet Room

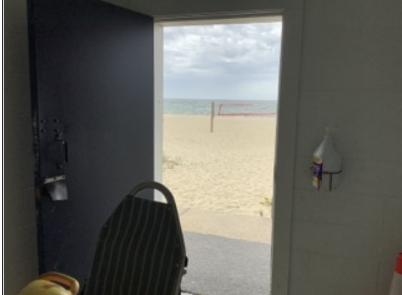
Maneuvering clearance(s) not provided	-	Relocate hand sanitizer to maintain the required 18" maneuvering clearance.	1	Labor	\$0

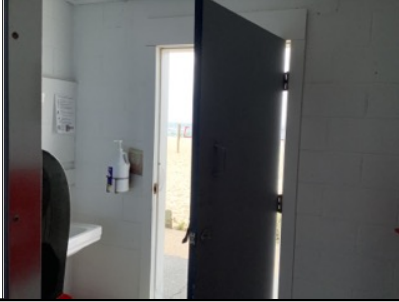
Maneuvering clearance(s) not provided	-	Relocate hand sanitizer to maintain the required 18" maneuvering clearance.	1	Labor	\$0
Signage												
21	Men's Toilet Room	Ext.		Signage	Designation

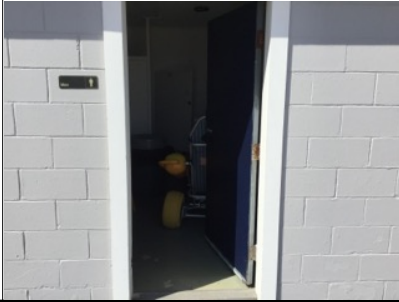
Raised characters not provided Braille not provided	- -	Provide text with raised characters duplicated in braille.	1	232	\$232
22	Women's Toilet Room	Ext.		Signage	Designation

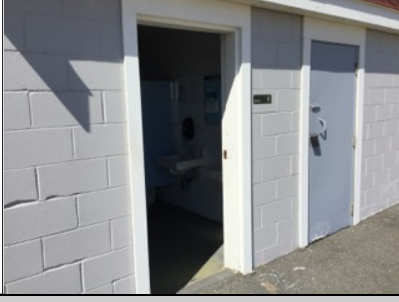
Raised characters not provided Braille not provided	- -	Provide text with raised characters duplicated in braille.	1	232	\$232
Picnic Tables												
23	Route to Bathhouse	Ext.		Picnic Tables	N/A

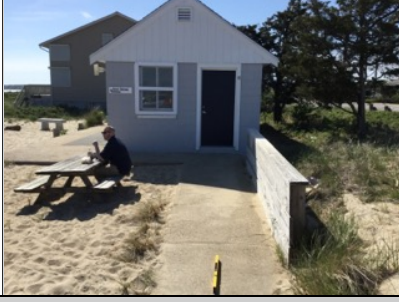
Top of picnic table < 28" or > 34 30" clear width not provided Picnic table not on an accessible route	25" 23.5" -	Provide a picnic table with top between 28"- 34" above the ground and 27" clear height underneath. Ensure that the picnic table is on an accessible route.	1	1400	\$1400

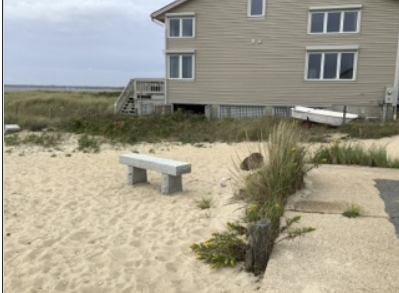
No accessible route to one bench in this area	-	Locate bench on an accessible route.	1	Labor	\$0

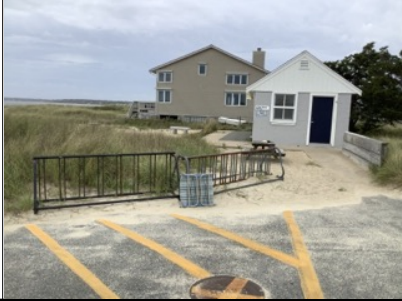
Not connected to an accessible route	-	Ensure bike racks are connected to an accessible route.	1	Labor	\$0
Toilet & Bathing Rooms												
Overall Access												
26	Women's Toilet Room	1		Overall Access	N/A

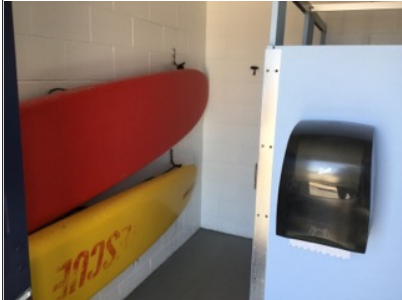
When the toilet room is renovated, if the approach is to the latch side of the accessible compartment, ensure clearance between the door and any obstruction is at least 42" wide.	1	-	\$0
27	Men's Toilet Room	1		Overall Access	Toilet Room

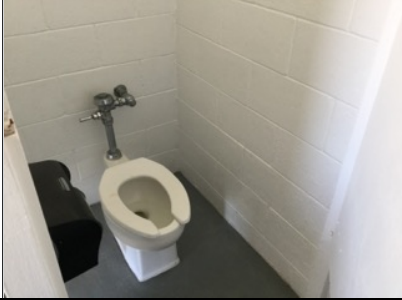
Accessible plumbing fixtures or stalls not provided	-	Provide one accessible wheelchair compartment.	1	6182	\$6182
28	Women's Toilet Room	1		Overall Access	Toilet Room

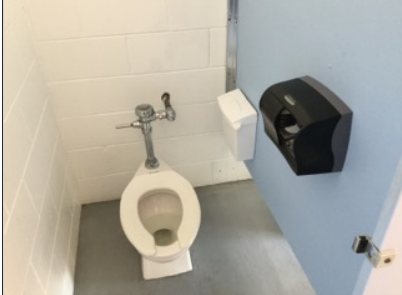
Accessible plumbing fixtures or stalls not provided	-	Provide one accessible wheelchair compartment.	1	6182	\$6182

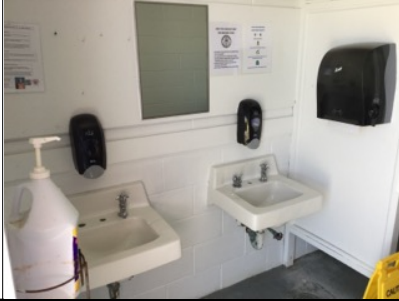
Toe or knee clearances not provided Exposed plumbing underneath Mirror above lavatory w/reflective surface > 40"	23" - 50"	Provide at least one lavatory with knee and toe clearance positioned for a forward approach. Insulate or otherwise configure pipes to prevent contact for at least one lavatory. Lower mirror so that the bottom surface is at 40" max. above the finished floor.	1	2034	\$2034
30	Women's Toilet Room	1		Lavatory	N/A

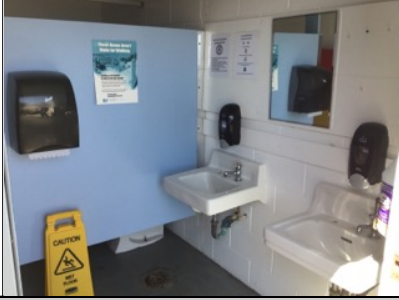
Toe or knee clearances not provided Exposed plumbing underneath Mirror above lavatory w/reflective surface > 40"	24.75" - 49"	Provide at least one lavatory with knee and toe clearance positioned for a forward approach. Insulate or otherwise configure pipes to prevent contact for at least one lavatory. Lower mirror so that the bottom surface is at 40" max. above the finished floor.	1	2034	\$2034

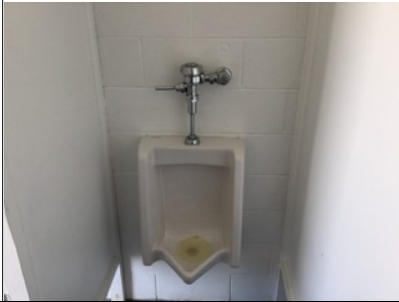
Rim > 17" high Clear floor space not provided at urinal Flush control too high or not properly located	21.25" 34.25" 49.5"	Provide at least one urinal with the rim no higher than 17" above the finished floor. Remove partition to provide a 30" min. by 48" min. clear floor space positioned for a forward approach. Mount flush control at 44" max. above the finished floor.	1	3878	\$3878
Outdoor Rinsing Showers												
32	Outdoor Shower	Ext.		Outdoor Rinsing Showers	N/A

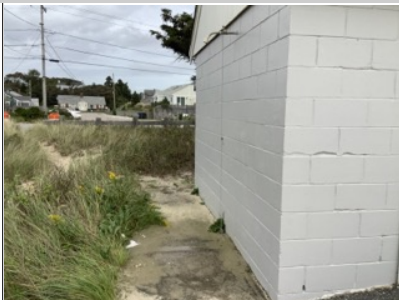
Clear floor space not provided at rinsing shower 2 fixed showerheads not provided	- -	Ensure there is a 30" by 48" clear floor space at the outdoor rinsing shower. Provide two shower heads located 48" and 72" min. above the ground.	1	3119	\$3119
Best Practice

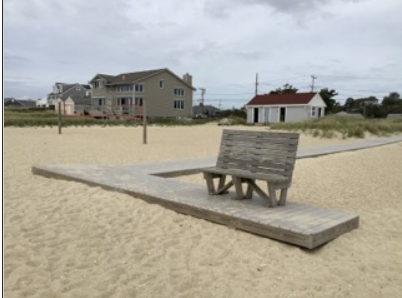
Recommend providing a deeper platform so there's an accessible route and space for two wheelchairs.	1	-	\$0
