Craigville Bathhouse and Beach

Town of Barnstable ADA Transition Plan

June 2021

**Town of Barnstable
Craigville Bathhouse and Beach**

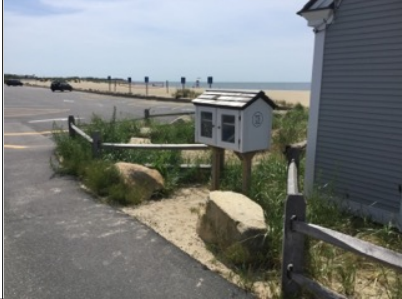
Accessible route not provided	-	Ensure an accessible route is provided to the book exchange box. Provide a surface that is stable, firm and slip resistant. (Cost based on an asphalt patch at base of book exchange.)	1	160	\$160
Beach Access Routes												
2	Beach Umbrella	Ext.		Beach Access Routes	Removable

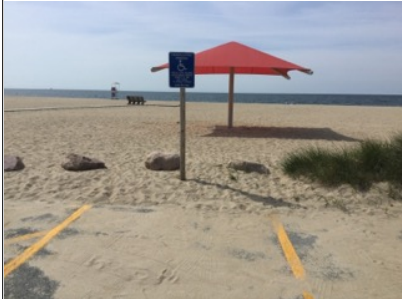
Beach route not provided Surface is not firm and stable	- -	Provide an accessible route that is firm and stable. Ensure an accessible route is provided to at least one umbrella. Reposition stones at edge of lot as needed to ensure an accessible route from the lot to the umbrella. (Cost based on a 6.5' wide x 16.5' long Mobi-mat brand beach mat.)	1	980	\$980

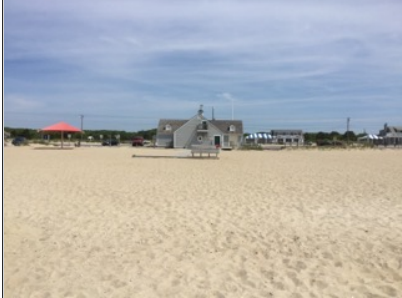
3	Beach Access Route to High Tide Level	Ext.		Beach Access Routes	Removable

Level changes > 1/4" Beach route not provided Surface is not firm and stable	- -	Alter change in level to provide a 1:12 (8.33%) max. slope that connects to a beach mat. Provide an accessible route that is firm and stable. Ensure the accessible route extends to the high tide level. (Cost based on 6.5'x50' beach mat.)	1	2492	\$2492
Access to Goods and Services												
Signage												
4	Changing Rooms - Bathhouse	Ext.		Signage	Designation

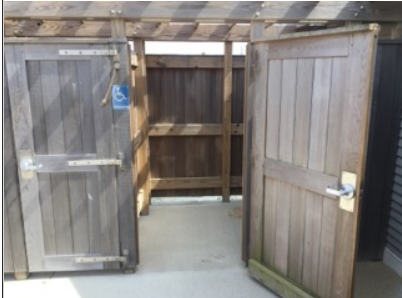
Raised characters not provided Braille not provided	- -	Provide text with raised characters duplicated in braille.	1	232	\$232

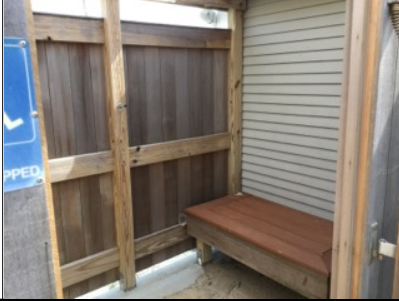
5% of changing rooms are not accessible Room is < 78" x 72" 30" clear not provided alongside bench	- - -	Provide an accessible changing room that is 78" by 72" minimum. Provide a 30" min. by 48" min. clear space along the side of the bench so that wheelchair users can transfer.	1	5866	\$5866
Toilet & Bathing Rooms												
Toilet Compartment												
6	Men's Toilet Room	1		Toilet Compartment	Accessible Compartment

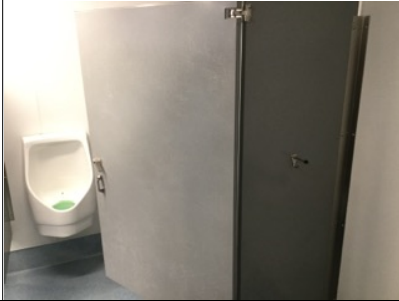
Door with malfunctioning self-closing hinge	-	Repair hinge.	1	Labor	\$0
7	Women's Toilet Room	1		Toilet Compartment	Accessible Compartment

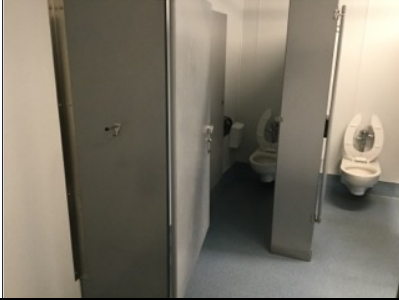
Door with malfunctioning self-closing hinge	-	Repair hinge.	1	Labor	\$0
8	Women's Toilet Room	1		Toilet Compartment	Ambulatory Compartment

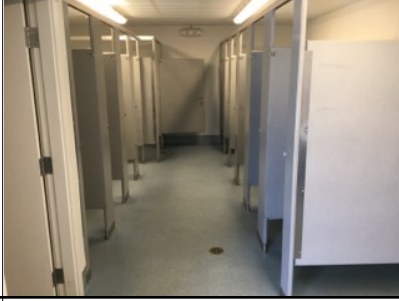
Ambulatory compartment width < 35" or > 37"	-	Provide an ambulatory accessible compartment that is 60" deep and 35"- 37" wide.	1	2052	\$2052

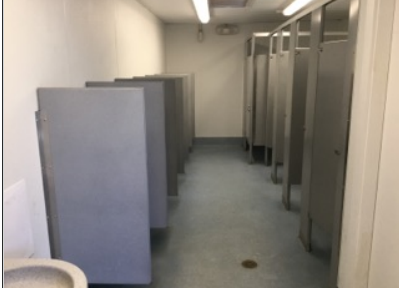
9	Men's Toilet Room	1		Toilet Compartment	Ambulatory Compartment

Ambulatory compartment width < 35" or > 37"	-	Provide an ambulatory accessible compartment that is 60" deep and 35"- 37" wide.	1	2052	\$2052

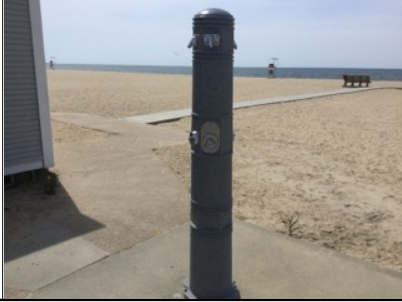
2 fixed showerheads not provided	-	Provide two showerheads located 48" and 72" min. above the ground.	1	2719	\$2719
Play and Sport Areas												
Court												
11	Volleyball	Ext.		Court	Volleyball

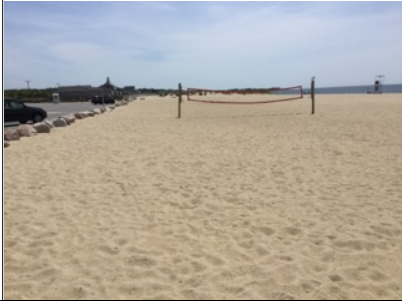
Not connected to accessible route	-	Provide an accessible route to the boundary of sport activity at the volleyball court. (Cost based on a 6.5' wide x 16.5' long Mobi-Mat beach mat extending from parking lot to boundary of sport activity. Relocate rocks in parking lot as needed to provide an accessible route.)	1	980	\$980
Best Practice												
Bench												
12	Bench	Ext.		Bench	N/A

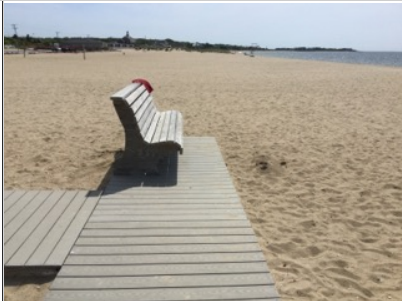
Recommend maintaining a 36" x 48" stable, firm and slip resistant surface at one end of the bench so a visitor with a wheelchair or other mobility device can sit alongside the bench with his or her shoulders aligned with someone seated on the bench.	1	-	\$0

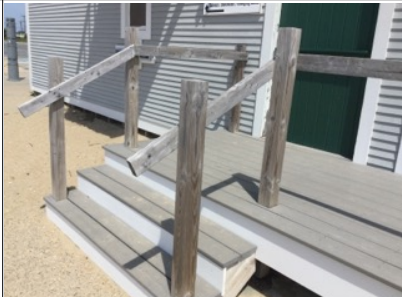
Stair Railings												
13	Stairs From Toilet Room to the Beach	Ext.		Stair Railings	N/A

Recommend providing handrails with a 1 1/4" - 2" circular cross section.	1	-	\$0
