Dowses Beach and Bathhouse

ADA Transition Plan

October 2021

**Town of Barnstable
Dowses Beach and Bathhouse**

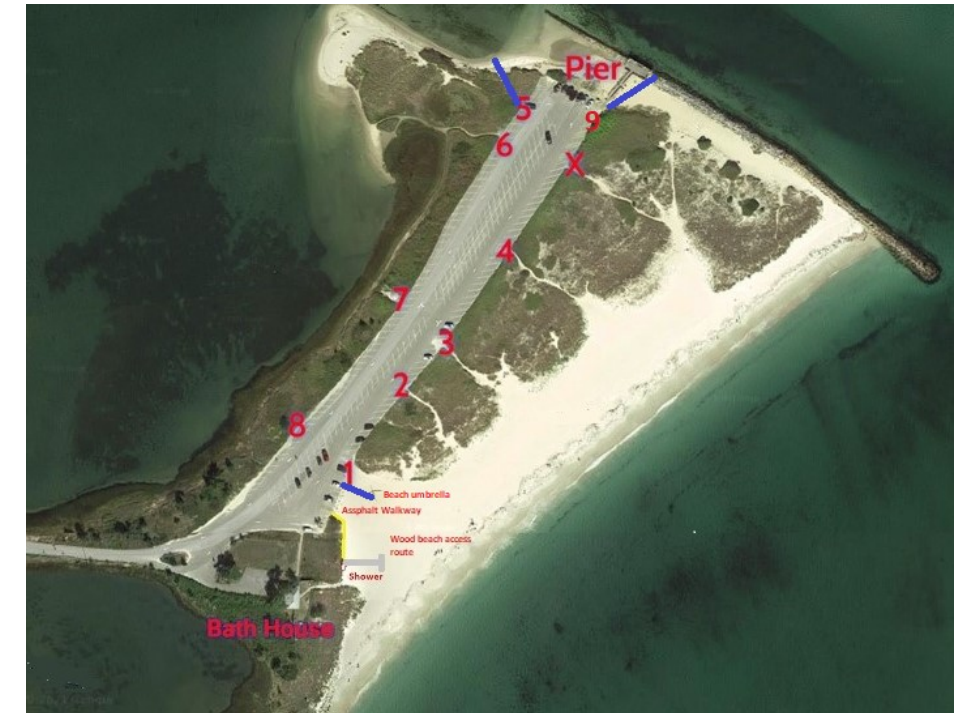
Figure 1: Red numbers show possible beach access points, with the X showing a beach access point that is marked as closed. The blue lines indicate the location where a beach access route could possibly be added (beach mat) including a route to at least one of the beach umbrellas. The yellow line shows the route of an existing asphalt walkway reaching the rinsing shower and a wooden beach access route, which is colored gray. The wooden access route should be extended to the high tide level.

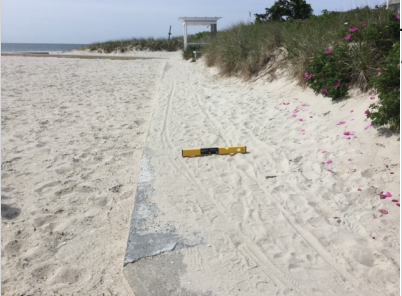
ID	Location	Floor	Room	Element	Type	Photo	Issues	Current Measure	Recommendations	Quantity	Price	Cost Estimation
Approach and Entrance												
Exterior Access Route												
1	Walkway Towards Shower and Wood Beach Access Route	Ext.		Exterior Access Route	Walkway

Cross slope > 1:50 (2.00%) Route not maintained in operable working condition	4.8% -	Reduce cross slope to be no steeper than 1:50 (2.00%). Ensure the accessible route is maintained in operable working condition between Entry Point 1 and the shower and wood beach access route. (Regularly remove sand.) (Cost based on asphalt to correct cross slope.)	1	240	\$240
2	Route From Parking to Bathhouse	Ext.		Exterior Access Route	Walkway

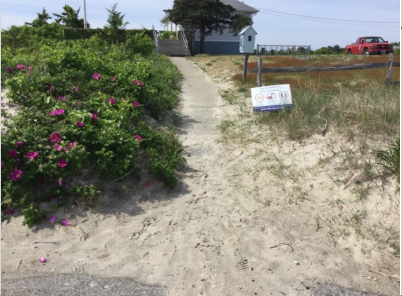
Route not maintained in operable working condition	-	Ensure the accessible route is maintained in operable working condition. (Regularly remove sand.)	1	Labor	\$0
3	Route From Bathhouse Steps to Bathhouse Entry	Ext.		Exterior Access Route	Exterior

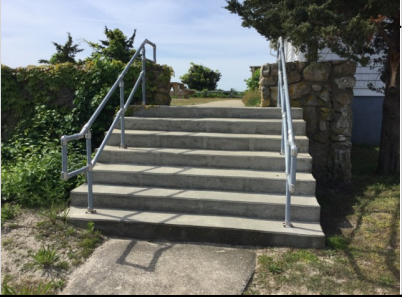
Accessible route not provided	-	Ensure an accessible route is provided. (Cost based on a new 30' pressure treated wood straight ramp providing an accessible route from this point at the stairs to the bathhouse entry door that presently has a stepped entry and high door threshold.)	1	3922	\$3922

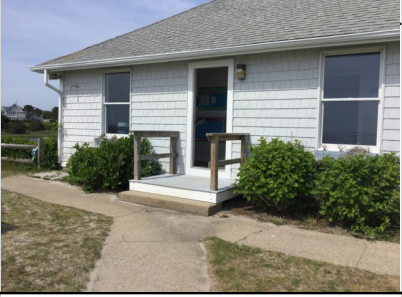
4	Route From Steps to Bathhouse Entry	Ext.		Exterior Access Route	Exterior

Accessible route not provided	-	Ensure an accessible route is provided. (Connect new ramp from exterior stairs by parking to this bathhouse entry point. Cost included in ID #3.)	1	-	\$0
5	Walkway Towards Shower and Wood Beach Access Route	Ext.		Exterior Access Route	Walkway

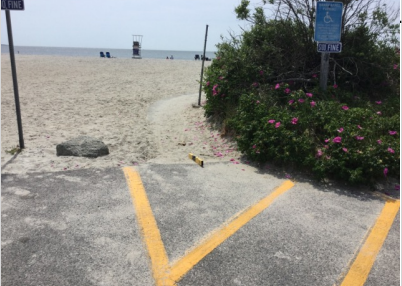
Accessible route not provided	-	Ensure an accessible route is provided. Regularly remove sand at permanent walkway to bench, shower and wooden beach access route.	1	Labor	\$0

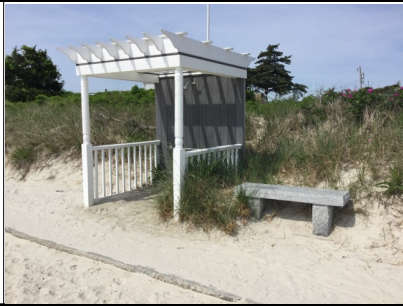
ID	Location	Floor	Room	Element	Type	Photo	Issues	Current Measure	Recommendations	Quantity	Price	Cost Estimation
6	Walkway Towards Shower and Wood Beach Access Route	Ext.		Exterior Access Route	Walkway

Accessible route not provided	-	Ensure an accessible route is provided. Regularly remove sand at permanent walkway to bench, shower and wooden beach access route.	1	Labor	\$0
Beach Access Routes												
7	Accessible Parking Near Beach Access 1 and Bathhouse	Ext.		Beach Access Routes	Removable

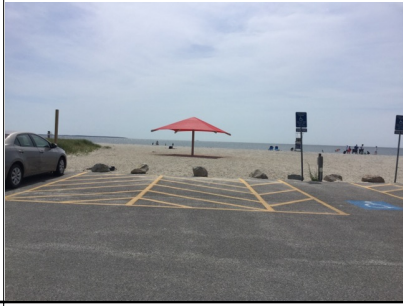
Beach route not provided	-	Provide an accessible route that is firm and stable to at least one beach umbrella. (Cost based on a 6 1/2' wide x 33' long beach mat extending from beach Access Point 1 at the accessible parking.)	1	1909	\$1909
8	Wood Beach Access Route	Ext.		Beach Access Routes	Removable

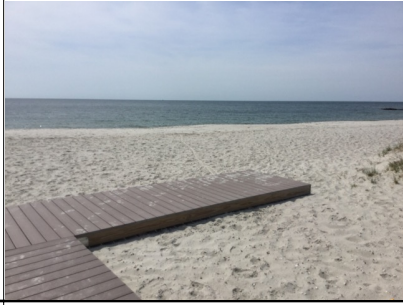
Beach route not provided	-	Provide an accessible route that is firm and stable. Ensure the accessible route extends to the high tide level. (Cost to extend existing wood beach access route to the high tide level is not provided.)	1	-	\$0

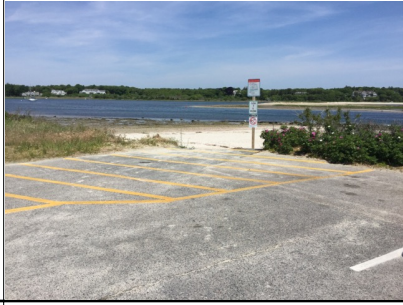
9	Beach Access Point 5, North End of Parking Lot - West Side of Pier	Ext.		Beach Access Routes	Removable

Beach route not provided	-	Provide an accessible route that is firm and stable. Ensure the accessible route extends to the high tide level. (Cost based on a 6 1/2' x 75' beach mat to the high tide level.)	1	3738	\$3738
10	Wood Beach Access Route	Ext.		Beach Access Routes	Removable

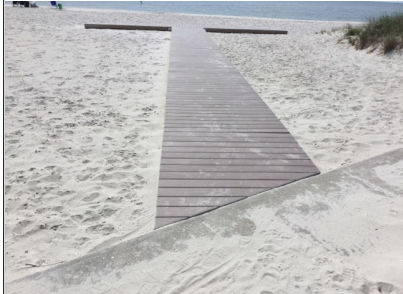
Surface is not firm and stable	-	Ensure surface at the accessible beach access route is firm and stable. (Regularly remove sand from permanent walk way and removable wood beach access route.)	1	Labor	\$0

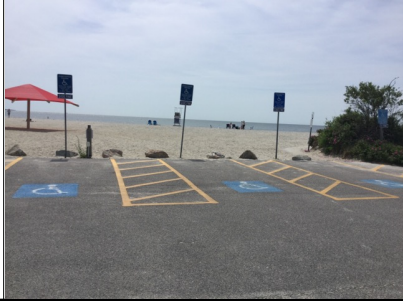
ID	Location	Floor	Room	Element	Type	Photo	Issues	Current Measure	Recommendations	Quantity	Price	Cost Estimation
Off-Street Parking Lot or Garage												
11	Accessible Parking\Near Beach Access 1 and Bathhouse	Ext.		Off-Street Parking Lot or Garage	N/A

Access aisle < 60" wide at car/van space	57"	Provide a marked access aisle that is at least 60" wide. (Re-stripe the access aisle that is just 57" wide.)	1	300	\$300
12	Accessible Parking Near Beach Access 1 and Bathhouse	Ext.		Off-Street Parking Lot or Garage	N/A

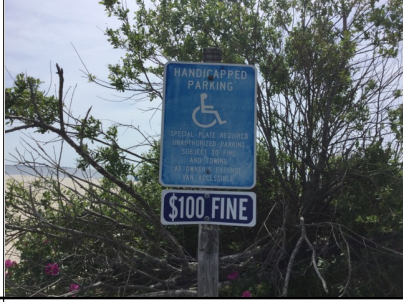
Sign bottom < 60" above finished grade	49"	Locate sign with the bottom of the sign 60" above the ground.	1	Labor	\$0
13	Accessible Parking Near Pier and Viewing Platform	Ext.		Off-Street Parking Lot or Garage	N/A

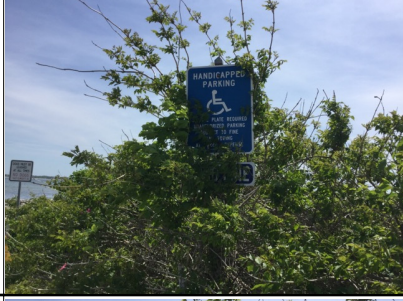
Sign not maintained in operable working condition		Trim/remove branches that block clear view of the parking sign or reposition sign.	1	Labor	\$0
14	Accessible Parking Near Pier and Viewing Platform	Ext.		Off-Street Parking Lot or Garage	N/A

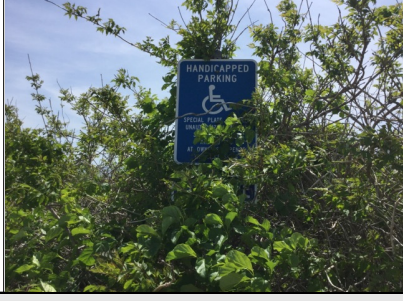
Sign not maintained in operable working condition		Trim/remove branches that block clear view of the parking sign or reposition sign.	1	Labor	\$0

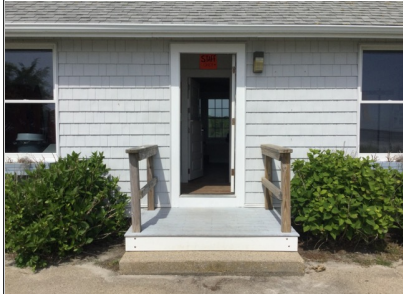
Access to Goods and Services												
Doors, Doorways, & Gates												
15	Entry to Bathhouse	Ext.		Doors, Doorways, & Gates	Toilet Room

Clear width at door < 32"	30" -	Widen the door so that there is 32" min. clear width.	1	3366	\$3366

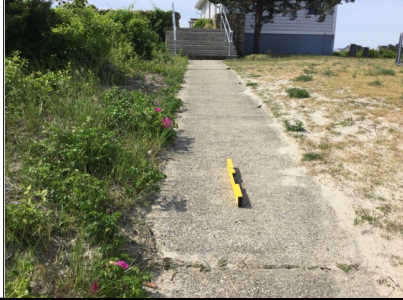
ID	Location	Floor	Room	Element	Type	Photo	Issues	Current Measure	Recommendations	Quantity	Price	Cost Estimation
Ramps												
16	Route From Parking to Bathhouse Stairs (A Ramp Due to Running Slope)	Ext.		Ramps	Exterior

Edge protection < 4" high Handrails not provided	10% - -	Provide edge protection that prevents the passage of a 4" diameter sphere, where any portion of the sphere is within 4" of the finished floor or ground surface. Provide handrails with 1-1/4" to 1-1/2" circular cross section. (Cost based on 120' of handrail (upper and lower on both sides) and 60' of edge protection.)	1	7800	\$7800
Stairways												
17	Pier and Viewing Platform Stairs to Beach	Ext.		Stairways	Exterior

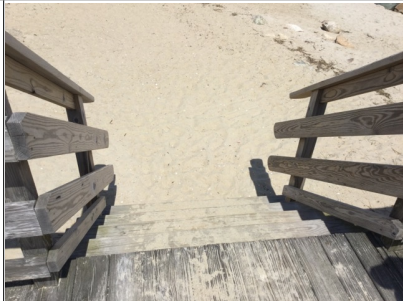
Handrails have non-compliant cross section	-	Provide handrails with a 1 1/4" - 2" circular cross section. (Cost based on 60' of compliant metal handrails.)	1	4440	\$4440
Operable Parts

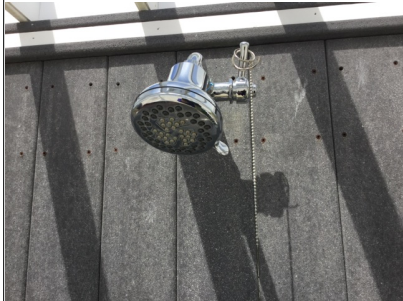
18	Rinsing Shower by Wood Beach Access Route	Ext.		Operable Parts	N/A

Side reach > 54" Not operable with a closed fist	- -	Relocate shower controls to 48" max. above the finished floor. Provide hardware that can be operable with one hand and does not require tight grasping, pinching, or twisting of the wrist. (Lower mechanism that controls shower and attach a control to the end that can be operated with a closed fist.)	1	Labor	\$0
Picnic Tables												
19	Adjacent to Bathhouse	Ext.		Picnic Tables	N/A

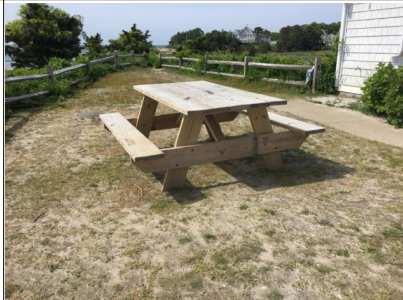
Toe or knee clearance at table not provided Picnic table not on an accessible route	9" -	Provide at least one picnic table with top between 28"- 34" above the ground and 27" clear height underneath. Ensure that the dining surface is connected to an accessible route.	1	1400	\$1400

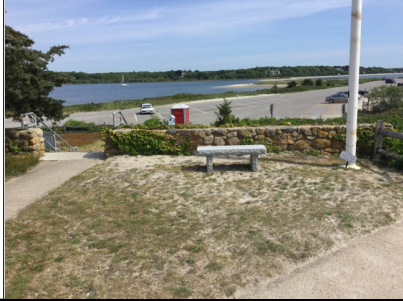
ID	Location	Floor	Room	Element	Type	Photo	Issues	Current Measure	Recommendations	Quantity	Price	Cost Estimation
Benches												
20	Adjacent to Bathhouse	Ext.		Benches	N/A

No accessible route to one bench in this area		Provide an accessible route to at least one bench in this area. (Cost based on a 4' wide min. x 6' long asphalt walkway connecting the existing walkway with the end of the bench.)	1	240	\$240
Bike Rack												
21	Near Bathhouse	Ext.		Bike Rack	N/A

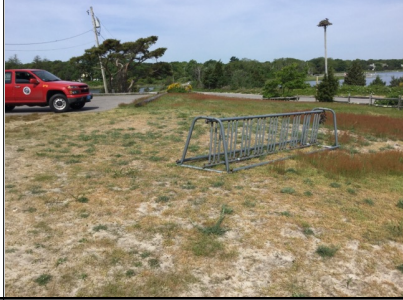
Not connected to an accessible route.		Ensure bike rack is connected to an accessible route. (Relocate bike rack.)	1	Labor	\$0
Toilet & Bathing Rooms												
Overall Access												
22	Women's Toilet Room	1		Overall Access	Toilet Room

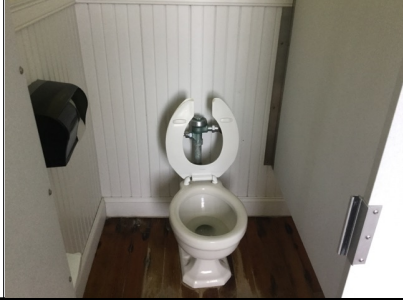
Accessible plumbing fixtures or stalls not provided	-	Provide one accessible wheelchair compartment.	1	6182	\$6182
23	Men's Toilet Room	1		Overall Access	Toilet Room

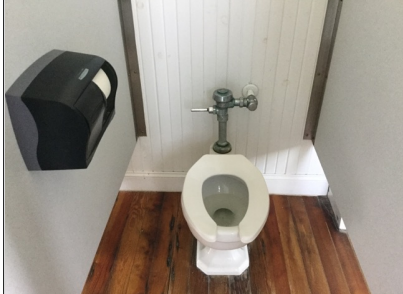
Accessible plumbing fixtures or stalls not provided	-	Provide one accessible wheelchair compartment.	1	6182	\$6182

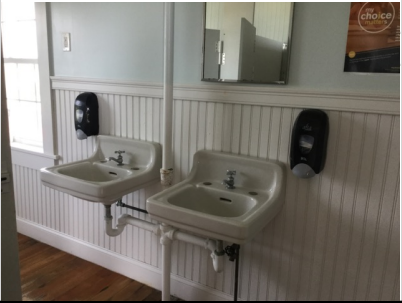
ID	Location	Floor	Room	Element	Type	Photo	Issues	Current Measure	Recommendations	Quantity	Price	Cost Estimation
Lavatory												
24	Men's Toilet Room	1		Lavatory	N/A

Toe or knee clearances not provided Exposed plumbing underneath Mirror above lavatory w/reflective surface > 40"	25" - 52"	Provide at least one lavatory with knee and toe clearance positioned for a forward approach. Insulate or otherwise configure pipes to prevent contact for at least one lavatory. Lower mirror so that the bottom surface is at 40" max. above the finished floor.	1	2034	\$2034
25	Women's Toilet Room	1		Lavatory	N/A

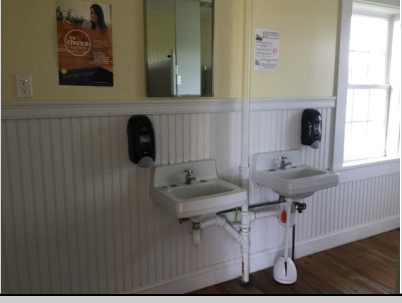
Toe or knee clearances not provided Mirror above lavatory w/reflective surface > 40"	24.5" 51.5"	Provide at least one lavatory with knee and toe clearance positioned for a forward approach. Lower mirror so that the bottom surface is at 40" max. above the finished floor.	1	1942	\$1942
Outdoor Rinsing Showers

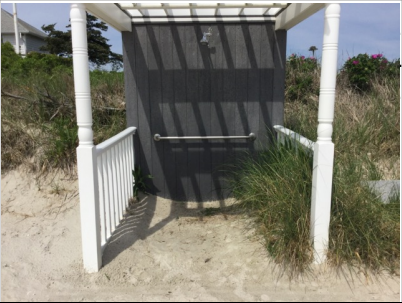
26	Rinsing Shower by Wood Beach Access Route	Ext.		Outdoor Rinsing Showers	N/A

Rinsing shower not on an accessible route 2 fixed showerheads not provided Showerheads > 48" or < 72" above the ground surface	- 69"	Ensure the accessible route is maintained in operable working condition. Regularly remove sand from shower surface. Provide two showerheads located 48" and 72" min. above the ground.	1	2719	\$2719
Portable Toilet												
27	Adjacent to Parking Lot	Ext.		Portable Toilet	N/A

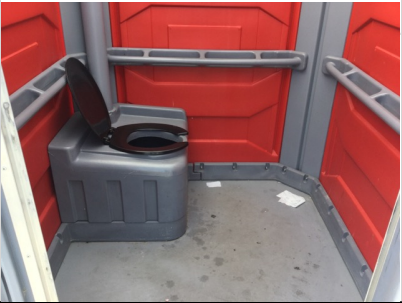
Accessible portable toilets not provided	59"	Provide an accessible portable toilet that has 60" wide and 72" deep clear floor space at the toilet. (Cost to provide an accessible portable toilet not provided.)	1	-	\$0
Best Practice

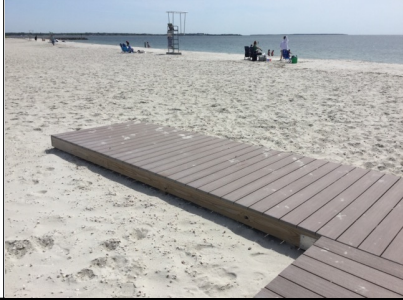
ID	Location	Floor	Room	Element	Type	Photo	Issues	Current Measure	Recommendations	Quantity	Price	Cost Estimation
Beach Access Route												
28	Wood Beach Access Route	Ext.		Beach Access Route	N/A

Recommend extending beach access route to at least one lifeguard station so a visitor with a mobility disability could more easily navigate to a lifeguard station should the need arise.	1	-	\$0
Monument												
29	Adjacent to Pier	Ext.		Monument	N/A

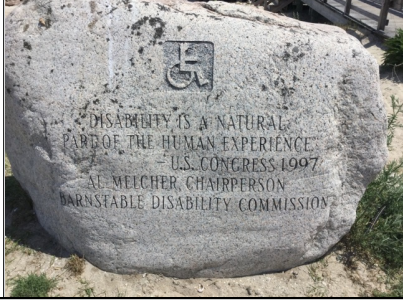
Recommend that the beach access route by the viewing platform at Access Point 5 include a portion that allows visitors with mobility disabilities to approach this monument.	1	-	\$0
Van Accessible Parking												
30	Accessible Parking Near Pier	Ext.		Van Accessible Parking	N/A

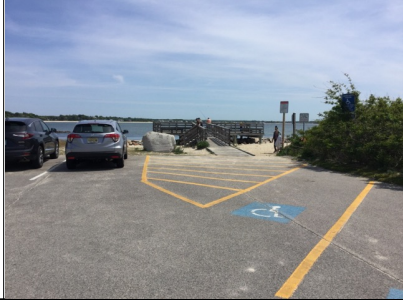
Recommend providing a van accessible parking space with a marked access aisle and sign at the northern end of the parking lot by the pier and observation deck. (The lot overall has the required number of car and van accessible parking spaces, and there are car accessible spaces at both ends of the lot, which is about 800 feet long, but the northern end of the lot lacks a van accessible space.)	1	-	\$0

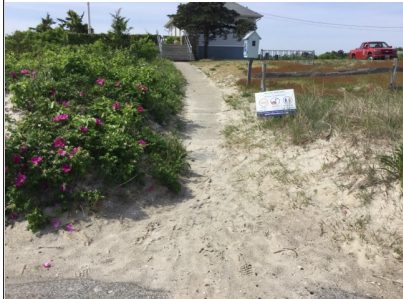
Walkway												
31	Route From Parking to Bath House	Ext.		Walkway	N/A

Recommend providing a sign indicating that there is an accessible route to the beach at both ends of the parking lot where the accessible parking is located.	1	-	\$0
