## Prince Cove Marina

## Town of Barnstable ADA Transition Plan

Institute for Human Centered Design

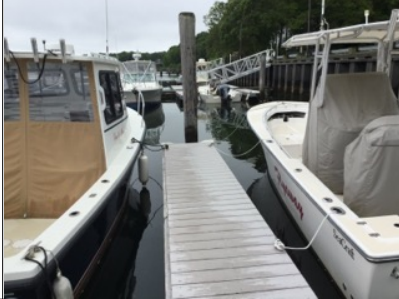
Boat slip clearance < 60" wide	36"	Ensure there is at least a 60" wide clear pier space at the boat slip.  (Cost of 60" min. width at pier is not provided.)	1	-	\$0
2	Near Office Entrance	Ext.		Exterior Access Route	Exterior

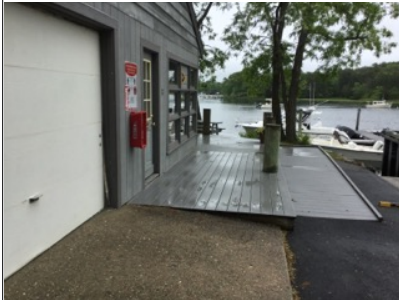
Route obstructed by protruding objects	6.75"	Provide a cane-detectable barrier at fire extinguisher.	1	306	\$306
3	Rental Shop Deck	Ext.		Exterior Access Route	Exterior

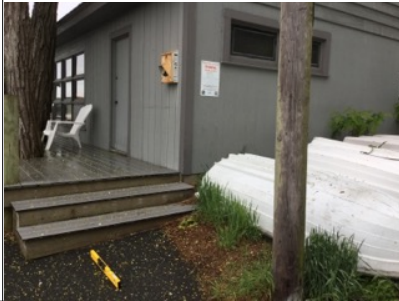
Route obstructed by protruding objects	8"	Relocate dog waste bags.	1	Labor	\$0
4	Near Office	Ext.		Exterior Access Route	Exterior

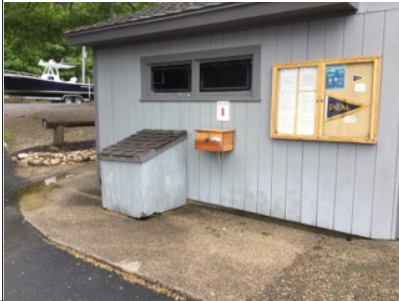
Route obstructed by protruding objects Level changes > 1/4"	13.7" 1.75"	Provide a cane-detectable barrier at the drop off box. Alter change in level to be 1/4" high max.  (Cost of renovating exterior access route is not provided.)	1	306	\$306

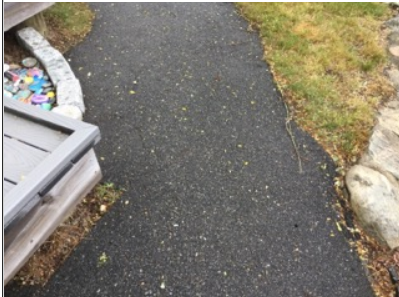
5	Route by Deck to Boat Ramp	Ext.		Exterior Access Route	Exterior

Cross slope > 1:50 (2.00%)	6.6%	Reduce cross slope to be no steeper than 1:50 (2.00%).	1	-	\$0

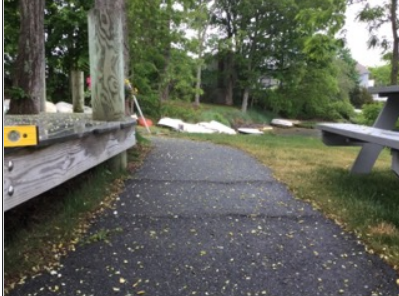
Cross slope > 1:50 (2.00%)	4.5%	Reduce cross slope to be no steeper than 1:50 (2.00%).	1	-	\$0
7	Route by Deck to Boat Ramp Facing North	Ext.		Exterior Access Route	Exterior

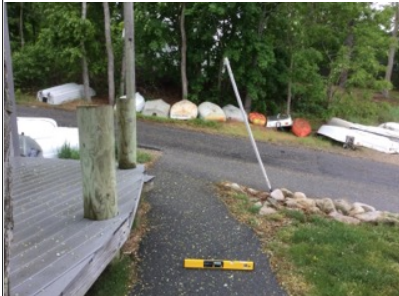
Cross slope > 1:50 (2.00%)	5.7%	Reduce cross slope to be no steeper than 1:50 (2.00%).	1	-	\$0
8	Ramp to Deck	Ext.		Exterior Access Route	Exterior

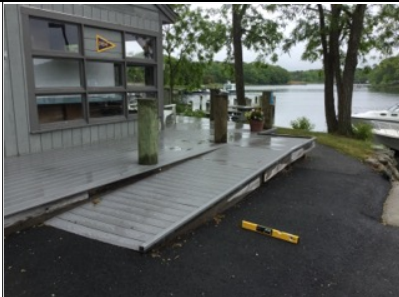
Cross slope > 1:50 (2.00%)	5.2%	Reduce cross slope to be no steeper than 1:50 (2.00%).	1	-	\$0
9	Path to Fishing Pier	Ext.		Exterior Access Route	Exterior

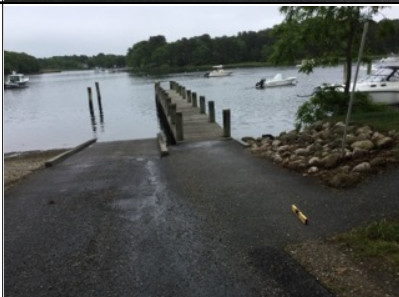
Cross slope > 1:50 (2.00%) Running slope > 1:20 (5%)	3.4% 12.1%	Reduce cross slope to be no steeper than 1:50 (2.00%). Reduce running slope to be no steeper than 1:20 (5%).	1	-	\$0
10	Route by Rental Shop Deck South Side	Ext.		Exterior Access Route	Exterior

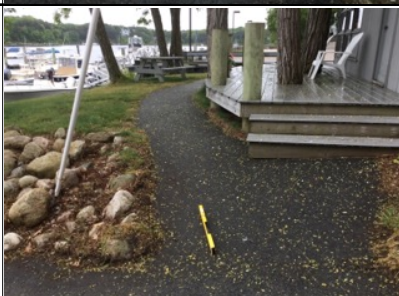
Cross slope > 1:50 (2.00%) Running slope > 1:20 (5%)	16.1% 11.1%	Reduce cross slope to be no steeper than 1:50 (2.00%). Reduce running slope to be no steeper than 1:20 (5%).	1	-	\$0

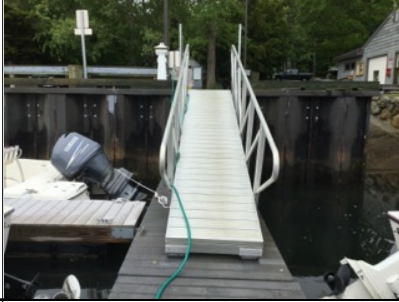
Level changes > 1/4" Pier clearance < 60" wide Edge protection not provided	9" 48" -	Provide a transition plate to alter change in level to be 1/4" high max.  (Cost of transition plate, widening the pier and edge protection is not provided.)	1	-	\$0
12	Route From Dock to Deck	Ext.		Exterior Access Route	Exterior

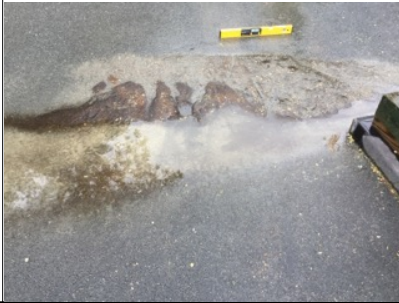
Surface is not stable, firm, and slip-resistant Does not prevent accumulation of water	- -	Repair surface.	1	-	\$0
13	To Toilet Rooms	Ext.		Exterior Access Route	Exterior

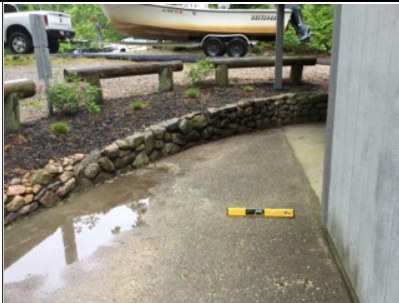
Does not prevent accumulation of water	-	Repair surface.	1	-	\$0
14	To Toilet Rooms	Ext.		Exterior Access Route	Exterior

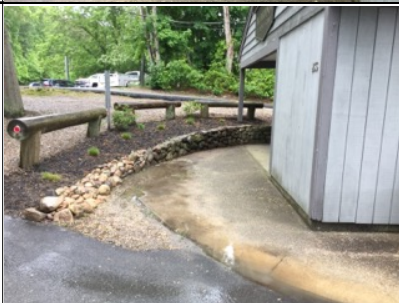
Does not prevent accumulation of water Route not maintained in operable working condition	- -	Repair surface. Ensure the accessible route is maintained in operable working condition.	1	-	\$0

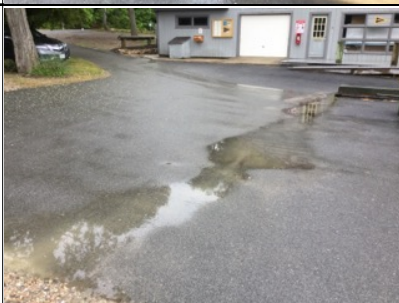
15	Route From Parking Lot to Office	Ext.		Exterior Access Route	Exterior

Does not prevent accumulation of water Route not maintained in operable working condition	- -	Repair surface. Ensure the accessible route is maintained in operable working condition.	1	-	\$0

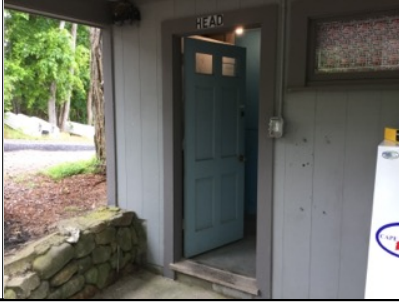
Accessible route not provided	-	Provide a 4' wide and 6' long ramp at the toilet room door.	1	1478	\$1478
<b>Off-Street Parking Lot or Garage</b>												
17	Parking Lot	Ext.		Off-Street Parking Lot or Garage	Visitor

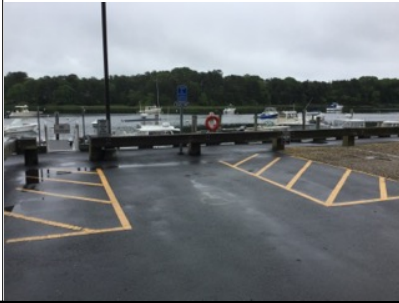
Sign does not have the designation "Van Accessible"	-	Add the designation "Van Accessible" to the sign located at the van accessible space.	1	500	\$500
<b>Access to Goods and Services</b>												
<b>Doors, Doorways, &amp; Gates</b>												
18	Single-User Toilet Room	1		Doors, Doorways, & Gates	Other

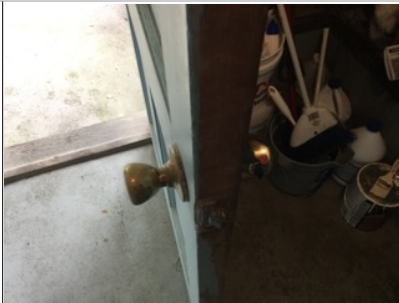
Hardware not operable with a closed fist	-	Provide hardware that can be operable with one hand and not require tight grasping, pinching, or twisting of the wrist.  (Cost included in ID #22.)	1	-	\$0

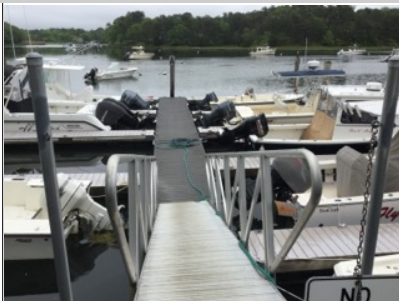
Running slope >1:12 (8.33%)	31.4%	Reduce running slope to be no steeper than 1:12 (8.33%).  (Study needed to determine the cost and feasibility of the gangway.)	1	-	\$0

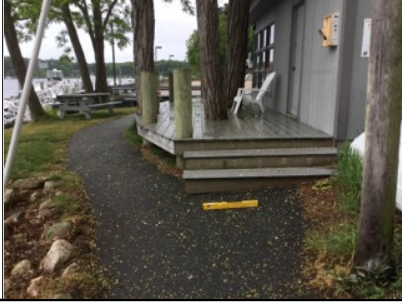
Handrails not provided Tread widths and/or riser heights are not uniform	- -	Provide handrails. It may not be technically feasible to adjust risers or treads, however stairs may be hazardous for users.  (Cost of 6' long handrails on both sides.)	1	834	\$834
<b>Picnic Tables</b>												
21	Route Near Deck to Boat Ramp	Ext.		Picnic Tables	N/A

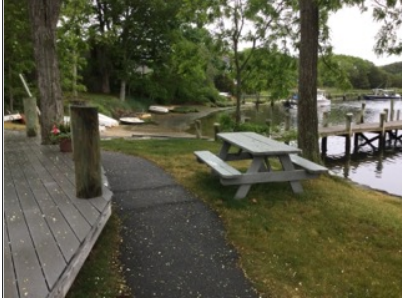
Top of picnic table < 28" or > 34" 30" clear width not provided Toe or knee clearance at table not provided	27.6" 28" 8	Provide one (1) picnic table with top between 28"- 34" above the ground and 27" clear height underneath.	1	1400	\$1400
<b>Toilet &amp; Bathing Rooms</b>												
<b>Overall Access</b>												
22	Single-User Toilet Room	1		Overall Access	Toilet Room

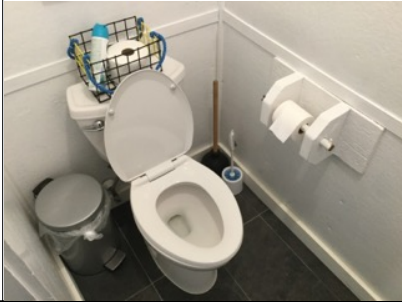
Turning space not provided	-	Provide an accessible single-user toilet room.  (Ensure the electrical closet does not interfere with the required clear floor space in the toilet room.)	1	24604	\$24604

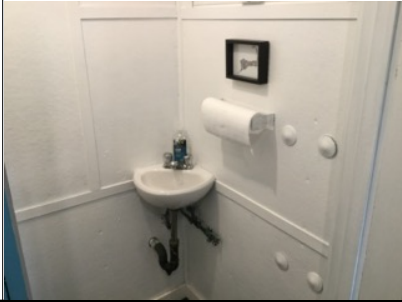
Toe or knee clearances not provided Faucet not operable with a closed fist Exposed plumbing underneath	- - -	Provide a lavatory with knee and toe clearance positioned for a forward approach. Provide a faucet that can be operable with one hand and not require tight grasping, pinching, or twisting of the wrist for at least one lavatory. Insulate or otherwise configure pipes to prevent contact for at least one lavatory.  (Cost to renovate lavatory included in ID #22.)	1	-	\$0
<b>Best Practice</b>

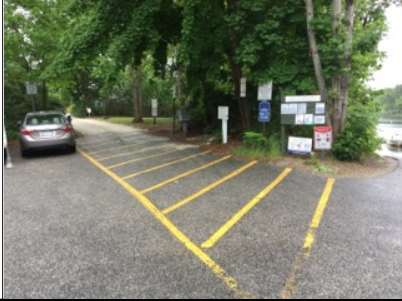
Recommend providing a sign indicating the location of the accessible parking space.	1		\$0
25	Rental Shop Deck	Ext.		Signage	N/A

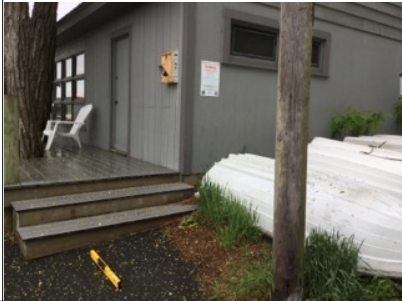
Recommend relocating fishing signage to the accessible parking space. Recommend providing contrasting color strips at exterior staircase.	1		\$0
26	Parking Lot	Ext.		Signage	N/A

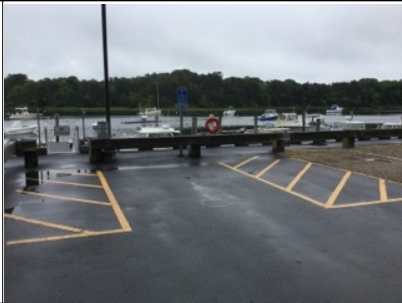
Recommend providing a sign with information on the accessible boat slip.	1		\$0
