# Comfort Station 4 at 110 Freezer Road

## Town of Barnstable ADA Transition Plan

July 2021

**Town of Barnstable**  
**Comfort Station at 110 Freezer Road**

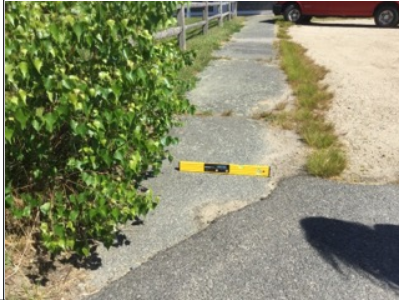
ID	Location	Floor	Room	Element	Type	Photo	Issues	Current Measure	Recommendations	Quantity	Price	Cost Estimation
<b>Approach and Entrance</b>												
<b>Exterior Access Route</b>												
1	Path to Comfort Station	Ext.		Exterior Access Route	Walkway

Cross slope > 1:50 (2.00%) Surface is not stable, firm, and slip-resistant	4.9% -	Reduce cross slope to be no steeper than 1:50 (2.00%). Repair surface.  (Cost provided in ID #3.)	1	-	\$0
2	Path to Comfort Station	Ext.		Exterior Access Route	Walkway

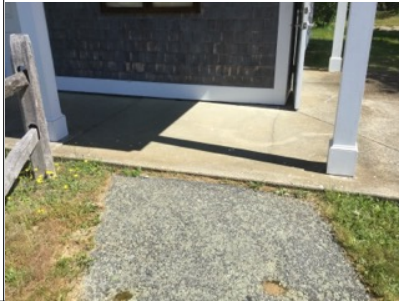
Level changes > 1/4" Does not prevent accumulation of water	1.5" -	Alter change in level to be 1/4" high max. Repair surface.  (Cost provided in ID #3.)	1	-	\$0
3	Path to Comfort Station	Ext.		Exterior Access Route	Walkway

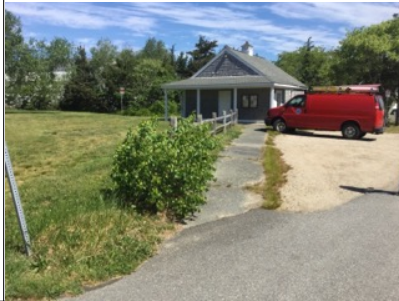
Surface is not stable, firm, and slip-resistant	-	Repair surface.  (Cost for a 4' wide by 60' long concrete path.)	1	3840	\$3840
4	Path to Comfort Station	Ext.		Exterior Access Route	Walkway

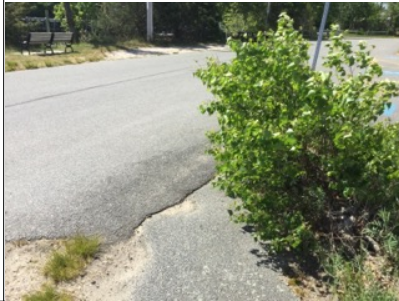
Surface is not stable, firm, and slip-resistant	-	Repair surface.  (Cost provided in ID #3.)	1	-	\$0

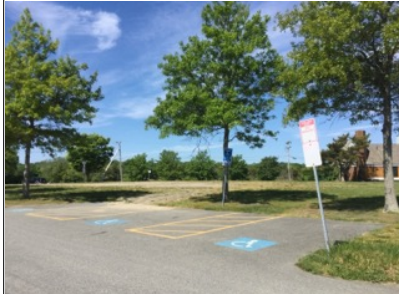
<b>Off-Street Parking Lot or Garage</b>												
5	Parking Lot	Ext.		Off-Street Parking Lot or Garage	Visitor

Total # of parking Total # of designated accessible parking spaces Total # of designated van accessible spaces Access aisle < 96" wide at van space Sign not provided Sign does not have the designation "Van Accessible" Sign top > 96" above finished grade	5 2 1 90" - 102.5"	Provide a marked access aisle that is at least 96" wide. Provide two (2) signs with the International Symbol of Accessibility (ISA) with the bottom of the sign 60" minimum above the ground and the top 96" max. above the ground. Add the designation "Van Accessible" to the sign located at the van accessible space. Locate top of sign 96" max. above the ground.	1	1800	\$1800
<b>Access to Goods and Services</b>

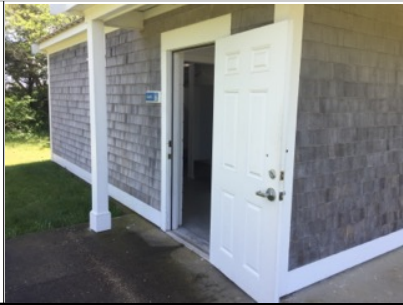
ID	Location	Floor	Room	Element	Type	Photo	Issues	Current Measure	Recommendations	Quantity	Price	Cost Estimation
<b>Doors, Doorways, &amp; Gates</b>												
6	Women's Toilet Room	Ext.		Doors, Doorways, & Gates	Toilet Room

Threshold > 1/2" high	1.25"	Alter the threshold to be 1/2" high max.	1	150	\$150
7	Women's Shower	1		Doors, Doorways, & Gates	Shower Compartment

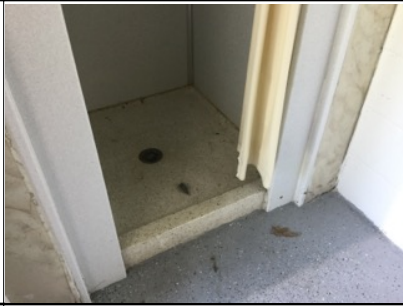
Threshold > 1/2" high	4"	Alter the threshold to be 1/2" high max. (Cost provided in ID #25.)	1	-	\$0
8	Men's Shower	1		Doors, Doorways, & Gates	Shower Compartment

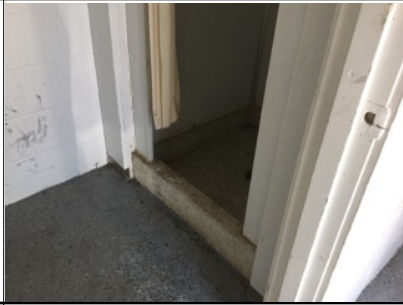
Threshold > 1/2" high	4"	Alter the threshold to be 1/2" high max. (Cost provided in ID #26.)	1	-	\$0
9	Men's Toilet Room	Ext.		Doors, Doorways, & Gates	Toilet Room

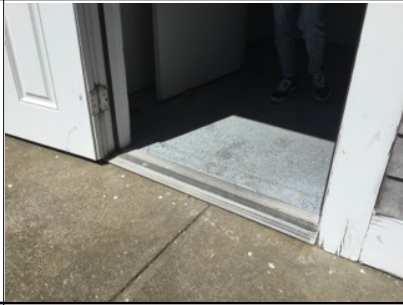
Threshold > 1/2" high	1.5"	Alter the threshold to be 1/2" high max.	1	150	\$150
10	Women's Shower	1		Doors, Doorways, & Gates	Shower Compartment

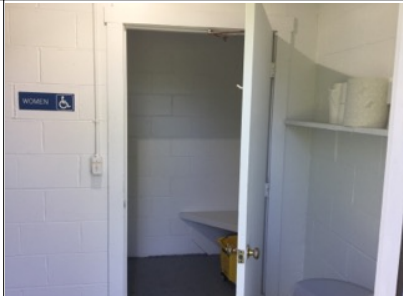
Hardware not operable with a closed fist	-	Provide hardware that can be operable with one hand and not require tight grasping, pinching, or twisting of the wrist.	1	484	\$484

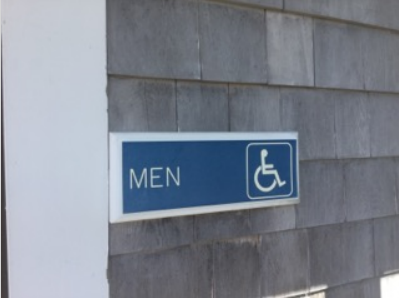
Raised characters not provided on sign Braille not provided on sign	- -	Provide text with raised characters duplicated in braille on sign.	1	232	\$232
13	Men's Shower	1		Signage	Designation

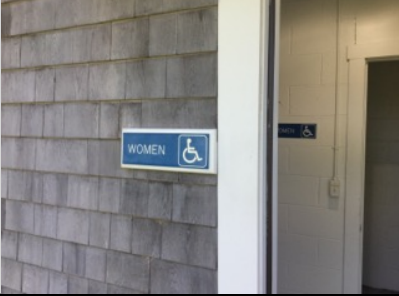
Raised characters not provided on sign Braille not provided on sign	- -	Provide text with raised characters duplicated in braille on sign.	1	232	\$232

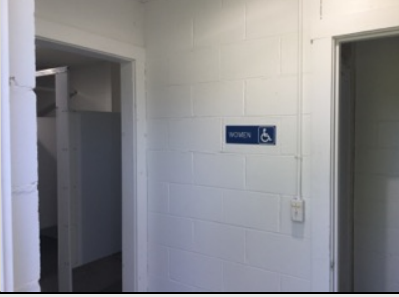
15	Women's Shower	1		Signage	Designation

Raised characters not provided on sign Braille not provided on sign	- -	Provide text with raised characters duplicated in braille on sign.	1	232	\$232
<b>Toilet &amp; Bathing Rooms</b>

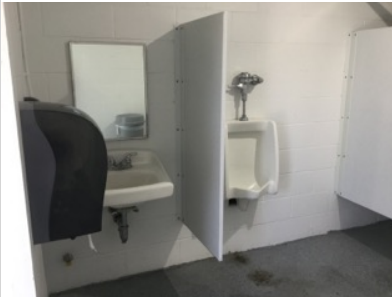
ID	Location	Floor	Room	Element	Type	Photo	Issues	Current Measure	Recommendations	Quantity	Price	Cost Estimation
<b>Overall Access</b>												
16	Men's Toilet Room	1		Overall Access	Toilet Room

Audible and visible alarms not provided	-	When fire system is updated, ensure that a visible and audible fire alarm is installed.  (Cost of fire systems is not provided.)	1	-	\$0
17	Women's Toilet Room	1		Overall Access	Toilet Room

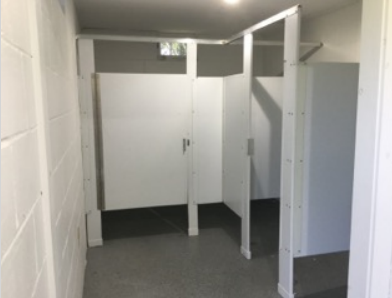
Audible and visible alarms not provided	-	When fire system is updated, ensure that a visible and audible fire alarm is installed.  (Cost of fire systems is not provided.)	1	-	\$0
<b>Lavatory</b>												
18	Women's Toilet Room	1		Lavatory	N/A

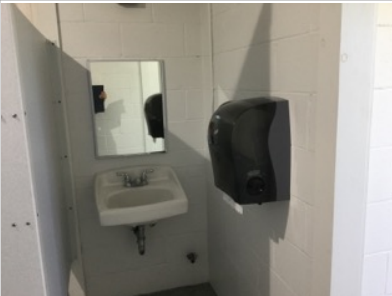
Clear floor space not provided at lavatory Toe or knee clearances not provided Dispenser acts as a protruding object Plumbing underneath is exposed	28" 26" - 9.5"	Provide a lavatory with a 30" min. by 48" min. clear floor space positioned for a forward approach. Provide a lavatory with knee and toe clearance positioned for a forward approach. Relocate dispenser out of the circulation path. Insulate or otherwise configure pipes to prevent contact for at least one lavatory.	1	2034	\$2034

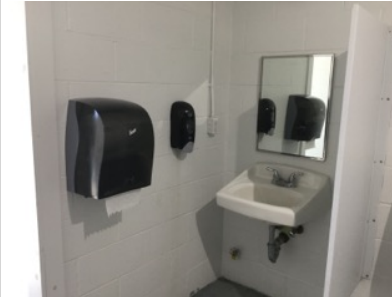
19	Men's Toilet Room	1		Lavatory	483

Plumbing underneath is exposed Dispenser acts as a protruding object	- 9.5"	Insulate or otherwise configure pipes to prevent contact for at least one lavatory. Relocate dispenser out of the circulation path.	1	348	\$348
<b>Toilet Compartment</b>												
20	Men's Toilet Room	1		Toilet Compartment	Accessible Compartment

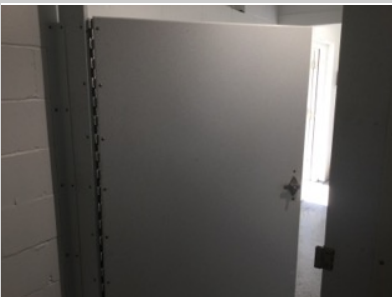
Door has non-compliant hardware Coat hook > 48"	- -	Provide hardware that can be operable with one hand and not require tight grasping, pinching, or twisting of the wrist. Lower coat hook so that it is no higher than 48".	1	220	\$220

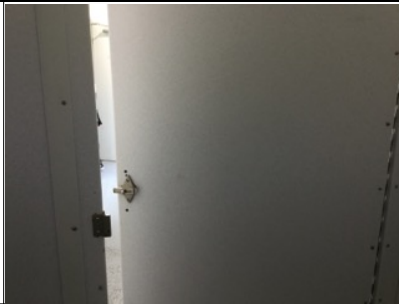
ID	Location	Floor	Room	Element	Type	Photo	Issues	Current Measure	Recommendations	Quantity	Price	Cost Estimation
21	Women's Toilet Room	1		Toilet Compartment	Accessible Compartment

Door has non-compliant hardware Coat hook > 48"	- -	Provide hardware that can be operable with one hand and not require tight grasping, pinching, or twisting of the wrist. Lower coat hook so that it is no higher than 48".	1	220	\$220
22	Women's Toilet Room	1		Toilet Compartment	Accessible Compartment

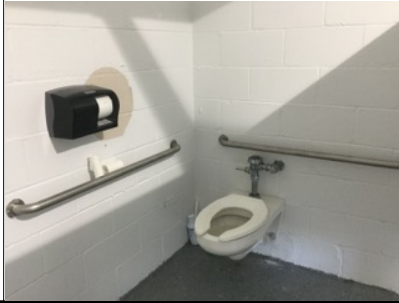
Side or rear grab bar < 33" or >36" high Flush control not on open side Non-compliant toilet paper dispenser	31" - -	Locate grab bars between 33"- 36" above the finished floor. Provide the flush control on the open side of the toilet (transfer side). Relocate toilet paper so that it is 24" minimum high, located under the grab bar, and between 7" and 9" from the front of the toilet.	1	1142	\$1142
23	Men's Toilet Room	1		Toilet Compartment	Accessible Compartment

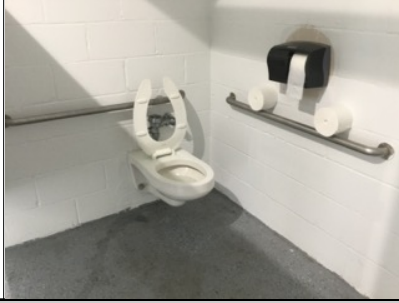
Side or rear grab bar < 33" or >36" high Non-compliant toilet paper dispenser Centerline < or > 18" (MAAB)	31.25" - 19"	Locate grab bars between 33"- 36" above the finished floor. Relocate toilet paper so that it is 24" minimum high, located under the grab bar, and between 7" and 9" from the front of the toilet. Relocate toilet so the centerline is 18" from the side wall.	1	3596	\$3596

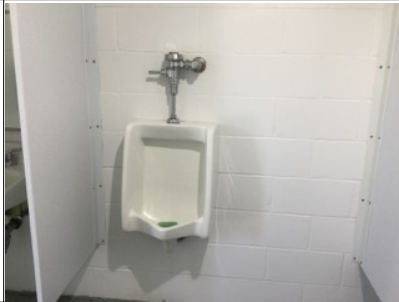
<b>Urinal</b>												
24	Men's Toilet Room	1		Urinal	N/A

Rim > 17" high Flush control too high or not properly located	25.75" 54"	Provide at least one urinal with the rim no higher than 17" above the finished floor. Mount flush control at 44" maximum above the finished floor.	1	3248	\$3248
<b>Shower Compartment</b>												
25	Women's Shower	1		Shower Compartment	N/A

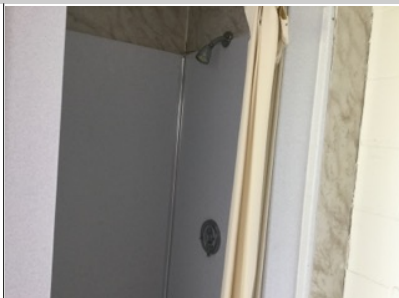
Accessible shower not provided	-	Provide one (1) accessible shower.  (Cost based on a transfer shower.)	1	6072	\$6072

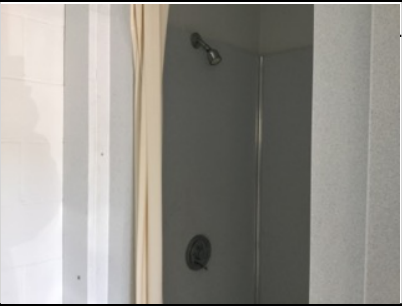
ID	Location	Floor	Room	Element	Type	Photo	Issues	Current Measure	Recommendations	Quantity	Price	Cost Estimation
26	Men's Shower	1		Shower Compartment	N/A

Accessible shower not provided	-	Provide one (1) accessible shower.  (Cost based on a transfer shower.)	1	6072	\$6072
<b>Changing Rooms</b>												
27	Women's Changing Room	1		Changing Rooms	Women's

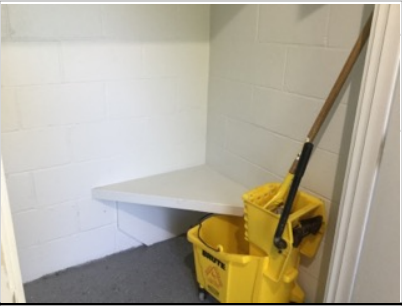
Room is < 78" x 72" 30" clear not provided alongside bench Bench < 24" deep Bench < 48" long	25.75" - - -	Provide an accessible changing room that is 78" by 72" minimum. Provide a 30" by 48" minimum clear space along the side of the bench so that wheelchair users can transfer. Provide a bench that is 24" deep and 48" long minimum.	1	5866	\$5866
28	Men's Shower Changing Room	1		Changing Rooms	Men's

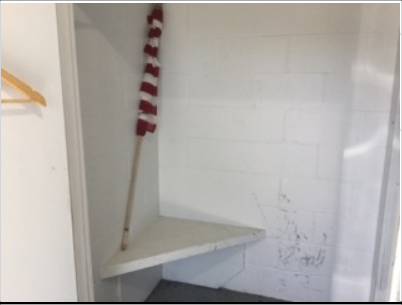
Room is < 78" x 72" 30" clear not provided alongside bench Bench < 24" deep Bench < 48" long	- 24.75" - -	Provide an accessible changing room that is 78" by 72" minimum. Provide a 30" by 48" minimum clear space along the side of the bench so that wheelchair users can transfer. Provide a bench that is 24" deep and 48" long minimum.	1	5866	\$5866

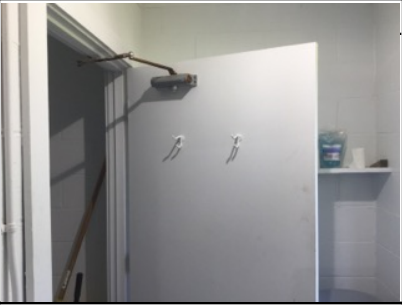
29	Women's Shower Changing Room	1		Changing Rooms	Women's

Hook > 48" high	63.75"	Locate hook no higher than 48" above the finished floor.  (Cost provided in ID #25.)	1	-	\$0
30	Men's Changing Room	1		Changing Rooms	Men's

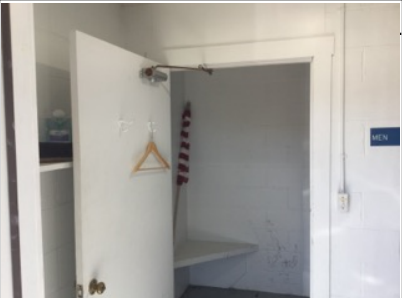
Hook > 48" high	63.75"	Locate hook no higher than 48" above the finished floor.  (Cost provided in ID #26.)	1	-	\$0
