Town Hall

Town of Barnstable ADA Transition Plan

October 2021

Institute for Human Centered Design

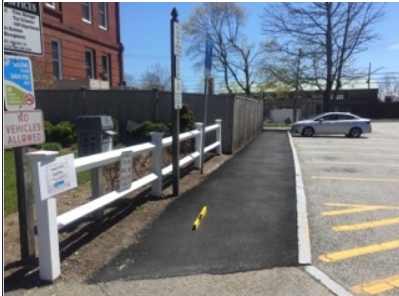
Cross slope > 1:50 (2.00%)	4.5"	Reduce cross slope to be no steeper than 1:50 (2.00%). (Cost for adding concrete to correct pathway cross slope.)	1	240	\$240
2	Town Hall Parking Lot - West Side	Ext.		Exterior Access Route	Exterior

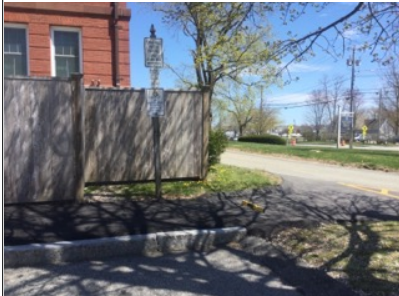
Cross slope > 1:50 (2.00%)	3.5%	Reduce cross slope to be no steeper than 1:50 (2.00%). (Cost for adding concrete to correct pathway cross slope.)	1	240	\$240
3	Town Hall Parking Lot - West Side	Ext.		Exterior Access Route	Exterior

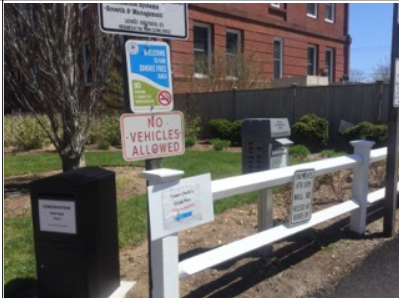
Accessible route not provided	-	Locate payment drop-off box on an accessible route.	1	Labor	\$0
4	Town Hall Parking Lot - West Side	Ext.		Exterior Access Route	Exterior

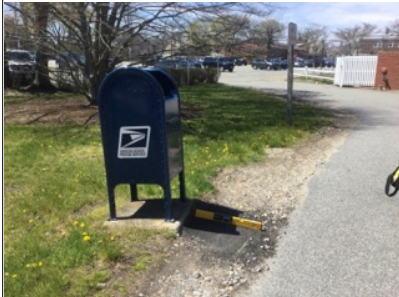
Accessible route not provided	-	Locate mail box on an accessible route.	1	Labor	\$0

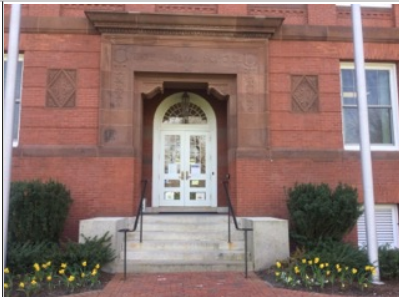
Entrance												
5	Main Front Entrance/Exit	Ext.		Entrance	Main Entrance

Entrance not on an accessible route Directional sign to accessible entrance not provided	- -	Provide a directional sign indicating the location of the nearest accessible entrance.	1	346	\$346

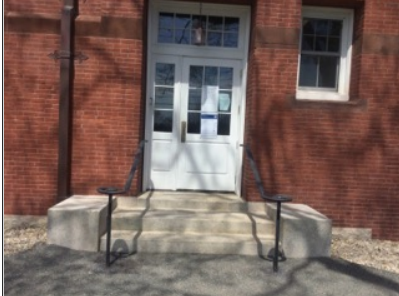
Entrance not on an accessible route Directional sign to accessible entrance not provided	- -	Provide a directional sign indicating the location of the nearest accessible entrance.	1	346	\$346
7	Entry/Exit - Stair Near Elevator	Ext.		Entrance	Secondary Entrance

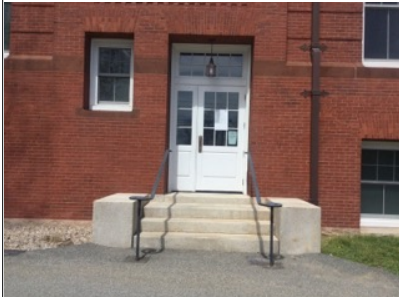
Entrance not on an accessible route Directional sign to accessible entrance not provided	- -	Provide a directional sign indicating the location of the nearest accessible entrance.	1	346	\$346
Access to Goods and Services												
Means of Egress												
8	Main Front Entrance/ Exit to Village Green	1		Means of Egress	N/A

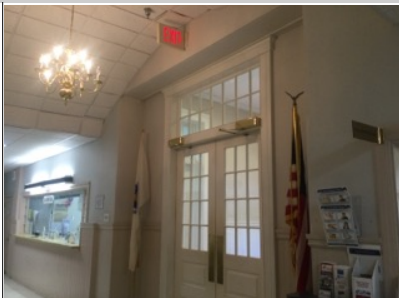
Tactile exit sign not provided	-	Ensure a tactile exit sign with raised characters and braille is provided at exit door. Mount sign between 48"- 60" above the finished floor located on the latch side of the door.	1	232	\$232

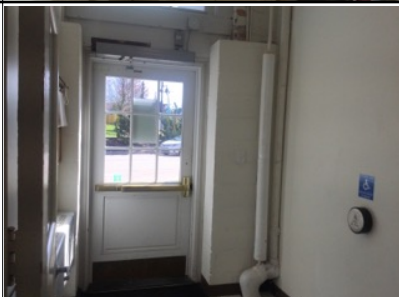
9	Accessible Entrance/ Exit	B		Means of Egress	N/A

Tactile exit sign not provided Illuminated ISA symbol not provided (MAAB)	- -	Ensure a tactile exit sign with raised characters and braille is provided at exit door. Mount sign between 48"- 60" above the finished floor located on the latch side of the door. Provide an illuminated sign with the International Symbol of Accessibility.	1	432	\$432
10	Entry/Exit - Stair #2	.5		Means of Egress	N/A

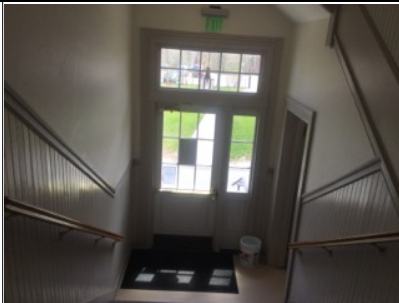
Tactile exit sign not provided Directional sign to accessible emergency egress not provided	- -	Ensure a tactile exit sign with raised characters and braille is provided at exit door. Mount sign between 48"- 60" above the finished floor located on the latch side of the door. Provide a directional sign indicating the location of the nearest accessible emergency egress.	1	232	\$232
Interior Access Route												
12	To Men's Toilet Room	B		Interior Access Route	N/A

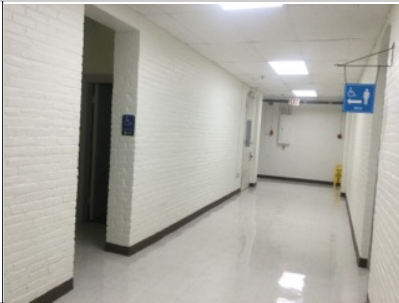
Obstructed by protruding objects	12"	Relocate directional sign so it does not protrude into the circulation path.	1	Labor	\$0
13	Planning & Development Entry Near Elevator	3		Interior Access Route	N/A

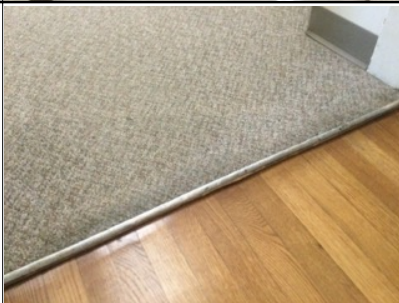
Level changes > 1/4"	1"	Alter change in level to be 1/4" high max. Ensure edge of carper is beveled.	1	Labor	\$0

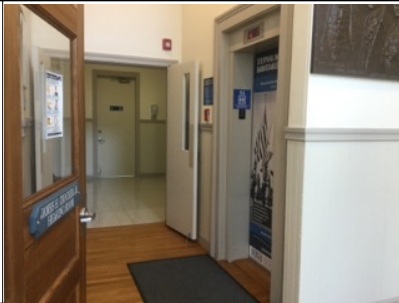
14	Elevator	2		Interior Access Route	N/A

Surface not stable, firm, and slip-resistant	-	Ensure mat is securely attached to the floor.	1	Labor	\$0
Doors, Doorways, & Gates												
15	Women's Toilet Room	1		Doors, Doorways, & Gates	Toilet Room

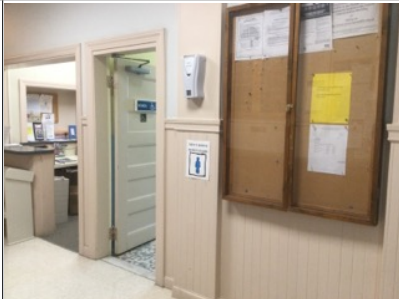
Clear width at door < 32"	29.4"	Widen the door so that there is 32" min. clear width.	1	3366	\$3366

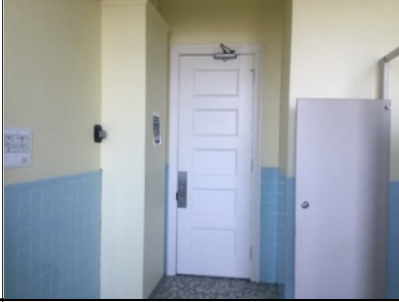
Clear width at door < 32" Door requires > 5 lbs. of force to open	30" 14 lbs.	Widen the door so that there is 32" min. clear width. Adjust closers so doors do not require more than 5 pounds of force to open.	1	3366	\$3366
17	Men's Toilet Room	B		Doors, Doorways, & Gates	Toilet Room

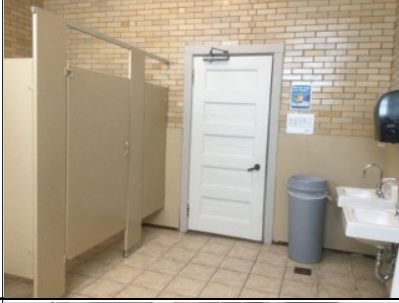
Maneuvering clearance(s) not provided	-	Relocate trash can to maintain the maneuvering clearance at the door.	1	Labor	\$0
18	Town Clerk's Office	1		Doors, Doorways, & Gates	Office

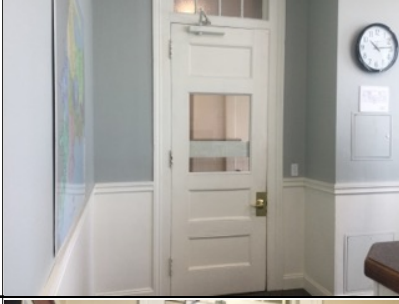
Maneuvering clearance(s) not provided	15.5"	See ID #28 for recommendation.	1	Labor	\$0
19	Town Manager	2		Doors, Doorways, & Gates	Office

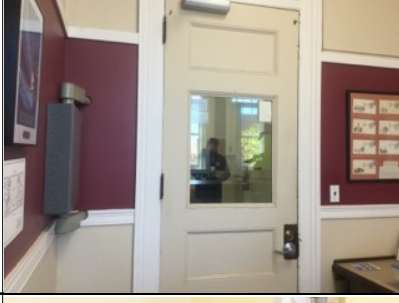
Maneuvering clearance(s) not provided	10.2"	Relocate desk to maintain the required 18" maneuvering clearance at the door or keep door open during business hours. See ID #72.	1	Labor	\$0

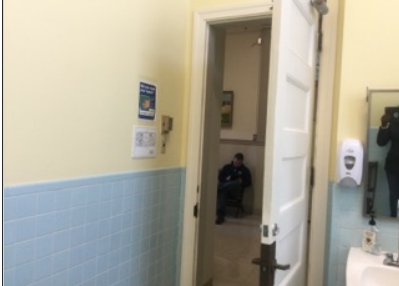
20	Women's Toilet Room	2		Doors, Doorways, & Gates	Toilet Room

Maneuvering clearance(s) not provided		Provide an automatic door opener.	1	3060	\$3060

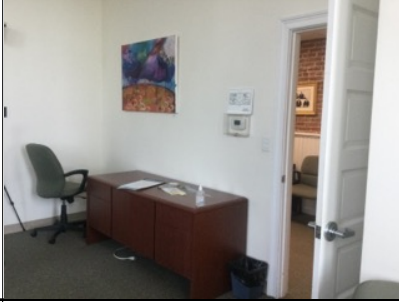
Maneuvering clearance(s) not provided	12.8"	Relocate furniture to maintain the required 18" maneuvering clearance at the door.	1	Labor	\$0
22	Planning & Development to Hallway From Women to Men	3		Doors, Doorways, & Gates	Office

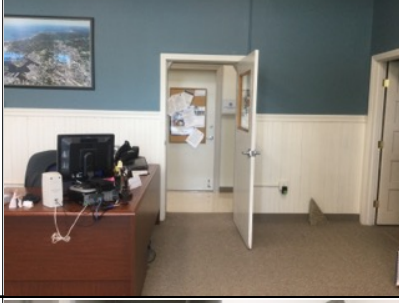
Maneuvering clearance(s) not provided	-	Relocate desk to maintain the required 18" min. maneuvering clearance on the push side of the door.	1	Labor	\$0
23	To GIS Unit	3		Doors, Doorways, & Gates	Office

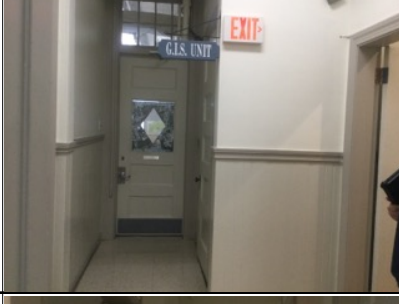
Maneuvering clearance(s) not provided	-	Keep door open during business hours.	1	Labor	\$0
24	To Community Conference Room - Near Men	3		Doors, Doorways, & Gates	Circulation

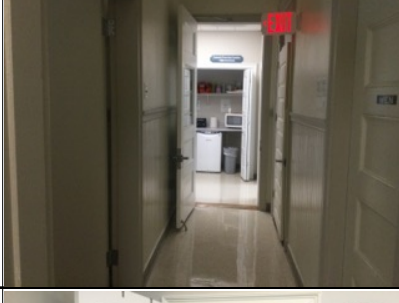
Maneuvering clearance(s) not provided	-	Keep door open during business hours.	1	Labor	\$0
25	Community Conference Room	3		Doors, Doorways, & Gates	N/A

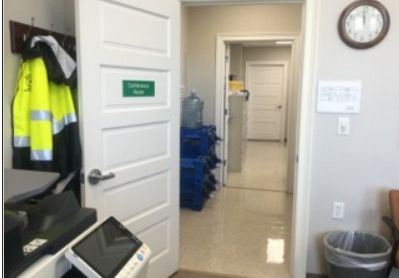
Maneuvering clearance(s) not provided	-	Remove trash container to maintain the required 18" maneuvering clearance.	1	Labor	\$0

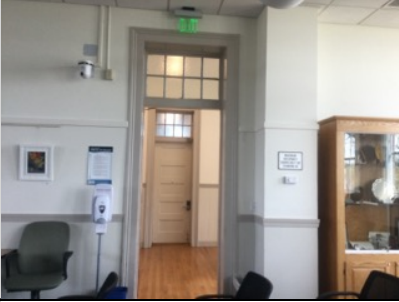
Maneuvering clearance not provided at recess > 6"	14.7"	Keep door open during business hours.	1	Labor	\$0
27	Community Services Dept. Entry - Near Stair #2	3		Doors, Doorways, & Gates	Office

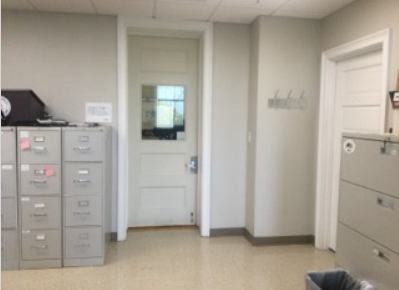
Maneuvering clearance not provided at recess > 6"	-	Keep door open during business hours.	1	Labor	\$0
28	Town Clerk's Office	1		Doors, Doorways, & Gates	263	 	Maneuvering clearance not provided at recess > 6" Door requires > 5 lbs. of force to open	14.25" 20 lbs	Keep door open during business hours. Adjust closers so doors do not require more than 5 pounds of force to open.	1	Labor	\$0
29	Women's Toilet Room	2		Doors, Doorways, & Gates	Toilet Room

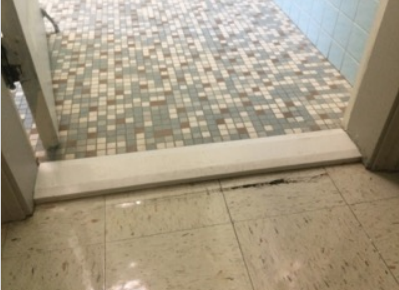
Threshold not beveled Threshold > 1/2" high	- 1"	Bevel the threshold. Alter the threshold to be 1/2" high max.	1	300	\$300

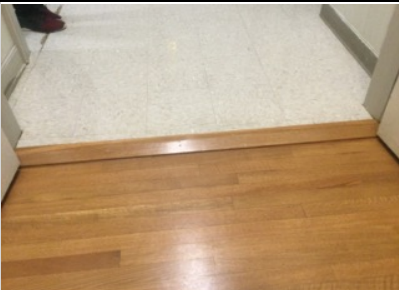
30	Towards Women's Toilet Room	3		Doors, Doorways, & Gates

Threshold > 1/2" high	1.25"	Alter the threshold to be 1/2" high max.	1	150	\$150

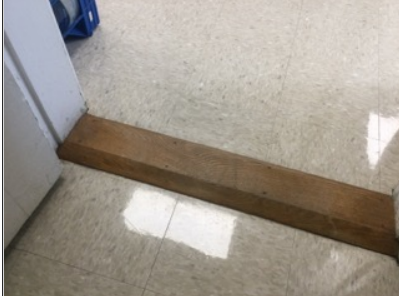
Threshold > 1/2" high	1.75"	Alter the threshold to be 1/2" high max.	1	150	\$150
32	Community Services Dept. Entry - Near Stair 2	3		Doors, Doorways, & Gates	Office

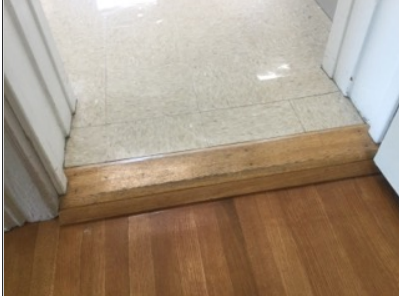
Threshold > 1/2" high	2.25"	Alter the threshold to be 1/2" high max.	1	150	\$150
33	Stair to Elevator	3		Doors, Doorways, & Gates	Circulation

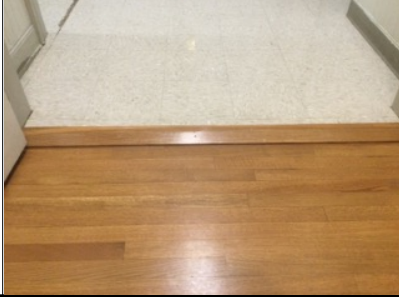
Threshold > 1/2" high	1.25"	Alter the threshold to be 1/2" high max.	1	150	\$150
34	Women's Toilet Room	3		Doors, Doorways, & Gates	Toilet Room

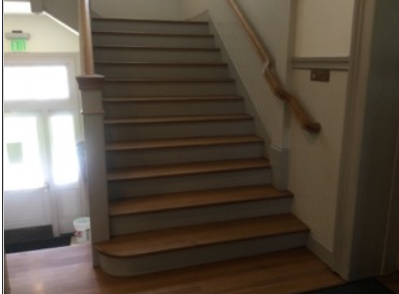
Handrail not provided on both sides	-	Provide handrail on one side.	1	-	\$0

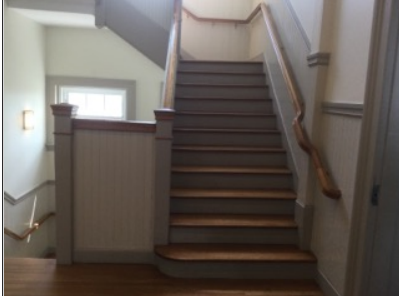
Handrail not provided on both sides	-	Provide handrail on one side.	1	-	\$0
37	Stair #2	B		Stairways	Egress

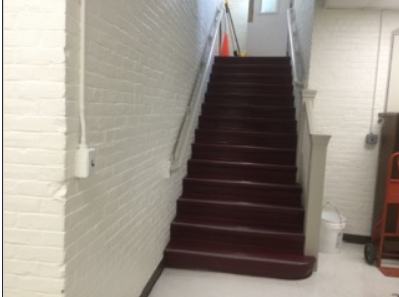
Handrail not provided on both sides Handrails do not extend 12" from stairs	- -	Provide handrail on one side. Top: Ensure handrails extend horizontally above the landing for 12" min. beginning above the first riser nosing. Bottom: Ensure handrails extend to one tread depth beyond the last riser.	1	-	\$0
38	Stair #2 To Basement	.5		Stairways	Egress

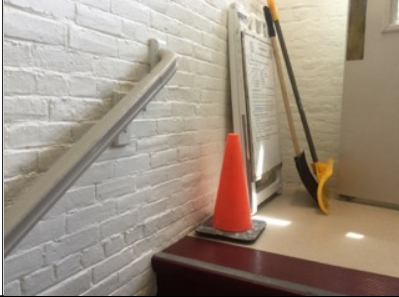
Handrails do not extend 12" from stairs	-	Top: Ensure handrails extend horizontally above the landing for 12" min. beginning above the first riser nosing. Bottom: Ensure handrails extend to one tread depth beyond the last riser.	1	-	\$0
39	Stair Near Elevator	B		Stairways	Egress

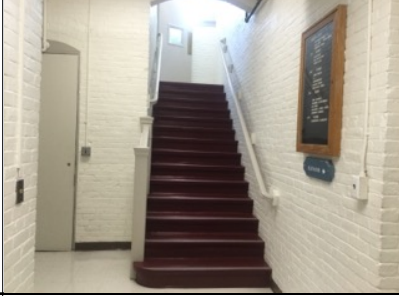
Handrails do not extend 12" from stairs Handrails not continuous where required	- -	Top: Ensure handrails extend horizontally above the landing for 12" min. beginning above the first riser nosing. Bottom: Ensure handrails extend to one tread depth beyond the last riser. Provide continuous handrails.	1	-	\$0

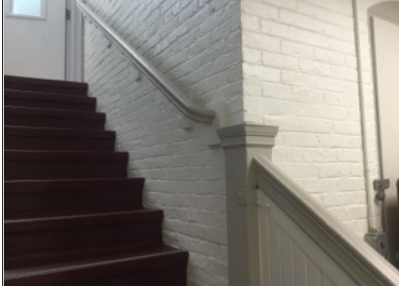
40	Stair #2	B		Stairways	Egress

Handrails not continuous where required	-	Provide continuous handrails.	1	-	\$0

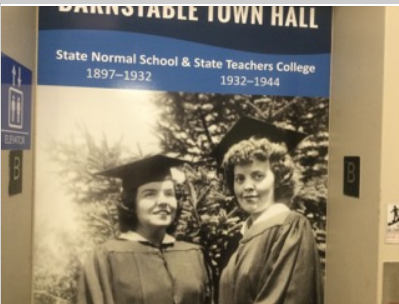
Visible or audible hall signals not provided	-	Note: Visible hall signals were not required before 2010 in existing elevators. Install audible hall signals.	1	-	\$0
42	Elevator	B		Elevator	Interior

The major accessibility issue is the lack of a compliant elevator that serves all floors in the Town Hall. The current elevator lacks the minimum dimensions required, lacks visible hall signals and lacks the required tactile star on both sides of the elevator jambs at main floor.

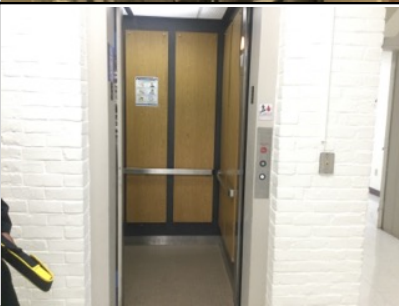
Elevator car dimension not compliant	-	Repair may require major renovation at elevator cab and hoistway.	1	-	\$0
43	Elevator	1		Elevator	Interior

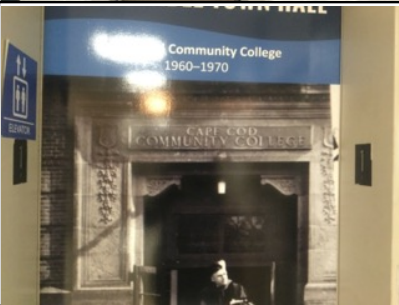
Tactile stars not provided at main entry level	-	Provide a tactile star on both sides of jambs at main floor. At other floors, provide appropriate number. Provide a tactile star at the main floor on the control panel within the car.	2	-	\$0
Signage												
44	Assessors Office	1		Signage	Designation

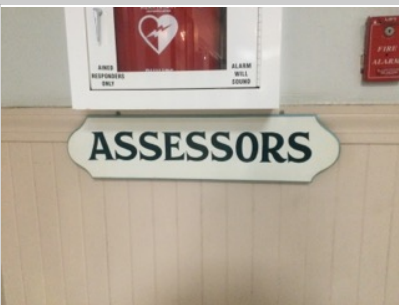
See ID #49.	1	-	\$0
45	Planning & Development Entry - Near Stair #2	3		Signage	Designation

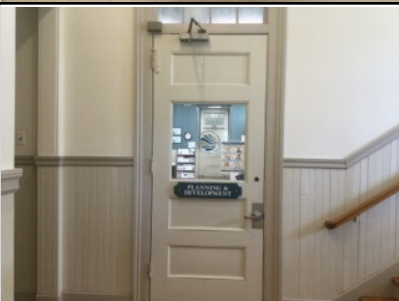
<p>Raised characters not provided on sign</p> <p>Raised characters < 48" or > 60" above ground</p> <p>Braille not provided on sign</p> <p>Sign not located on the latch side of the door</p>	- 42.9" - -	<p>Provide text with raised characters duplicated in braille on sign.</p> <p>Mount sign so that the baseline of the lowest tactile character is 48" min. above finished floor and the baseline of the highest tactile character is 60" max. above the finished floor.</p> <p>Locate sign at permanent rooms alongside the door on the latch side.</p>	1	232	\$232

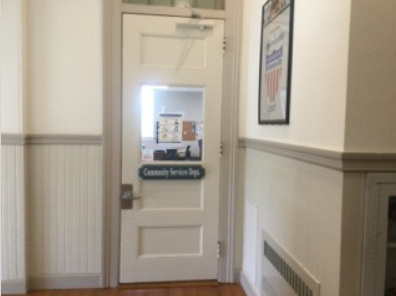
Raised characters not provided on sign Raised characters < 48" or > 60" above ground Braille not provided on sign Sign not located on the latch side of the door	- 42.9" - -	Provide text with raised characters duplicated in braille on sign. Mount sign so that the baseline of the lowest tactile character is 48" min. above finished floor and the baseline of the highest tactile character is 60" max. above the finished floor. Locate sign at permanent rooms alongside the door on the latch side.	1	232	\$232
47	Town Manager's Office	2		Signage	Designation

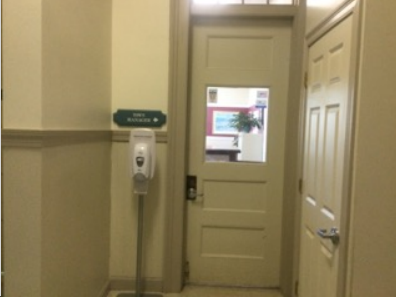
Raised characters not provided on sign Braille not provided on sign	- -	Provide text with raised characters duplicated in braille on sign.	1	232	\$232
48	Planning & Development Entry Along Hallway From Women to Men	3		Signage	Designation

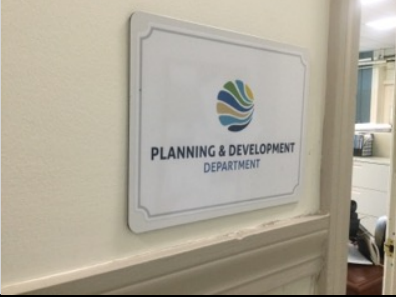
Raised characters not provided on sign Braille not provided on sign	- -	Provide text with raised characters duplicated in braille on sign.	1	232	\$232

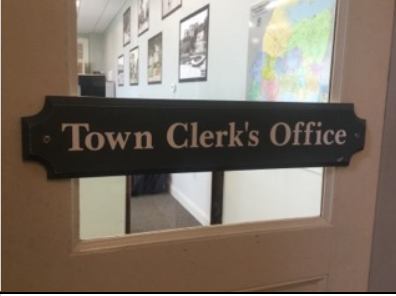
49	Town Clerk's Office	1		Signage	Designation

Raised characters not provided on sign Braille not provided on sign Sign not located on the latch side of the door	- - -	Provide text with raised characters duplicated in braille on sign. Locate sign at permanent rooms alongside the door on the latch side.	1	232	\$232
50	Assessors Office	1		Signage	Designation

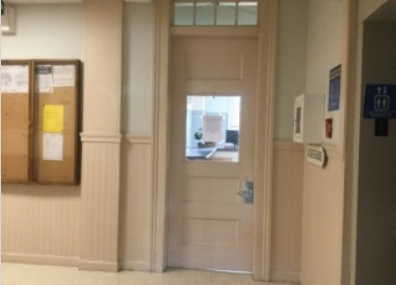
Raised characters not provided on sign Braille not provided on sign Sign not located on the latch side of the door	- - -	Provide text with raised characters duplicated in braille on sign. Locate sign at permanent rooms alongside the door on the latch side.	1	232	\$232

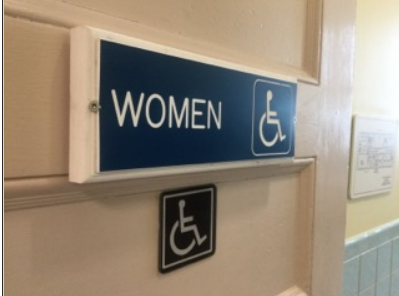
Raised characters not provided on sign Braille not provided on sign Sign not located on the latch side of the door	- - -	Provide text with raised characters duplicated in braille on sign. Locate sign at permanent rooms alongside the door on the latch side.	1	232	\$232
52	Collector of Taxes	1		Signage	Designation

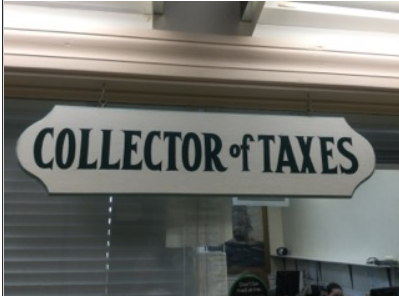
Raised characters not provided on sign Braille not provided on sign Sign not located on the latch side of the door	- - -	Provide text with raised characters duplicated in braille on sign. Locate sign at permanent rooms alongside the door on the latch side.	1	232	\$232
53	Men's Toilet Room	2		Signage	Designation

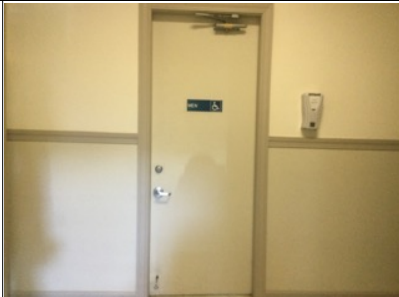
Raised characters not provided on sign Braille not provided on sign Sign not located on the latch side of the door	- - -	Provide text with raised characters duplicated in braille on sign. Locate sign at permanent rooms alongside the door on the latch side.	1	232	\$232

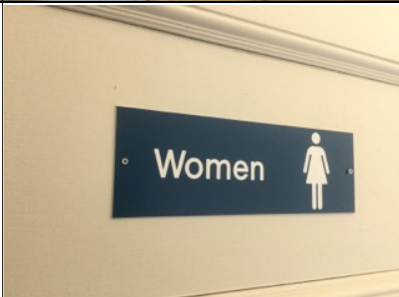
Raised characters not provided on sign Braille not provided on sign Sign not located on the latch side of the door	- - -	Provide text with raised characters duplicated in braille on sign. Locate sign at permanent rooms alongside the door on the latch side.	1	232	\$232
55	Town Hearing Room Entry Near Elevator	2		Signage	Designation

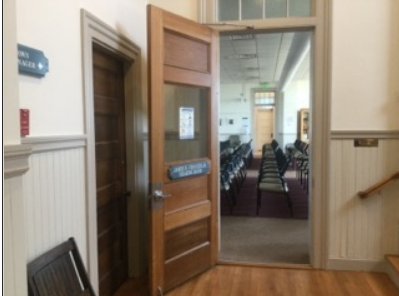
Raised characters not provided on sign Braille not provided on sign Sign not located on the latch side of the door	- - -	Provide text with raised characters duplicated in braille on sign. Locate sign at permanent rooms alongside the door on the latch side.	1	232	\$232
57	Town Council Office	2		Signage	Designation

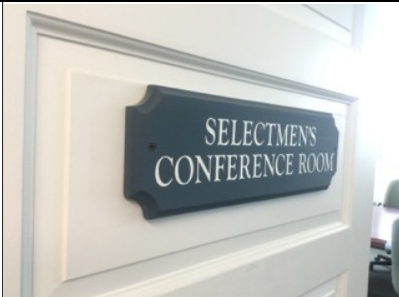
Raised characters not provided on sign Braille not provided on sign Sign not located on the latch side of the door	- - -	Provide text with raised characters duplicated in braille on sign. Locate sign at permanent rooms alongside the door on the latch side.	1	232	\$232

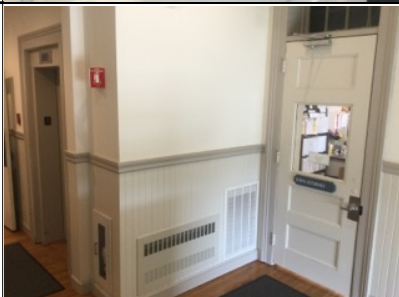
Raised characters not provided on sign Braille not provided on sign Sign not located on the latch side of the door	- - -	Provide text with raised characters duplicated in braille on sign. Locate sign at permanent rooms alongside the door on the latch side.	1	232	\$232
60	Planning & Development Office - Near Elevator	3		Signage	Designation

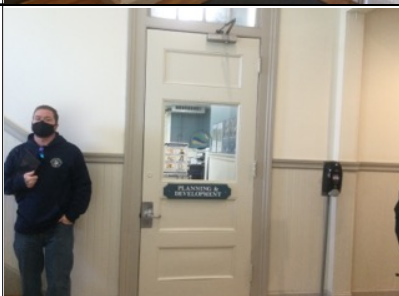
Raised characters not provided on sign Braille not provided on sign Sign not located on the latch side of the door	- - -	Provide text with raised characters duplicated in braille on sign. Locate sign at permanent rooms alongside the door on the latch side.	1	232	\$232

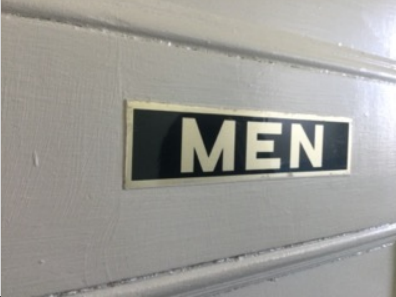
Raised characters not provided on sign Braille not provided on sign Sign not located on the latch side of the door Directional sign to access toilet not provided	- - - -	Provide text with raised characters duplicated in braille on sign. Locate sign alongside the door on the latch side. Until the toilet room is made accessible provide a directional sign indicating the location of the nearest accessible toilet room. After the toilet room is made accessible provide a sign with the International Symbol of Accessibility (ISA).	1	464	\$464

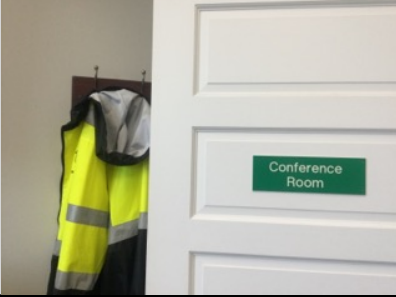
63	Community Conference Room	3		Signage	Designation

Raised characters not provided on sign Braille not provided on sign Sign not located on the latch side of the door	- - -	Provide text with raised characters duplicated in braille on sign. Locate sign at permanent rooms alongside the door on the latch side.	1	232	\$232
64	Planning & Development	3		Signage	Designation

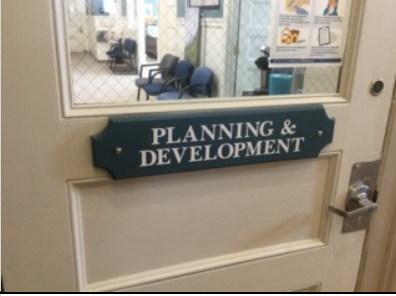
Raised characters not provided on sign Braille not provided on sign Sign not located on the latch side of the door	- - -	Provide text with raised characters duplicated in braille on sign. Locate sign at permanent rooms alongside the door on the latch side.	1	232	\$232
65	Route Along South Street From Accessible Entrance Parking	Ext.		Signage	Informational

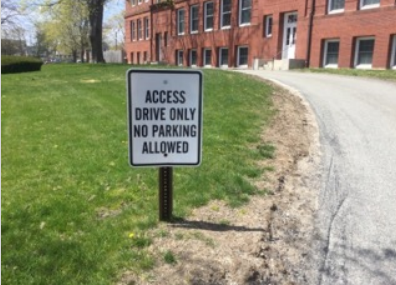
Visual characters < 40" above ground	15.7"	Mount visual sign so that the baseline of the lowest character is 40" min. above the finished floor.	1	Labor	\$0

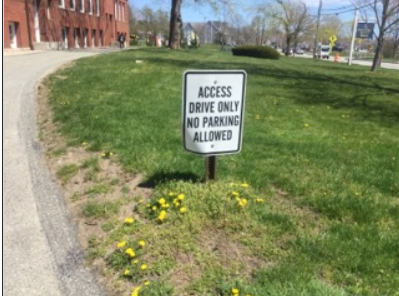
Visual characters < 40" above ground	11.7"	Mount visual sign so that the baseline of the lowest character is 40" min. above the finished floor.	1	Labor	\$0
67	South Street Parking Near Town Hall Parking Lot	Ext.		Signage

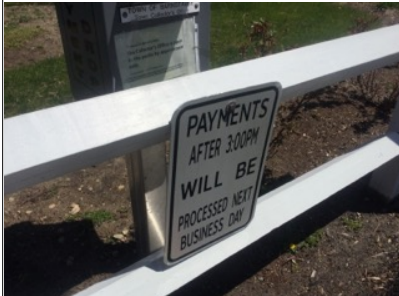
Visual characters < 40" above ground	-	Mount visual sign so that the baseline of the lowest character is 40" min. above the finished floor.	1	Labor	\$0
68	Men's Toilet Room	B		Signage	Designation

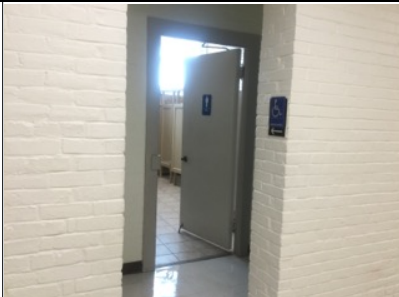
Sign not located on the latch side of the door	-	Locate sign at permanent rooms alongside the door on the latch side.	1	Labor	\$0
69	Men's Toilet Room	B		Signage	Designation

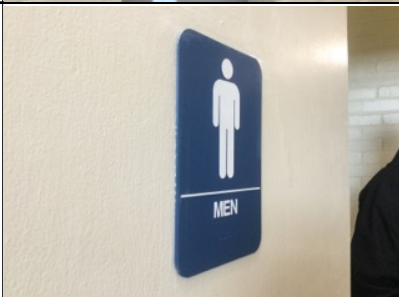
Sign not located on the latch side of the door	-	Locate sign at permanent rooms alongside the door on the latch side.	1	Labor	\$0

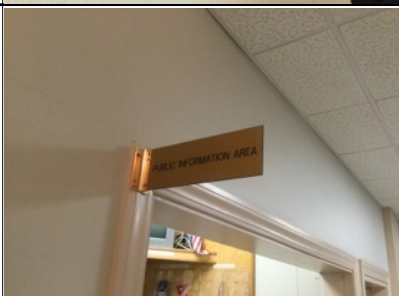
70	Public Information Area	1		Signage	Informational

Text size non-compliant on sign	-	Ensure that character size on the sign complies with the Character Height Table 703.5.5 in the ADA 2010 Standards.	1	-	\$0

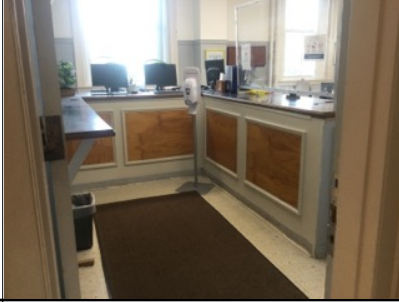
Counter > 36" high	42.6"	Ensure auxiliary counter is mounted 36" max. above the finished floor.	1	Labor	\$0
72	Collector of Taxes	1		Service Counter	N/A

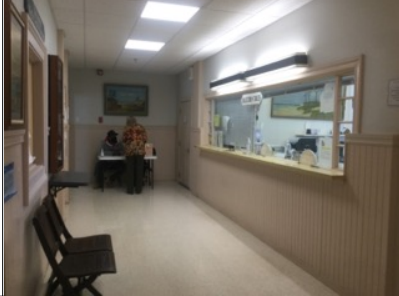
Counter > 36" high	42"	Provide a counter that is 36" max. above the ground or finished floor.	1	880	\$880
73	Town Manager	2		Service Counter	N/A

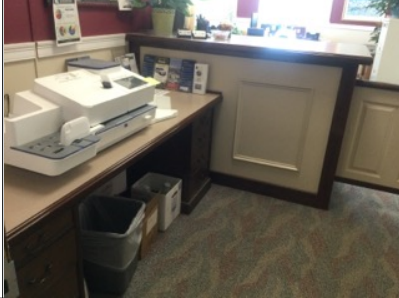
Counter > 36" high	45"	Provide a counter that is 36" max. above the ground or finished floor.	1	880	\$880
74	Town Council Office	2		Service Counter	N/A

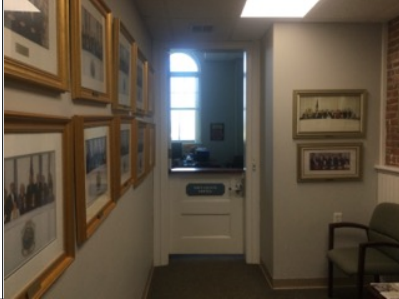
Counter > 36" high	41.5"	Provide a counter that is 36" max. above the ground or finished floor.	1	880	\$880
Operable Parts												
75	Planning & Development	3		Operable Parts	Clothes Rod/Hooks

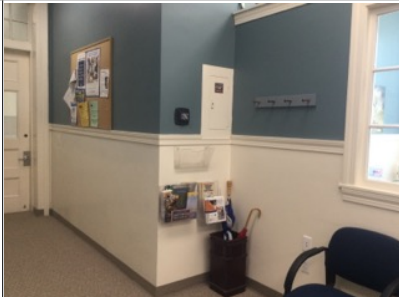
Reach < 15" or > 48"(forward/side approach)	65.2"	Provide a hook mounted 48" max. above the finished floor.	1	Labor	\$0

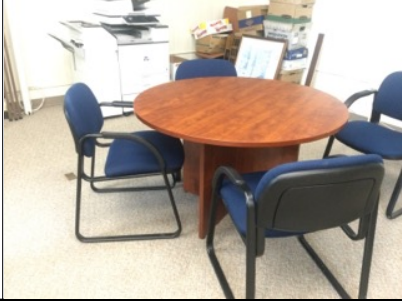
Knee or toe clearance not provided	-	Provide at least 1 work surface with 27" min. knee and toe clearance.	1	700	\$700
Toilet & Bathing Rooms												
Overall Access												
77	Men's Toilet Room	3		Overall Access	Toilet Room

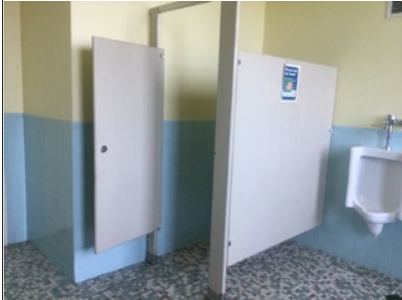
Accessible plumbing fixtures or stalls not provided	-	Provide one accessible wheelchair compartment.	1	6182	\$6182
Lavatory												
78	Women's Toilet Room	1		Lavatory	N/A

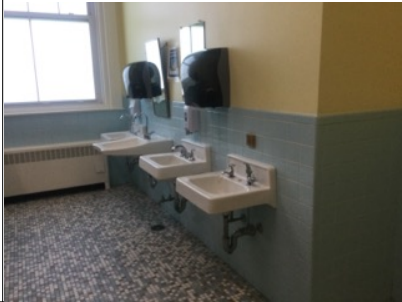
Plumbing underneath is exposed	-	Insulate or otherwise configure pipes to prevent contact for at least one lavatory.	1	92	\$92
79	Men's Toilet Room	B		Lavatory	N/A

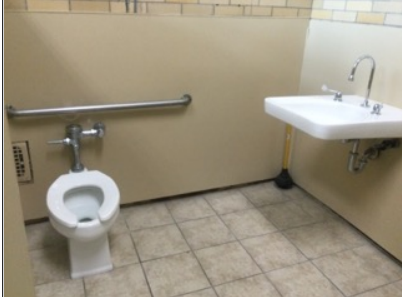
Plumbing underneath is exposed	-	Insulate or otherwise configure pipes to prevent contact for at least one lavatory. See ID #87 for additional accessibility issues.	1	92	\$92

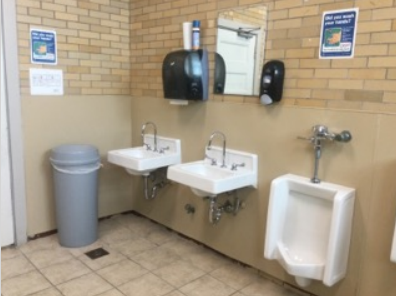
Plumbing underneath is exposed Mirror above lavatory w/reflective surface > 40"	- 52.5"	Insulate or otherwise configure pipes to prevent contact for at least one lavatory. Lower mirror so that the bottom surface is at 40" max. above the finished floor.	1	348	\$348
81	Women's Toilet Room	1		Lavatory	N/A

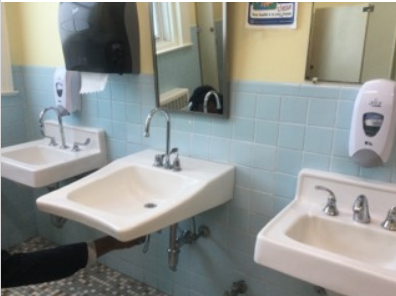
Plumbing underneath is exposed Mirror above lavatory w/reflective surface > 40"	- 42.9"	Insulate or otherwise configure pipes to prevent contact for at least one lavatory. Lower mirror so that the bottom surface is at 40" max. above the finished floor.	1	348	\$348
82	Men's Toilet Room	2		Lavatory	N/A

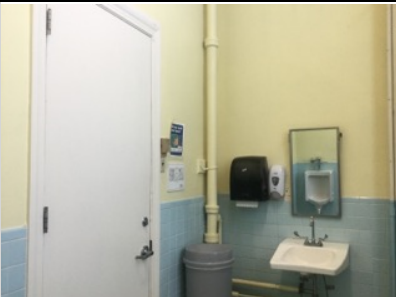
Plumbing underneath is exposed Mirror above lavatory w/reflective surface > 40"	- 42.5"	Insulate or otherwise configure pipes to prevent contact for at least one lavatory. Lower mirror so that the bottom surface is at 40" max. above the finished floor.	1	348	\$348

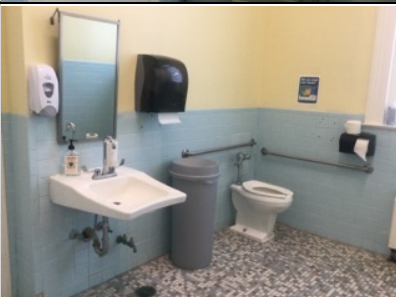
83	Women's Toilet Room	2		Lavatory	N/A

Plumbing underneath is exposed Mirror above lavatory w/reflective surface > 40"	- 42"	Insulate or otherwise configure pipes to prevent contact for at least one lavatory. Lower mirror so that the bottom surface is at 40" max. above the finished floor.	1	348	\$348
84	Women's Toilet Room	3		Lavatory	N/A

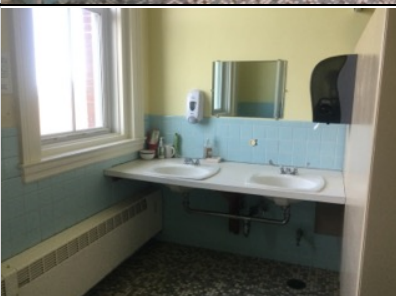
Plumbing underneath is exposed Mirror above lavatory w/reflective surface > 40"	- 51.4"	Insulate or otherwise configure pipes to prevent contact for at least one lavatory. Lower mirror so that the bottom surface is at 40" max. above the finished floor.	1	348	\$348

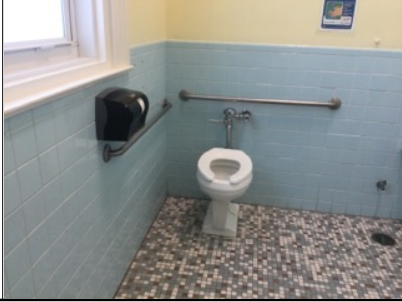
Toilet seat < 17" or > 19" high Flush control not on open side Toilet paper dispenser is not compliant	20.6" - -	Install a toilet with a seat between 17"- 19" high above the finished floor. Relocate the flush control to the open side. Relocate toilet paper so that it is 24" min. high, located under the grab bar, and between 7" and 9" from the front of the toilet.	1	2422	\$2422
Toilet Compartment												
86	Women's Toilet Room	1		Toilet Compartment	Accessible Compartment

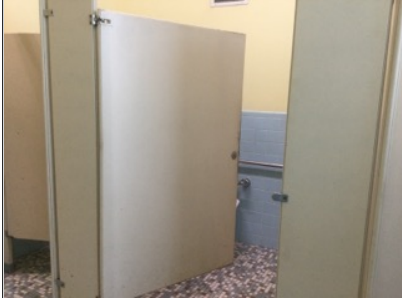
Door has malfunctioning self-closing hinge Door pull not provided	- -	Repair hinge. Provide a door pull on both sides of the door near the latch.	1	70	\$70
87	Women's Toilet Room	3		Toilet Compartment	Accessible Compartment

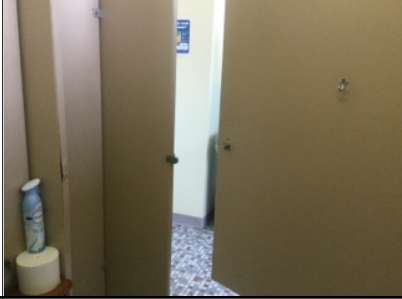
Door has malfunctioning self-closing hinge Door pull not provided	- -	Repair hinge. Provide a door pull on both sides of the door near the latch.	1	70	\$70

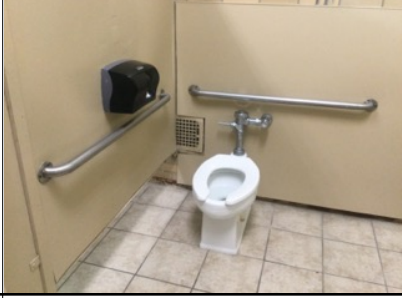
Side or rear grab bar < 33" or >36" high Flush control not on open side Non-compliant toilet paper dispenser	30.5" - -	Locate grab bars between 33"- 36" above the finished floor. Provide the flush control on the open side of the toilet (transfer side). Relocate toilet paper so that it is 24" min. high, located under the grab bar, and between 7" and 9" from the front of the toilet.	1	1142	\$1142
89	Women's Toilet Room	3		Toilet Compartment	Accessible Compartment

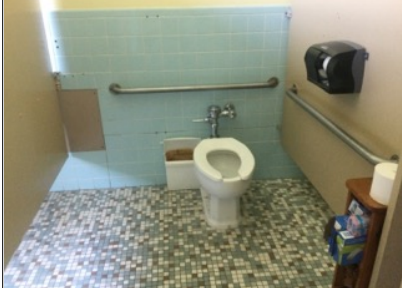
Side or rear grab bar < 33" or >36" high Non-compliant toilet paper dispenser	30.2" -	Locate grab bars between 33"- 36" above the finished floor. Relocate toilet paper so that it is 24" min. high, located under the grab bar, and between 7" and 9" from the front of the toilet.	1	768	\$768

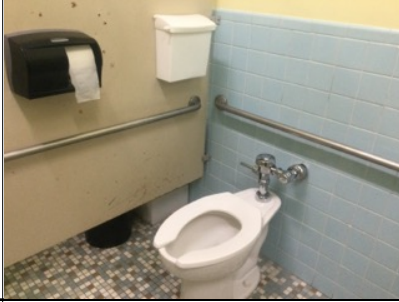
Flush control not on open side Non-compliant toilet paper dispenser	- -	Provide the flush control on the open side of the toilet (transfer side). Relocate toilet paper so that it is 24" min. high, located under the grab bar, and between 7" and 9" from the front of the toilet.	1	630	\$630
91	Men's Toilet Room	B		Toilet Compartment	Ambulatory Compartment

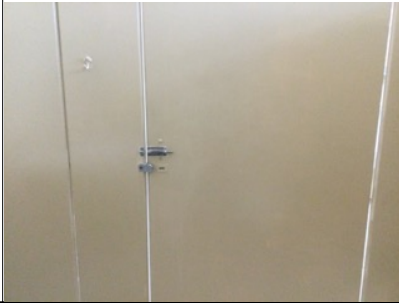
Door pull not provided	-	Provide a door pull on both sides of the door near the latch.	1	70	\$70
Urinal												
92	Men's Toilet Room	2		Urinal	N/A

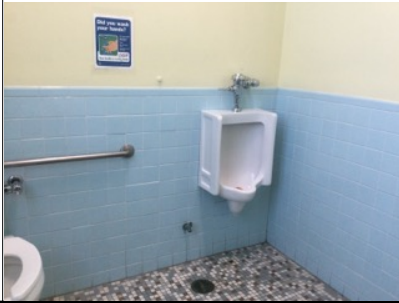
Rim > 17" high	24.4"	Provide at least one urinal with the rim no higher than 17" above the finished floor.	1	3248	\$3248
93	Men's Toilet Room	3		Urinal	N/A

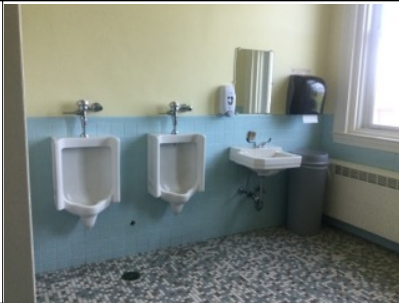
Rim > 17" high	23"	Provide at least one urinal with the rim no higher than 17" above the finished floor.	1	3248	\$3248

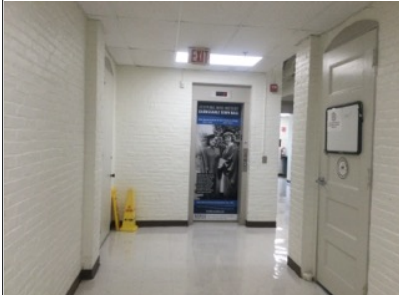
Recommend providing directory near the elevator with the listing of the offices on this floor.	1	-	\$0

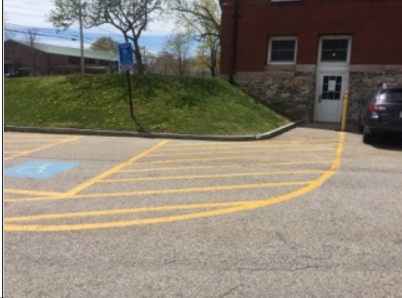
Recommend providing a sign at all the access aisles that reads "No Parking in Access Aisle".	1	-	\$0
Assembly Area												
96	Town Hearing Room	2		Assembly Area	N/A

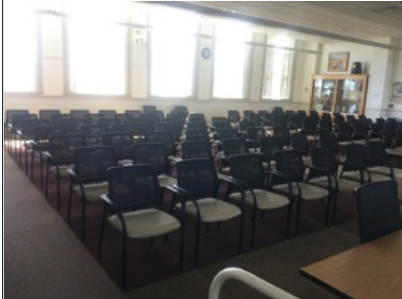
Recommend removing a few chairs to provide clear floor space for patrons who may need an accessible space.	1	-	\$0
Bench												
97	Women	3		Bench	N/A

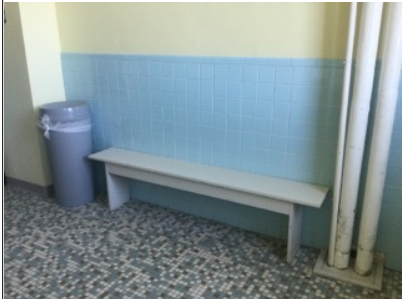
Recommend providing a bench that is at least 24" wide.	1	-	\$0
Directory												
98	Opposite Elevator	3		Directory	N/A

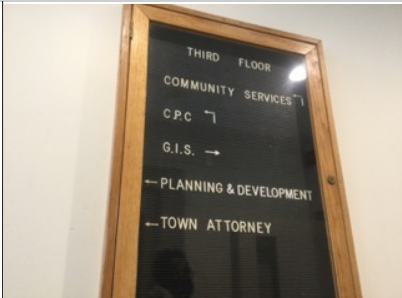
Recommend relocating the directory to avoid glare.	1	-	\$0

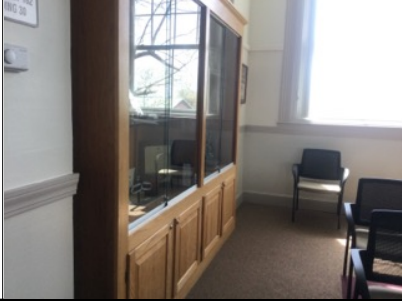
Recommend relocating the display to avoid glare.	1	-	\$0
Flooring												
100	Stair #2 to Elevator	B		Flooring	N/A

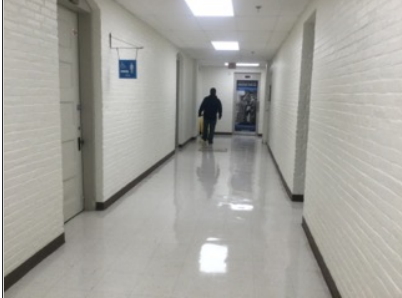
Recommend switching to a matte flooring finish. The floor is so highly polished that it creates a serious glare problem. Many people with low vision and some with perceptual differences related to brain-based issues cannot comfortably navigate that floor surface.	1	-	\$0
Sign												
101	Men's Toilet Room	B		Sign	N/A

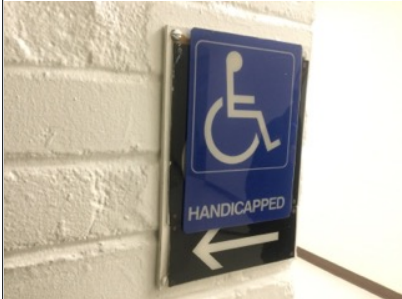
Recommend changing the sign for a sign that says "Accessible".	1	-	\$0
Signage												
102	Near Women's Toilet Room	1		Signage	N/A

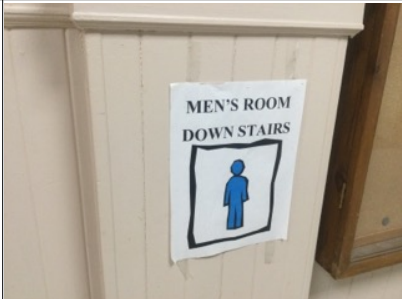
-	Recommend providing a permanent informational sign.	1	-	\$0

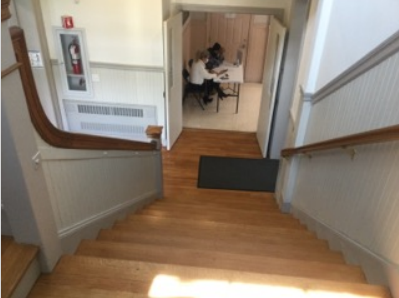
Recommend providing strips at the stair treads for visual contrast at all stairs.	1	-	\$0
