BARNSTABLE HISTORICAL COMMISSION – JUNE 16th MEETING MATERIALS Table of Content

- Page 2Hyannis Rotary, LLC, c/o Ford and Ford Attorneys at Law, 10 Hyannis
Avenue, Hyannis Port, Map 287, Parcel 131, GB Holbrook House, built
c.1905, contributing structure in the Hyannis Port Historic District
Partial demolition of the Water Tower remove portions of lower water
tower structure and reconstruct; top section of water tower to be removed
and placed on a newly reconstructed lower portion; remove and replace all
stucco

G.B. HOLBROOK HOUSE WATER TOWER

Noblin and Associates, LLC (Noblin) has completed a visual evaluation of the wood framed water tower structure at the above referenced property. Our services included site observations and documentation of the existing water tower structure wood floor and wall framing, exterior sheathing, connections, foundation, etc. as part of the on-going rehabilitation/renovation work currently being performed by E. B. Norris & Son Builders (the Contractor). Please reference the below report for background, observations, recommendations based on our observation.

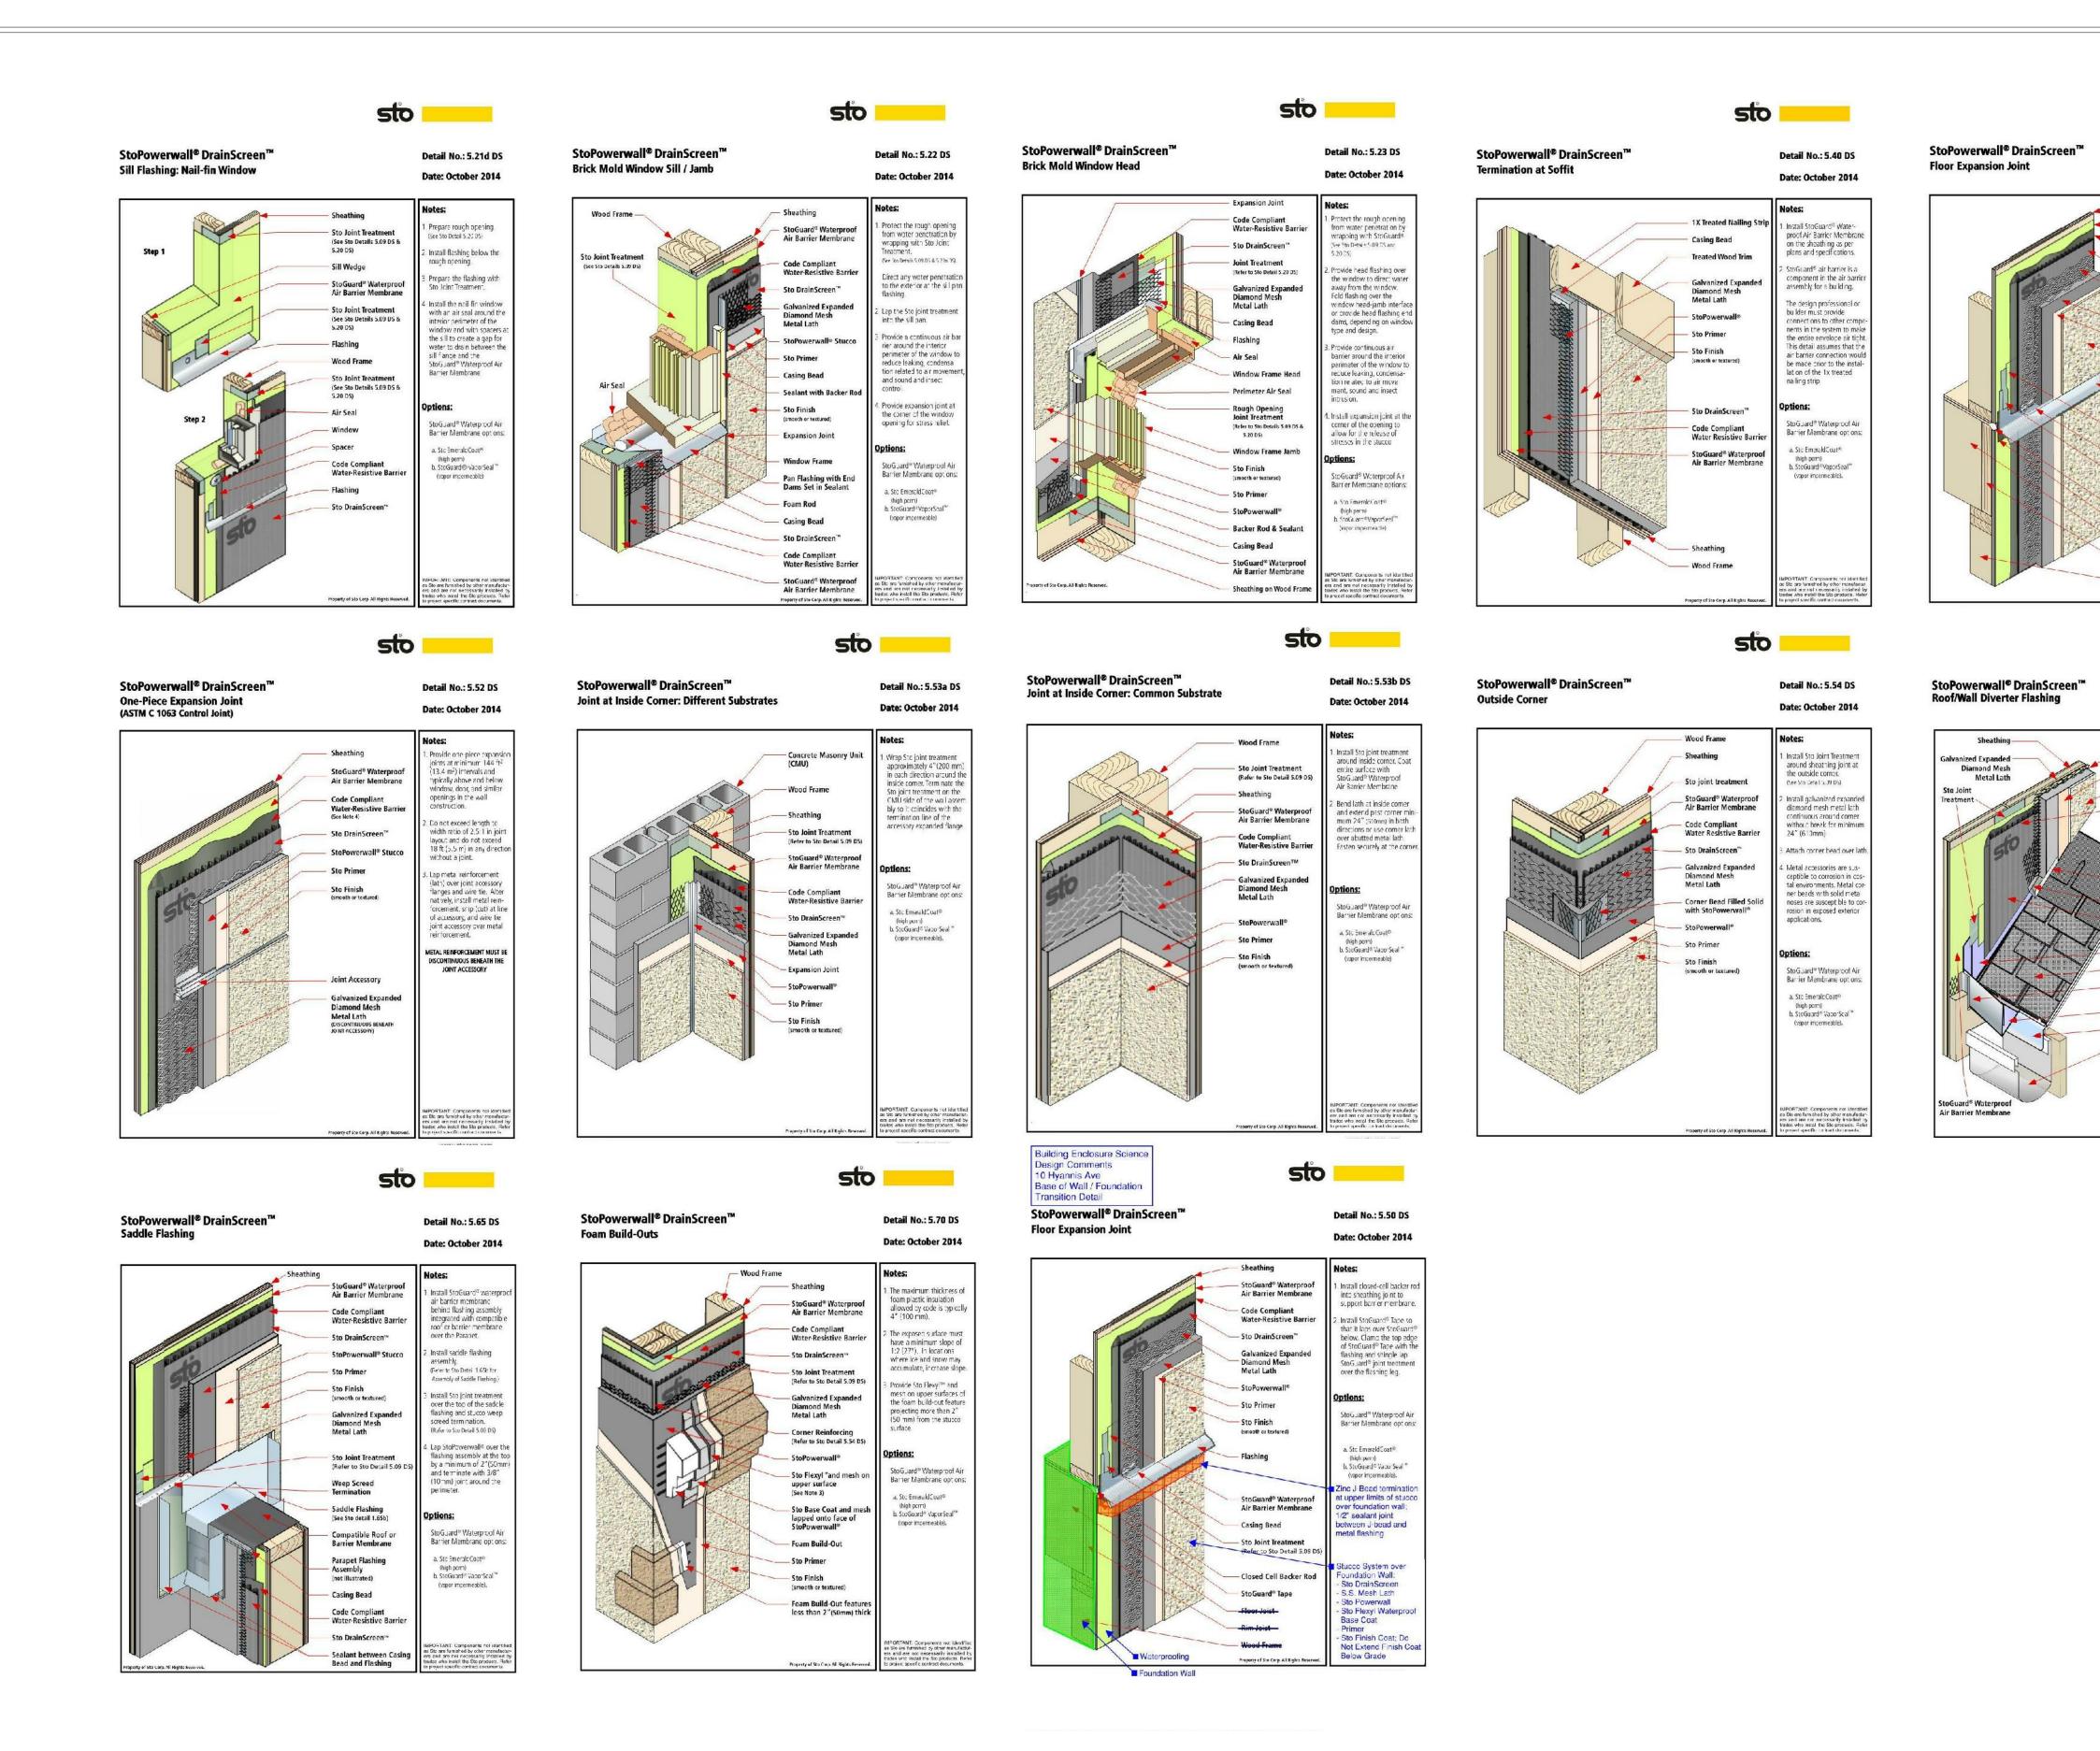
sto				
	Detall No.: 5.62 DS Date: October 2014			
StoPowerwall® Sto Primer Sto Finish (smocth or textured)	 Instal SteGuard® prior to installation of flashing. Provide step flashing mini- mum 4*(100mm) extending up the wall. 			
Code Compliant Water-Resistive Barrier Terminate 2"(50mm) above finished roof Casing Bead Sto DrainScreen'" Step Flashing Rool Finish	 Provide S.: Deverwall® overlap of the step flashing 2" (S0mm) and terminate StoPowervall® a minimum of 2" (S0mm) above the fin isher roof. The space permits remoting at a future date and he ps prevent debris from accumulating between roof and StoPowervall® Terminate the step flashing with a water-tight Diverter (kick-out) Flashing to direct water into the guiter Seler Lo Sto Detail 2:620 an fabrication of the Diverter Flashing 		RENOVATION FOR	ËNUË MA
Seal between Casing Bead and Diverter Diverter Flashing Edge Flashing	 Provide a 3/8" (10m m) joint around the Diverter Fashing and Seal Options: StoGuard® Waterproof Air 			γ Ť

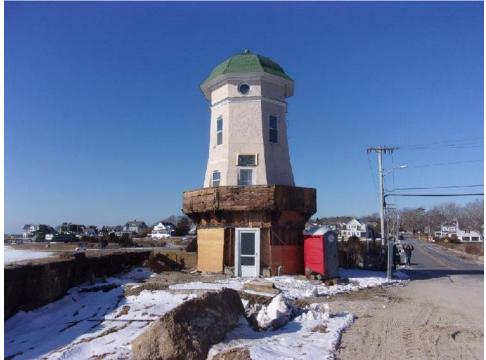
Overall structure elevation looking west with noticeable tilt to the southwest

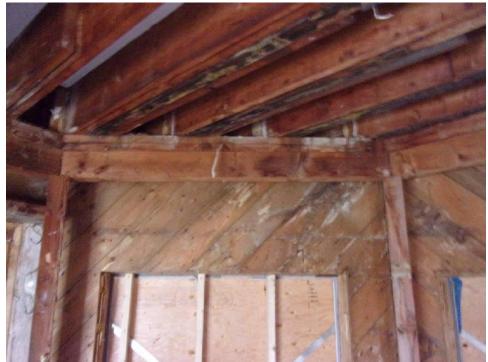
Typical second floor supplemental support framing with sporadically fastened, sistered floor beams; no mechanical fasteners connecting supplement interior framing

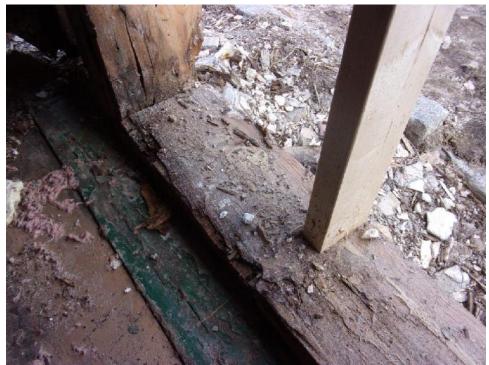
First floor supplemental framing with discontinuous column framing; no mechanical fasteners securing column base to foundation

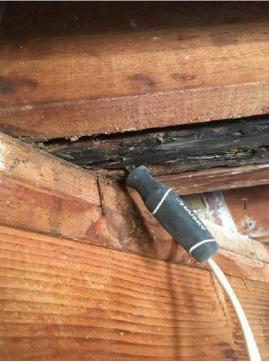
Typical deteriorated first floor sole plate at exterior wall (in contact with foundation); no mechanical fasteners connecting sole plate to foundation

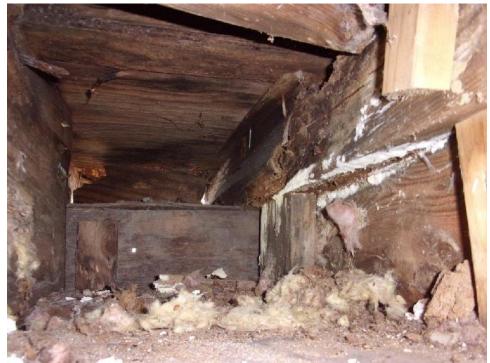
Typical deteriorated second floor beam end supported on supplemental interior framing

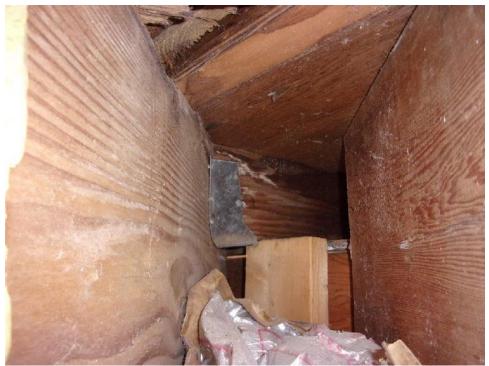
Typical deteriorated cantilever support beam for wrap-around exterior balcony at first floor exterior wall top plate (underside)

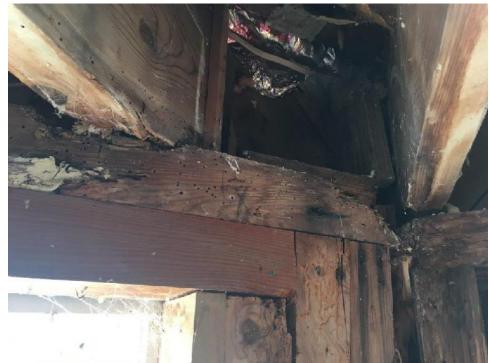
Typical second floor balcony supplemental cantilever framing attachment and support

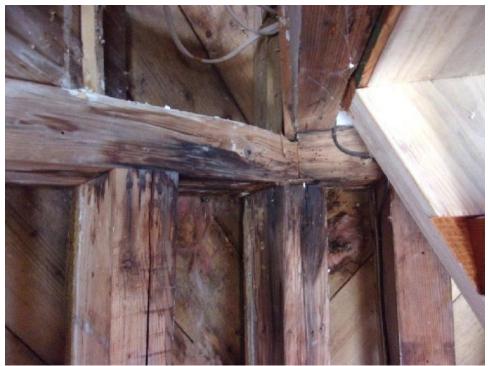
Third floor beam with evidence of insect infestation and bearing failure at second floor exterior wall top plate; deterioration/rotting visible along top plates

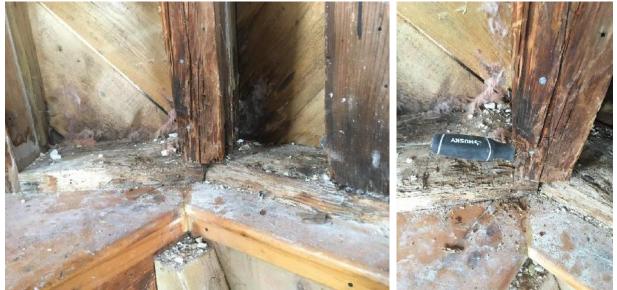
Second floor exterior wall framing with visible water staining, rot & crushing of top plate

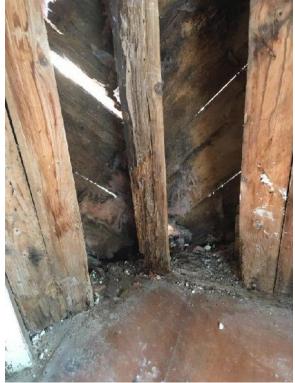
Typical second floor exterior wall stud rot/deterioration at sole plate of second floor exterior wall

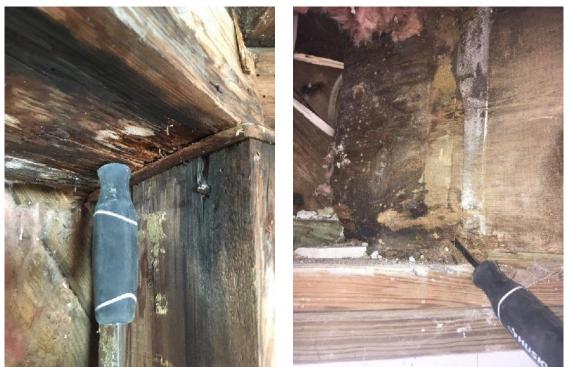
Typical second floor exterior wall stud and wall board with evidence of staining and deterioration

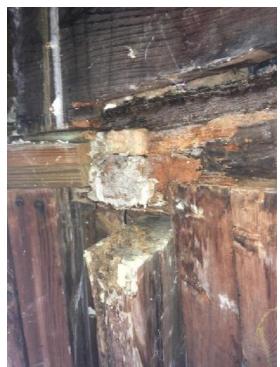
Typical second floor wall top plate & third floor beam with rot/deterioration at exterior wall support top plate; no mechanical fasteners observed or no longer engaging framing

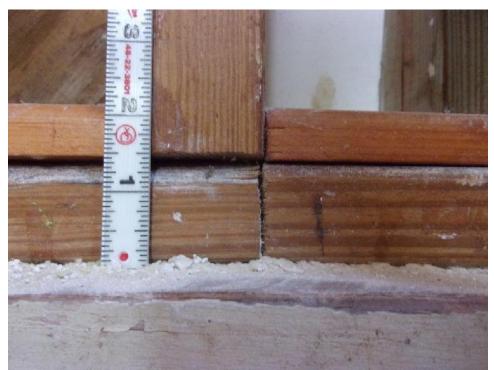
Typical second floor wall stud fully separated top plate; no longer providing support to gravity load resisting system

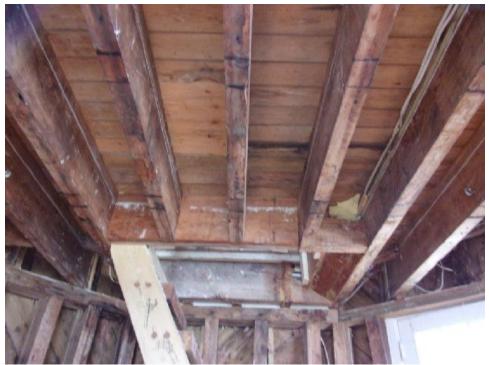
Typical discontinuous second floor exterior wall sole plate joint with no mechanical attachment observed

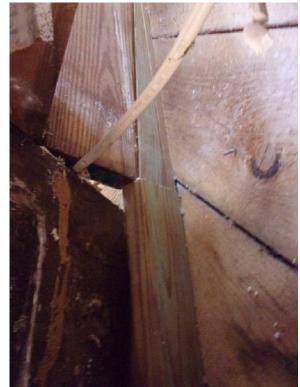
Typical third floor support framing with discontinuous header at stair opening framing at third floor

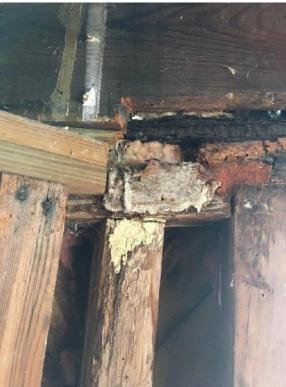
Typical third floor exterior wall stud and "wedge" not fully supported; mechanical fastening of wedges to studs not observed

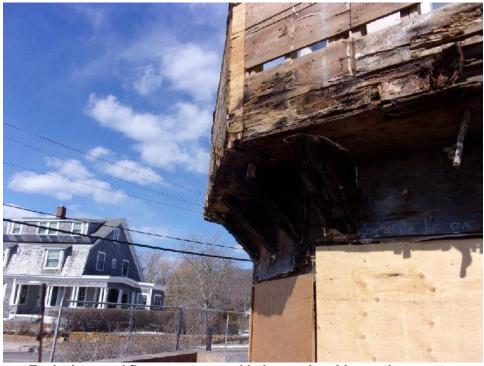
Typical second floor wrap-around balcony sheathing and supports; constructed with dimensional lumber

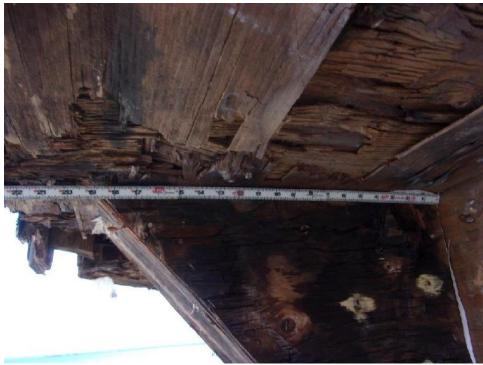
Typical rotted/deteriorated second floor wrap-around balcony board sheathing and exterior railing post; constructed with dimensional lumber

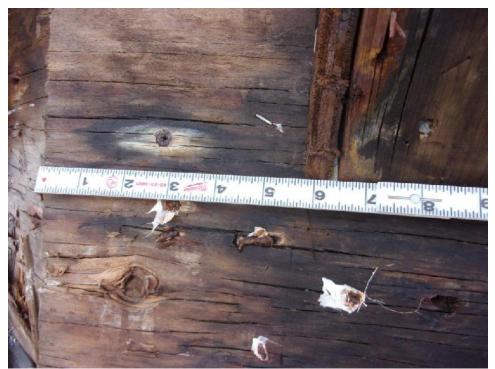
Typical underside of second floor wrap-around balcony with failed sheathing (layers separating); constructed with dimensional lumber

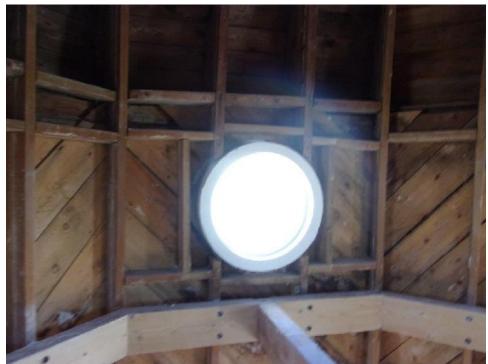
Typical third floor exterior wall framing at portal window; no jack or king studs installed (discontinuous gravity load path); constructed with dimensional lumber

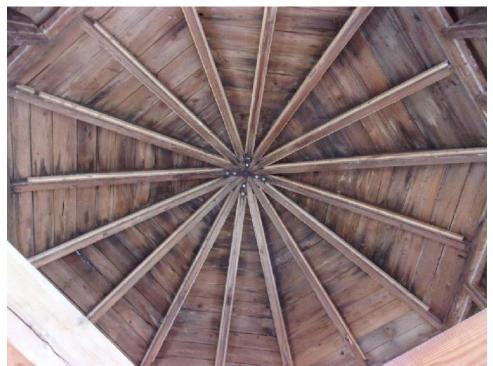
Typical third floor board sheathing with visible water staining and deterioration; constructed with dimensional lumber

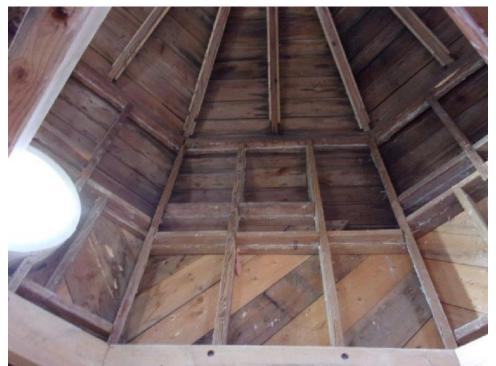
Typical existing (original) dome roof framing with visible water staining at third floor

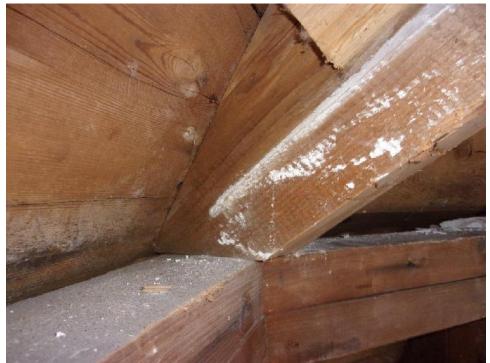
Visible discontinuous bridging at dome roof eave at third floor exterior wall framing

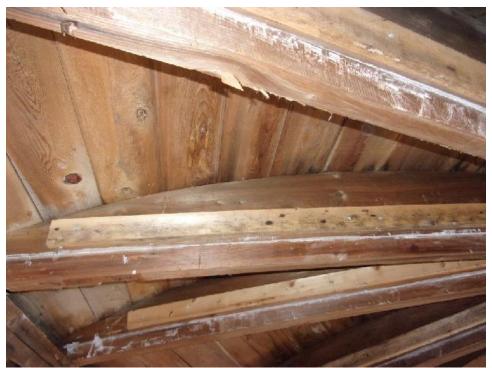
Typical dome roof framing support at double top plate at third floor exterior wall; no mechanical fasteners observed

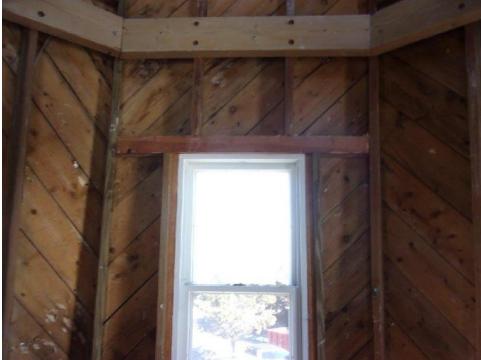
Typical third floor window header and tension/compression ring wood framing; tension/compression ring framing secured with carbon steel fasteners

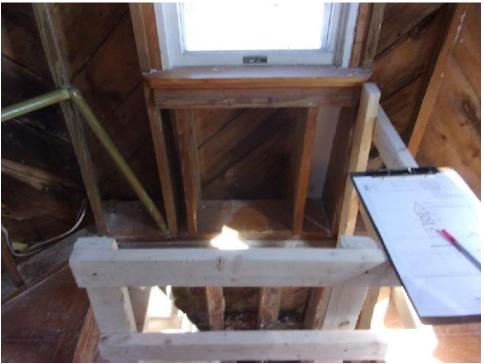
Typical third floor window sill framing

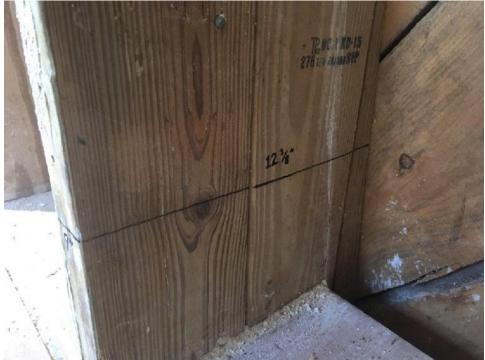
Typical third floor wall framing with "wedges" at exterior surface; "toe-nailed" mechanical attachment secured stud to wedge

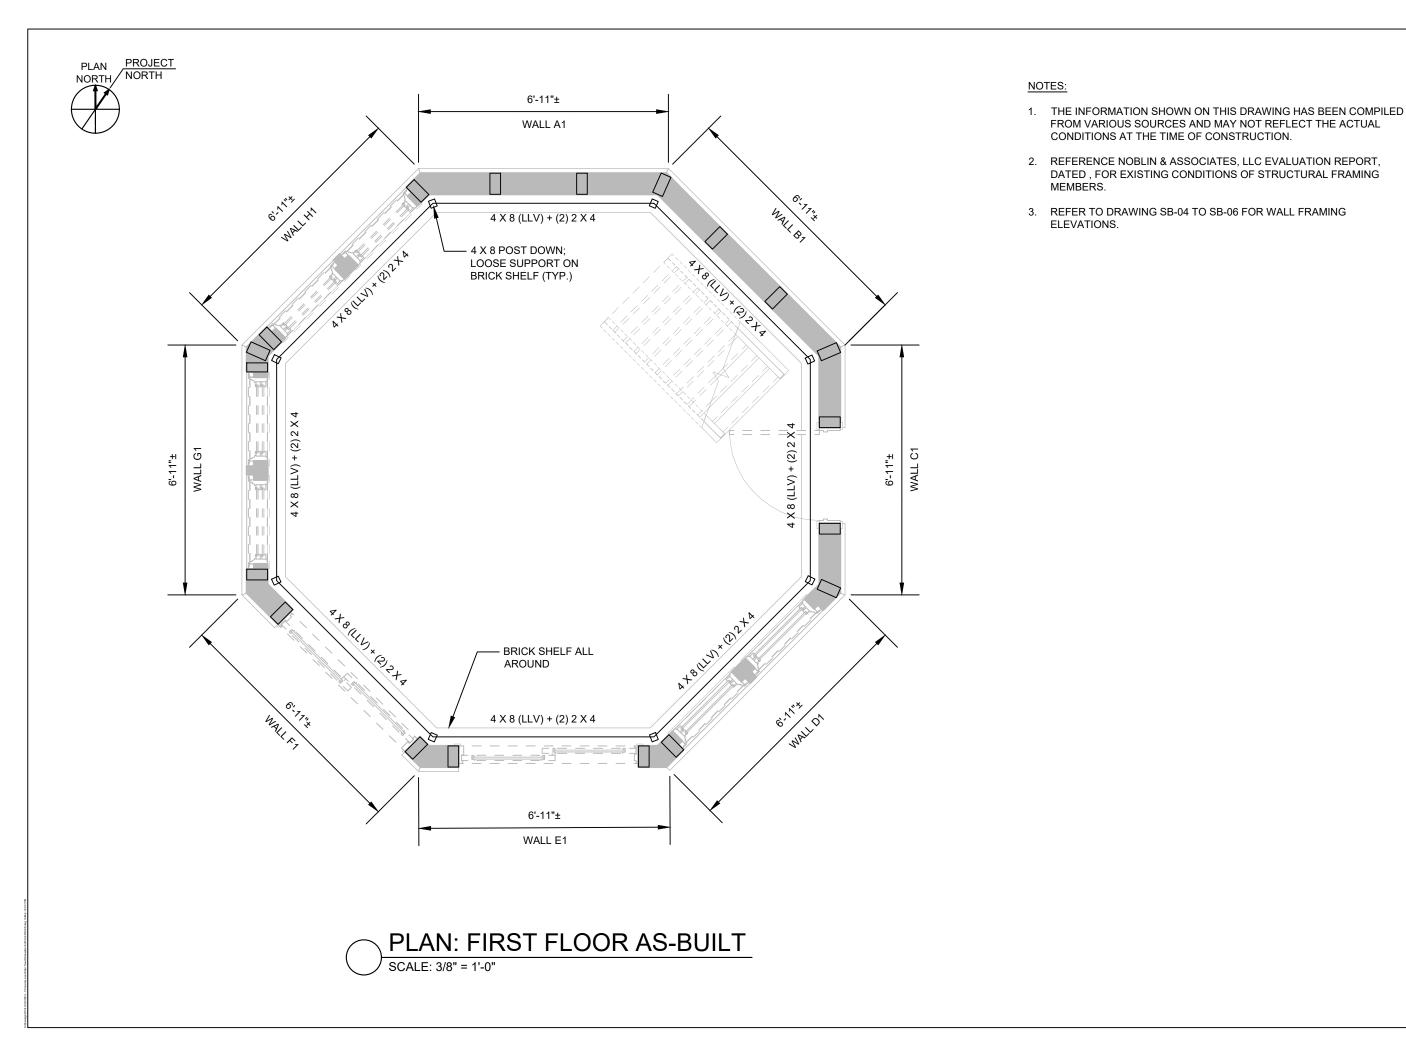
FOR REVIEW ONLY		NOT FOD	CONSTRUCTION	
PROJECT		STRUCTURAL ENGINEERING CONSULTATION EXISTING WATER TOWER 10 HYANNIS AVENUE	HYANNIS, MA 02601	OWNER	GAVIN & SULLIVAN ARCHITECTS 128 WARREN STREET	LOWELL, MA 01852
NO.		NOTE		DESCF	RIPTION	BY
	_	CT NO.		02.059		
CAD DES	_	ILE		9.02.059-XS.dwg INK/CJG		
DRA		I BY: ED BY:	JNI MN			
DAT	_	ED BT.		28/201	9	
DRA	WI	NG SCALE GRA		" = 1'-0		
		SH	IEET	TITLE		
FRAMING PLAN FIRST FLOOR						
DRAWING NO.						
	XS-01					
					1 OF 6

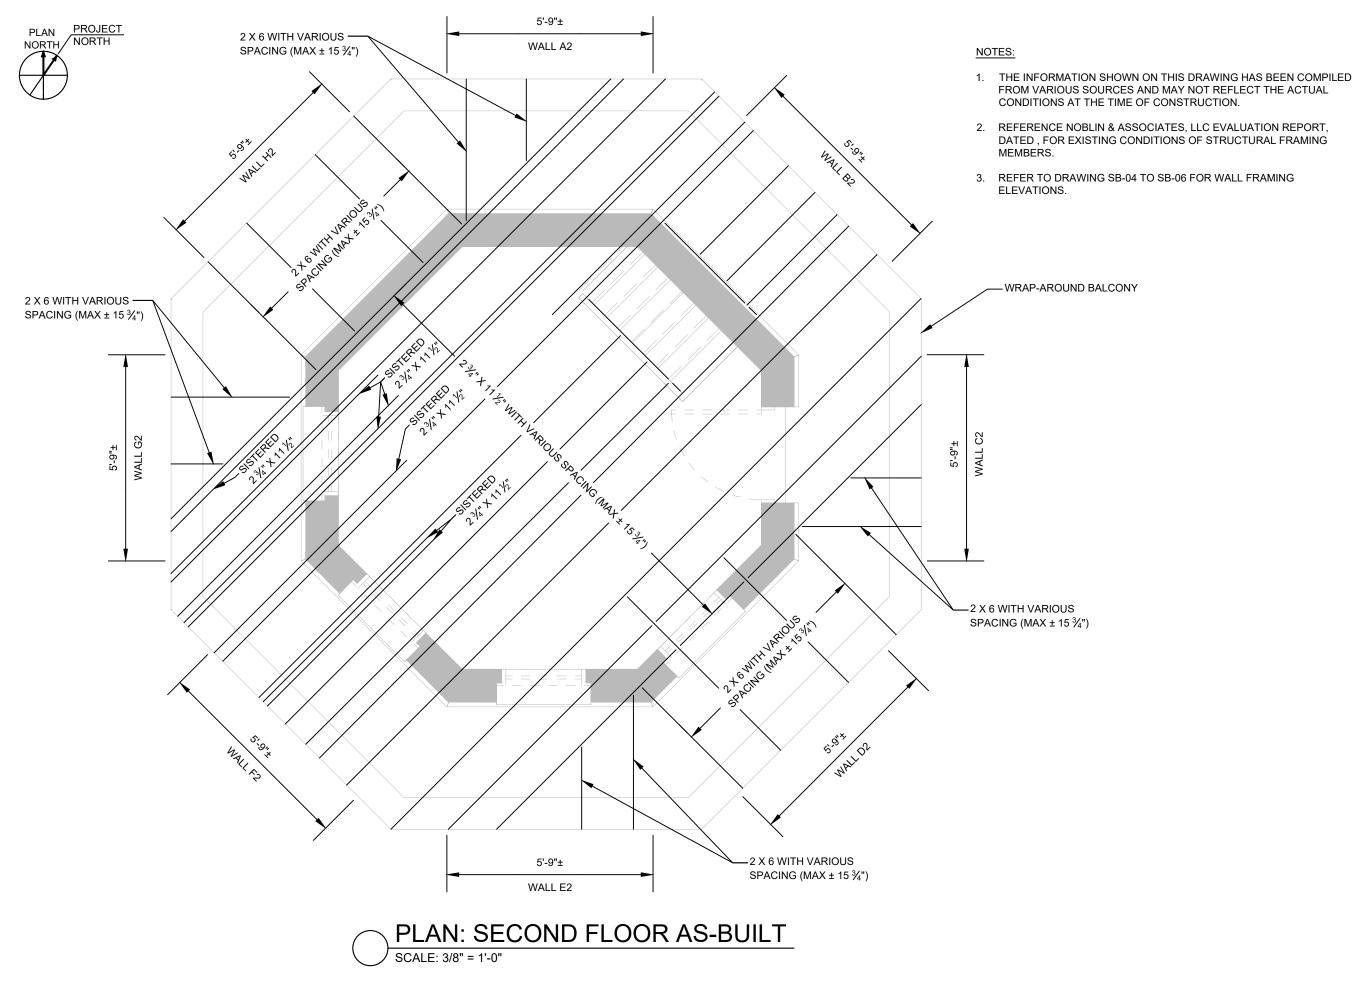
FOR REVIEW ONLY		NOT FOR	CONSTRUCTION		
PROJECT		STRUCTURAL ENGINEERING CONSULTATION EXISTING WATER TOWER 10 HYANNIS AVENUE	HYANNIS, MA 02601	OWNER	GAVIN & SULLIVAN ARCHITECTS 128 WARREN STREET	LOWELL, MA 01852	
NO.		NOTE		DESCF	RIPTION	BY	
	_						
PRO.	_	CT NO.	_	02.059			
	_	IED BY:	-	19.02.059-XS.dwg MNK/CJG			
DRA	_	I BY: ED BY:		JNL			
DATE			MNK 03/28/2019				
DRA	WI	NG SCALE		3/8" = 1'-0" PHIC SCALE			
		GR/	PHIC	, SUAL	c		
	SHEET TITLE						
FRAMING PLAN SECOND FLOOR							
	DRAWING NO.						
	XS-02						
				-	2 OF 6

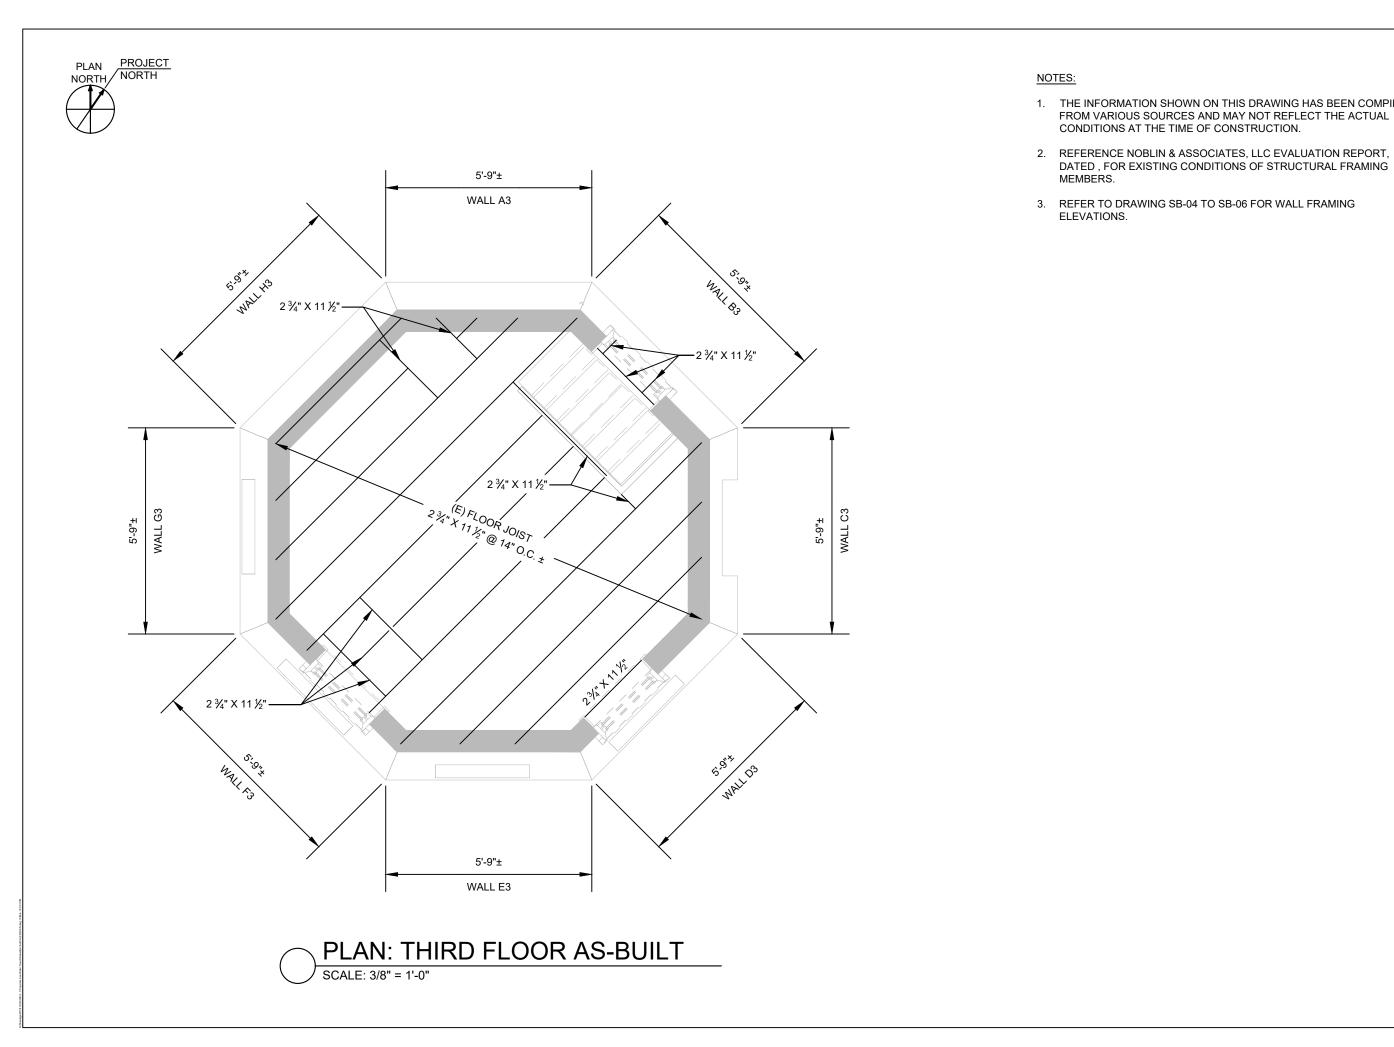
FOR REVIEW ONLY		NOT FOD	CONSTRUCTION	
PROJECT		STRUCTURAL ENGINEERING CONSULTATION EXISTING WATER TOWER 10 HYANNIS AVENUE	HYANNIS, MA 02601	OWNER	GAVIN & SULLIVAN ARCHITECTS 128 WARREN STREET	LOWELL, MA 01852
NO.		NOTE		DESCF	RIPTION	BY
PRO CAD	_	CT NO.		02.059) -XS.dwg	
DES	IGN	IED BY:		K/CJG	•	
DRA	_	I BY: ED BY:		JNL MNK		
DAT				28/201	9	
DRA	wi	NG SCALE		" = 1'-0		
		GRA	PHIC	SCAL	c	
		SH	IEET	TITLE		
FRAMING PLAN THIRD FLOOR						
DRAWING NO.						
	DRAWING NO. XS-03					
	3 OF 6
