# SNOW'S CREEK RESTORATION – RAPID ASSESSMENT

Hyannis, Massachusetts

June 2011

Prepared By:  
Comprehensive Environmental Inc.  
225 Cedar Hill Street  
Marlborough, MA 01752

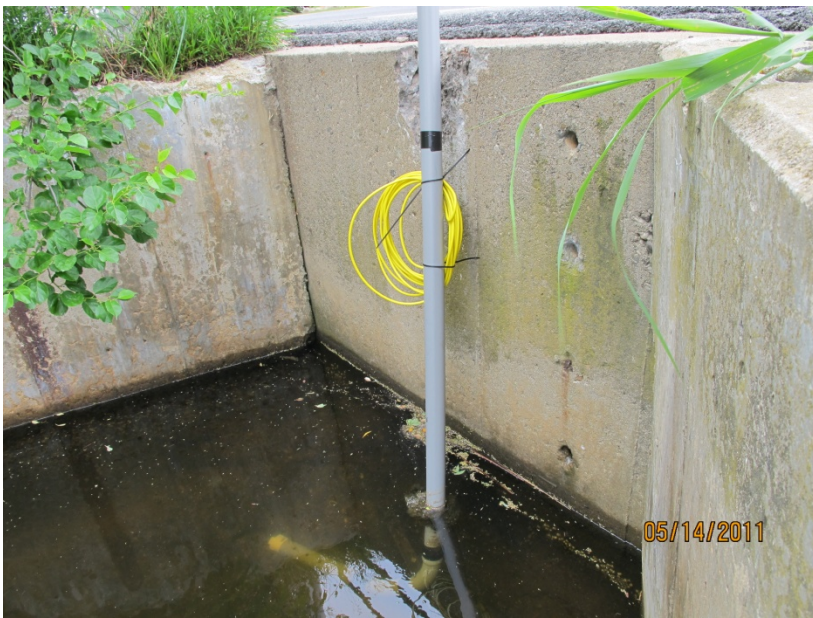
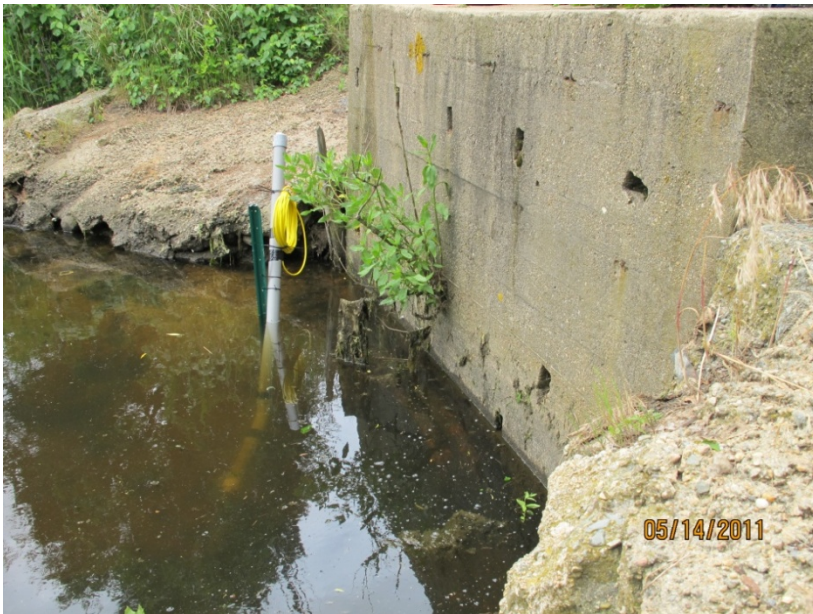
Two water level data loggers (Global WL16 data loggers) were installed at the Ocean Street culvert (upstream/pond – west of the road and downstream/ocean – east of the road). Water level data and temperature was collected continuously at 10-minute intervals from June 14<sup>th</sup> through June 24<sup>th</sup>. Additionally, conductivity data was collected in the same locations using CTF Diver D1271 data loggers at 10-minute intervals from June 21<sup>st</sup> through June 24<sup>th</sup>. Raw water level data was then adjusted based on benchmark elevation points that were collected. The data loggers were installed at the upstream and downstream sides of the culvert to assess its hydraulic characteristic and capacity. Culvert hydrographs and representative Snow's Creek tidal hydrographs were produced based on this data.

**Above: Upstream culvert data logger.  
Below: Downstream culvert data logger.**

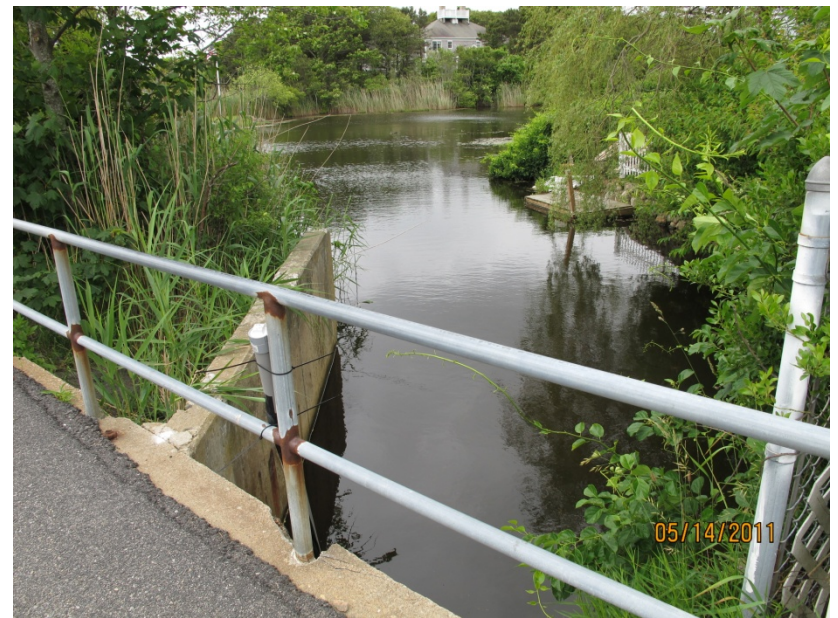
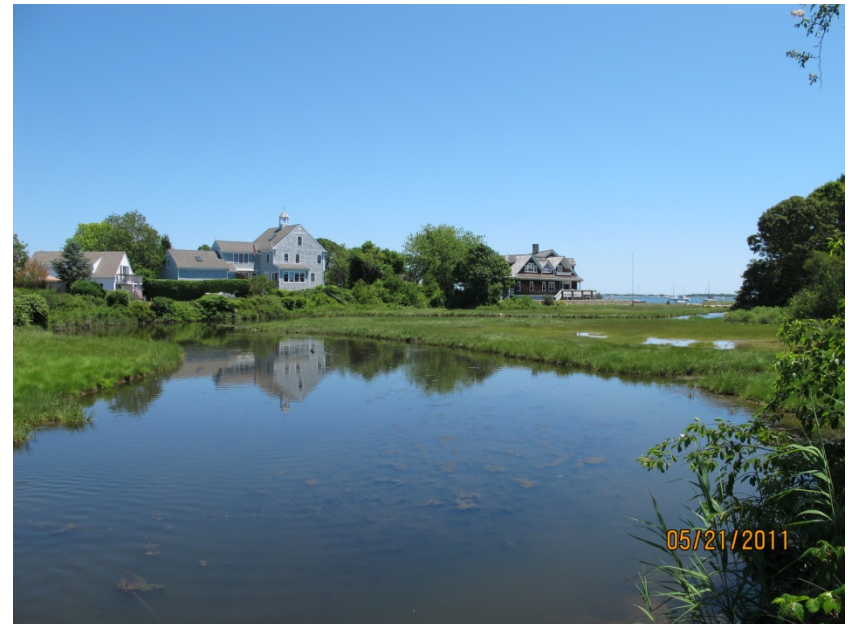
The Ocean Street culvert is a single 36-inch corrugated metal pipe (CMP) encased in a precast concrete headwall on both ends. The upstream headwall includes two 16-foot wingwalls to protect the adjacent bank from erosion. Concrete has been poured on the banks at the downstream headwall to stabilize the soil. A sinkhole has formed behind the downstream headwall in which stormwater flows through and is causing soil to erode. The structural integrity of the headwall will decline as the bank becomes unstable with the loss of soil.

There is no scour protection at either pipe invert, however the streambed is firm with a mixed gradation of sand and stones. A structural anomaly was noted consisting of a semi-submerged weir or knee wall structure in front of the culvert. This appeared to be a remnant from previous construction. This weir blocks half of the pipe opening which effectively decreases the culvert capacity in half and reduces tidal exchange in and out of Snow's Creek.

**Above: Upstream culvert from Ocean Street.  
Below: Downstream culvert from Ocean Street.**

Increasing tidal flow into Snow's Creek could be achieved by simply removing a section of the existing weir wall that is blocking the opening of the culvert pipe. Work would include cutting a notch in the concrete weir wall and removing the section that is currently obstructing flow. This would allow the existing culvert to remain in place and avoid the need for new construction and limit the time needed for a temporary traffic detour. Channel restoration on the upstream side of the culvert would also improve tidal flow by removing material that has built up against the weir wall.

Removing the weir wall would increase flow velocity in the pipe and at either end of the culvert. Project design considerations should include scour protection at each end of the culvert pipe to stabilize the channel. Loss of channel material at either end of the culvert could compromise the foundation of the headwalls. Complete removal of the weir wall is not recommended since it could affect the structural integrity of the culvert and wingwalls. The total construction costs associated with this project to remove a notch from the weir wall, remove material from the creek channel and placement of scour protection are estimated to be \$15,000. The cost to permit the project is estimated to be \$12,500.

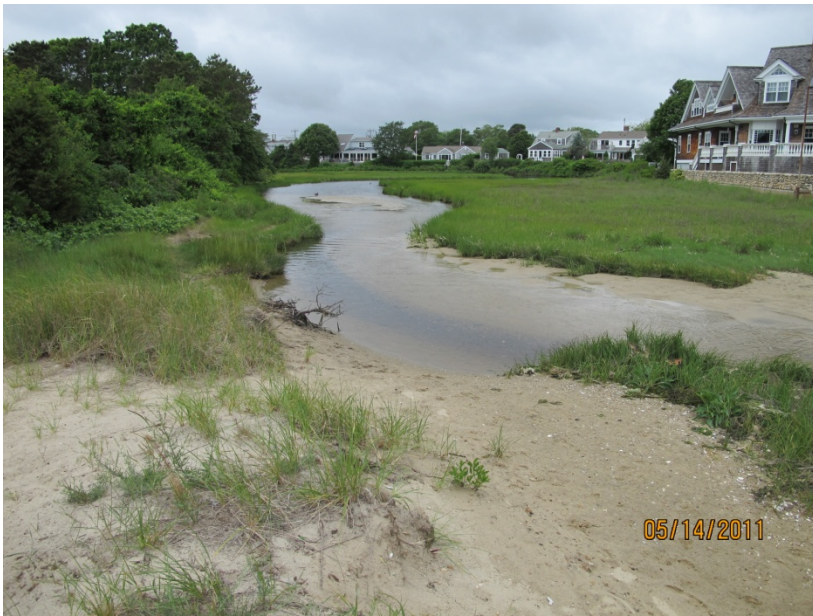
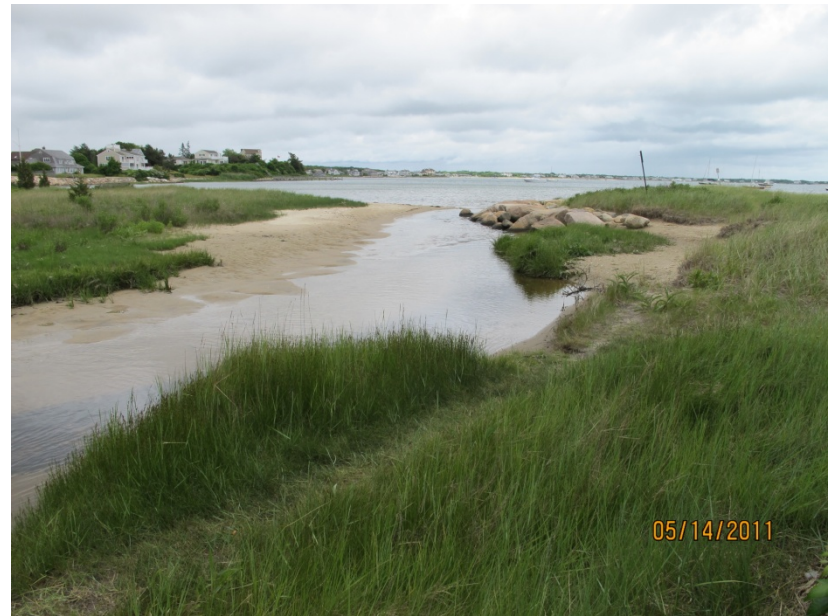
In comparison, field observations of the seaward side of the Ocean Street culvert show a more open salt marsh/dune habitat accessible via Veterans Beach. This area east of the culvert is dominated by a low high and middle high marsh vegetation mix of *S. patens*, *D. spicata*, and *S. alterniflora*. Marsh border vegetation includes *Myrica sp.* (Bayberry), *Rosa palustris* (Swamp Rose) and *Rosa rugosa* (Rugosa Rose). The intertidal area along this waterway showed signs of crab and clam habitat while minnows were observed around the ocean side of the Ocean Street culvert. The Ocean Street culvert was not visible. The adjacent landowner indicated that the culvert at one time was visible during low tides however he had not observed it for several years due to increased sedimentation, which would also affect the hydraulic characteristics of the culvert.

**Above: Snow's Creek east of Ocean Street looking west.  
Below: Minnows at downstream culvert area.**

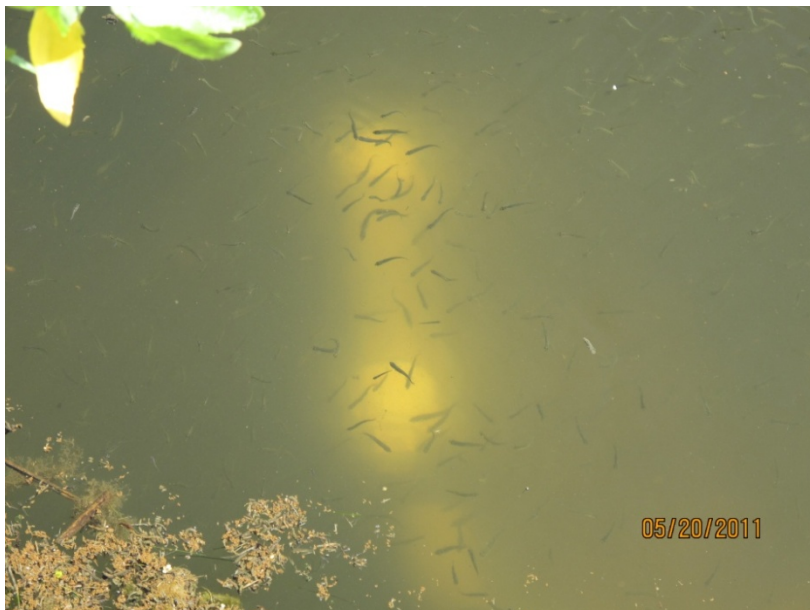
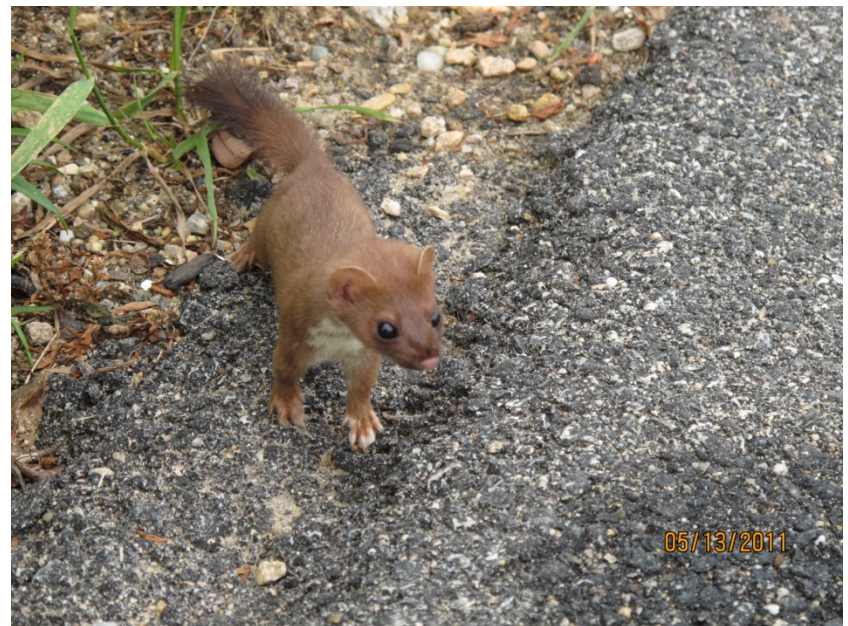
**Above: Mouth of Snow's Creek; view of Lewis Bay.  
Below: Weasel near culvert.**

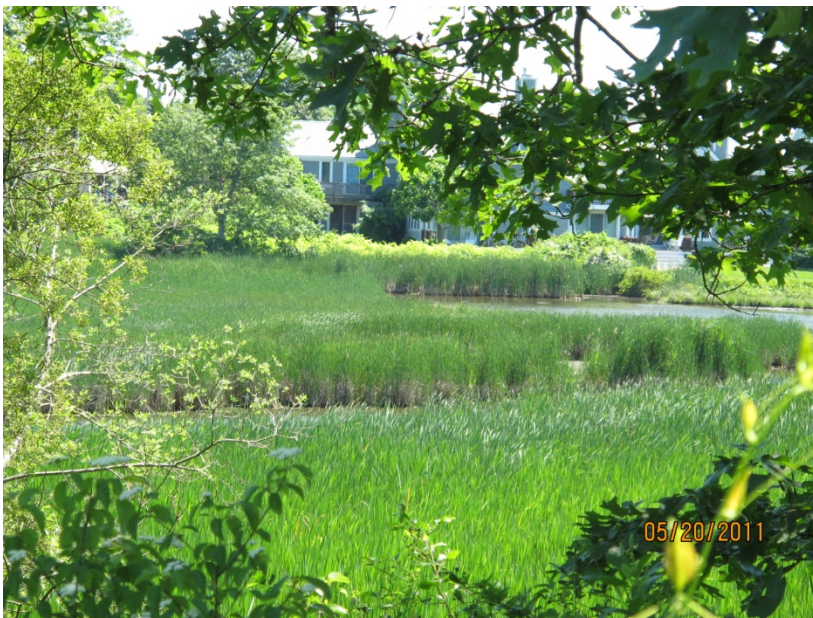
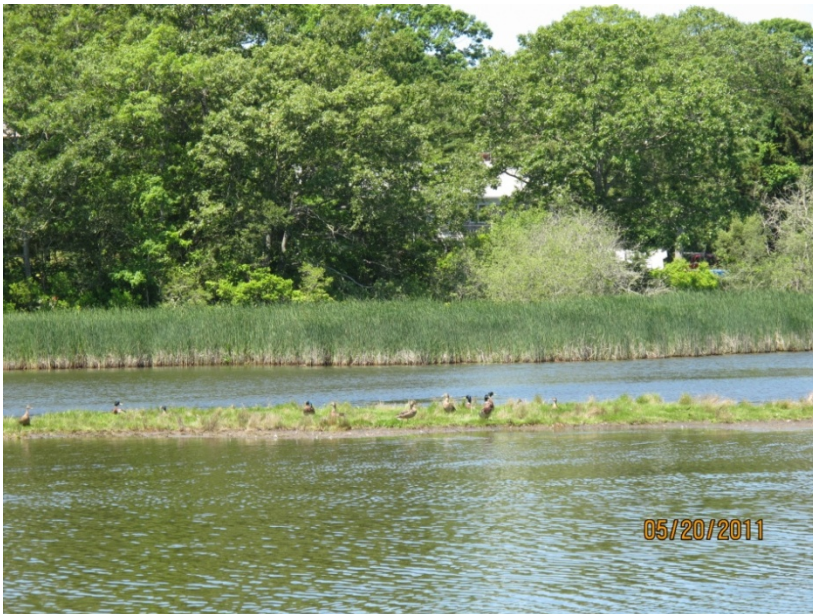
With small elevated areas of substrate accumulation creating island type habitat for ducks and swans, several small sediment deltas were observed. Other than periodic evidence of typical marsh mammal foraging and avifauna, no other unique characteristics were noted. Snow's Creek is mapped as BioMap Critical Natural Landscape which is identified as habitat for wide-ranging native species, supports intact ecological processes, maintains connectivity among habitats, and enhances ecological resilience including buffering uplands around coastal, wetland, and aquatic Core Habitats to ensure long term integrity. Snow's Creek is northwest of Core Habitat/Species

**Above: Western side of Snow's Creek viewed from 16 Walley Court.  
Below: Sediment delta in foreground; NE Snow's Creek viewed from 381 Ocean Street.**

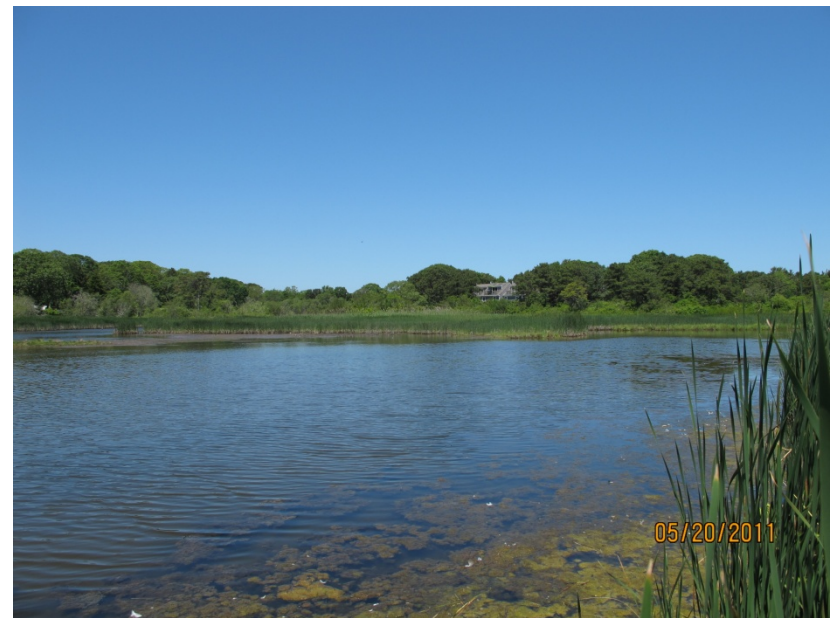
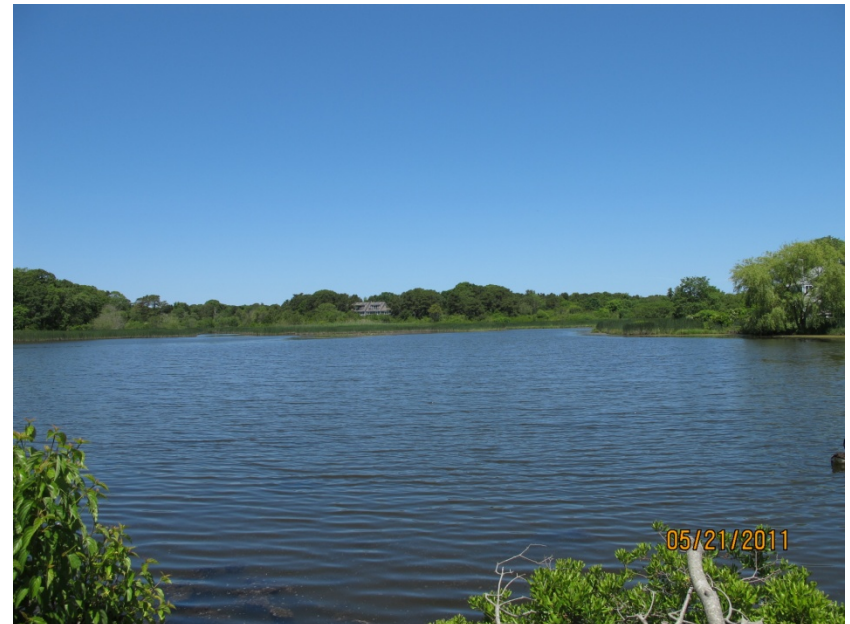
**Above: NE section of Snow's Creek from 381 Ocean Street.  
Below: Center of Snow's Creek from 20 Stanley Place.**

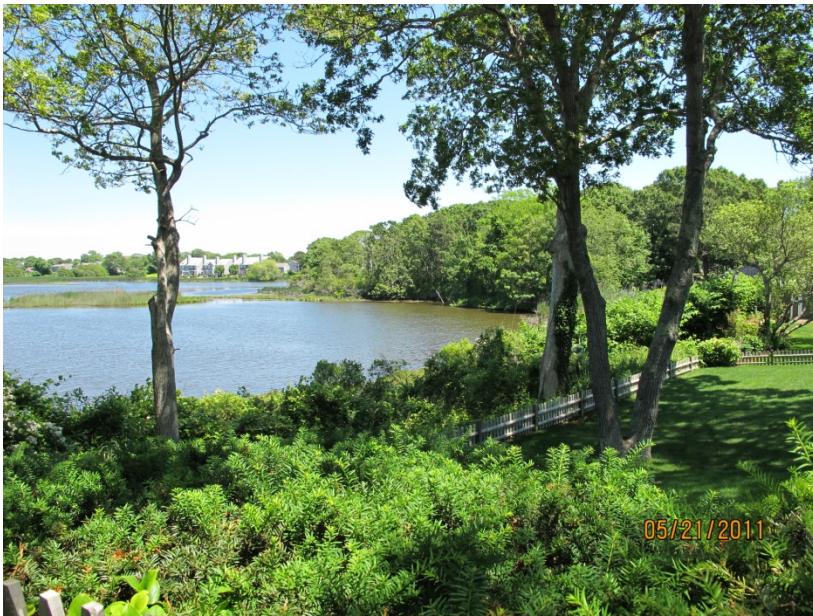
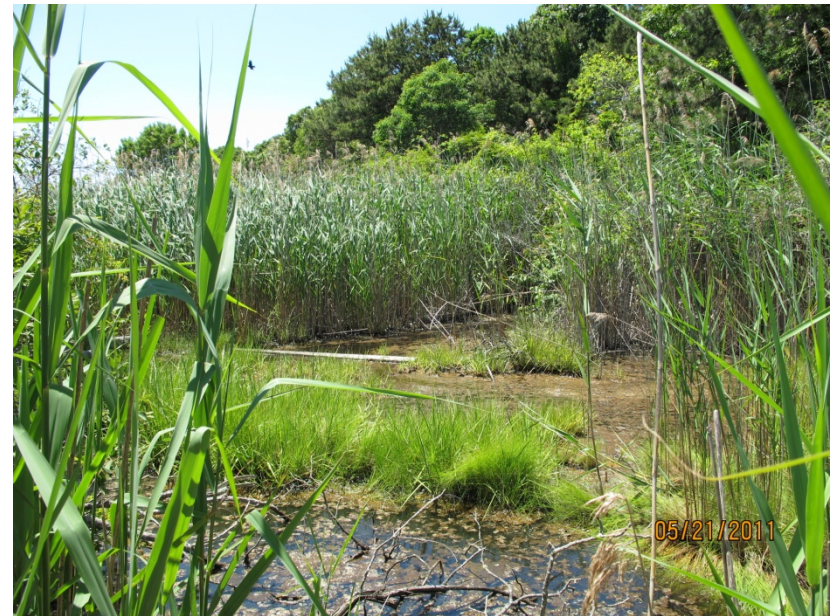
sparse middle high marsh areas with a mix of *Spartina patens* (salt meadow grass) and *Distichlis spicata* (salt/spike grass). This mix is similar to the vegetation observed on the sandy shore inlet east of Ocean Street leading to Veterans Beach along with the short form of *Spartina alterniflora*. Further west as salinities likely decrease, the marsh border is colonized by nearly monospecific stands of *Typha sp.* (Cattail). Serving as potential habitat for some wetland and shoreline species, *Typha sp.* can provide nesting habitat, substrate cover and erosion control functions. Although not on the MA Department of Agricultural Resources (MassDAR) *Prohibited Plant List* (invasive species), *Typha sp.* are considered aggressive and invasive by some as it can form dense stands in aquatic habitats thereby reducing plant diversity and limiting direct waterbody access. With similar growth patterns, *Phragmites australis* (Common Reed) was observed in most marsh border areas directly abutting the stands of *Typha sp.* *P. australis* is on the MassDAR *Prohibited Plant List* as an invasive plant species and although some may argue that it can provide some habitat functionality, its benefits are limited. As in Snow's Creek, *P. australis* often dominates an area with monospecific stands of vegetation that can displace the more desirable *Spartina sp.* known to support greater marsh diversity. Conversations with several abutting residents indicated that invasive species removal along some shoreline properties by the property owners for better access and aesthetic views resulted in a significant Canada Goose problem now with direct access to lawns and patios. Increased tidal flow can often increase the salinity to a level that may help reduce/eliminate the existing *P. australis* stands. However, freshwater influences may inhibit this effort. Additionally, hydrologic modifications may also result in simply moving the *P. australis* stand to a slightly higher elevation. Upper elevations of Snow's Creek are characterized by typical forested and scrub/shrub freshwater wetland habitat that appear to provide a moderate buffer to Snow's Creek. Invasive vegetation such as *P. australis* and *Lonicera japonica* (Japanese Honeysuckle) were observed in several areas adjacent to roadways within the watershed. Despite the urban medium density setting, vegetated buffers appeared to be maintained and the area has urban viewscape value for residents.

Above: Northern area of Snow's Creek from 56 Cook Circle.  
Below: *Phragmites australis* along Gosnold Street.

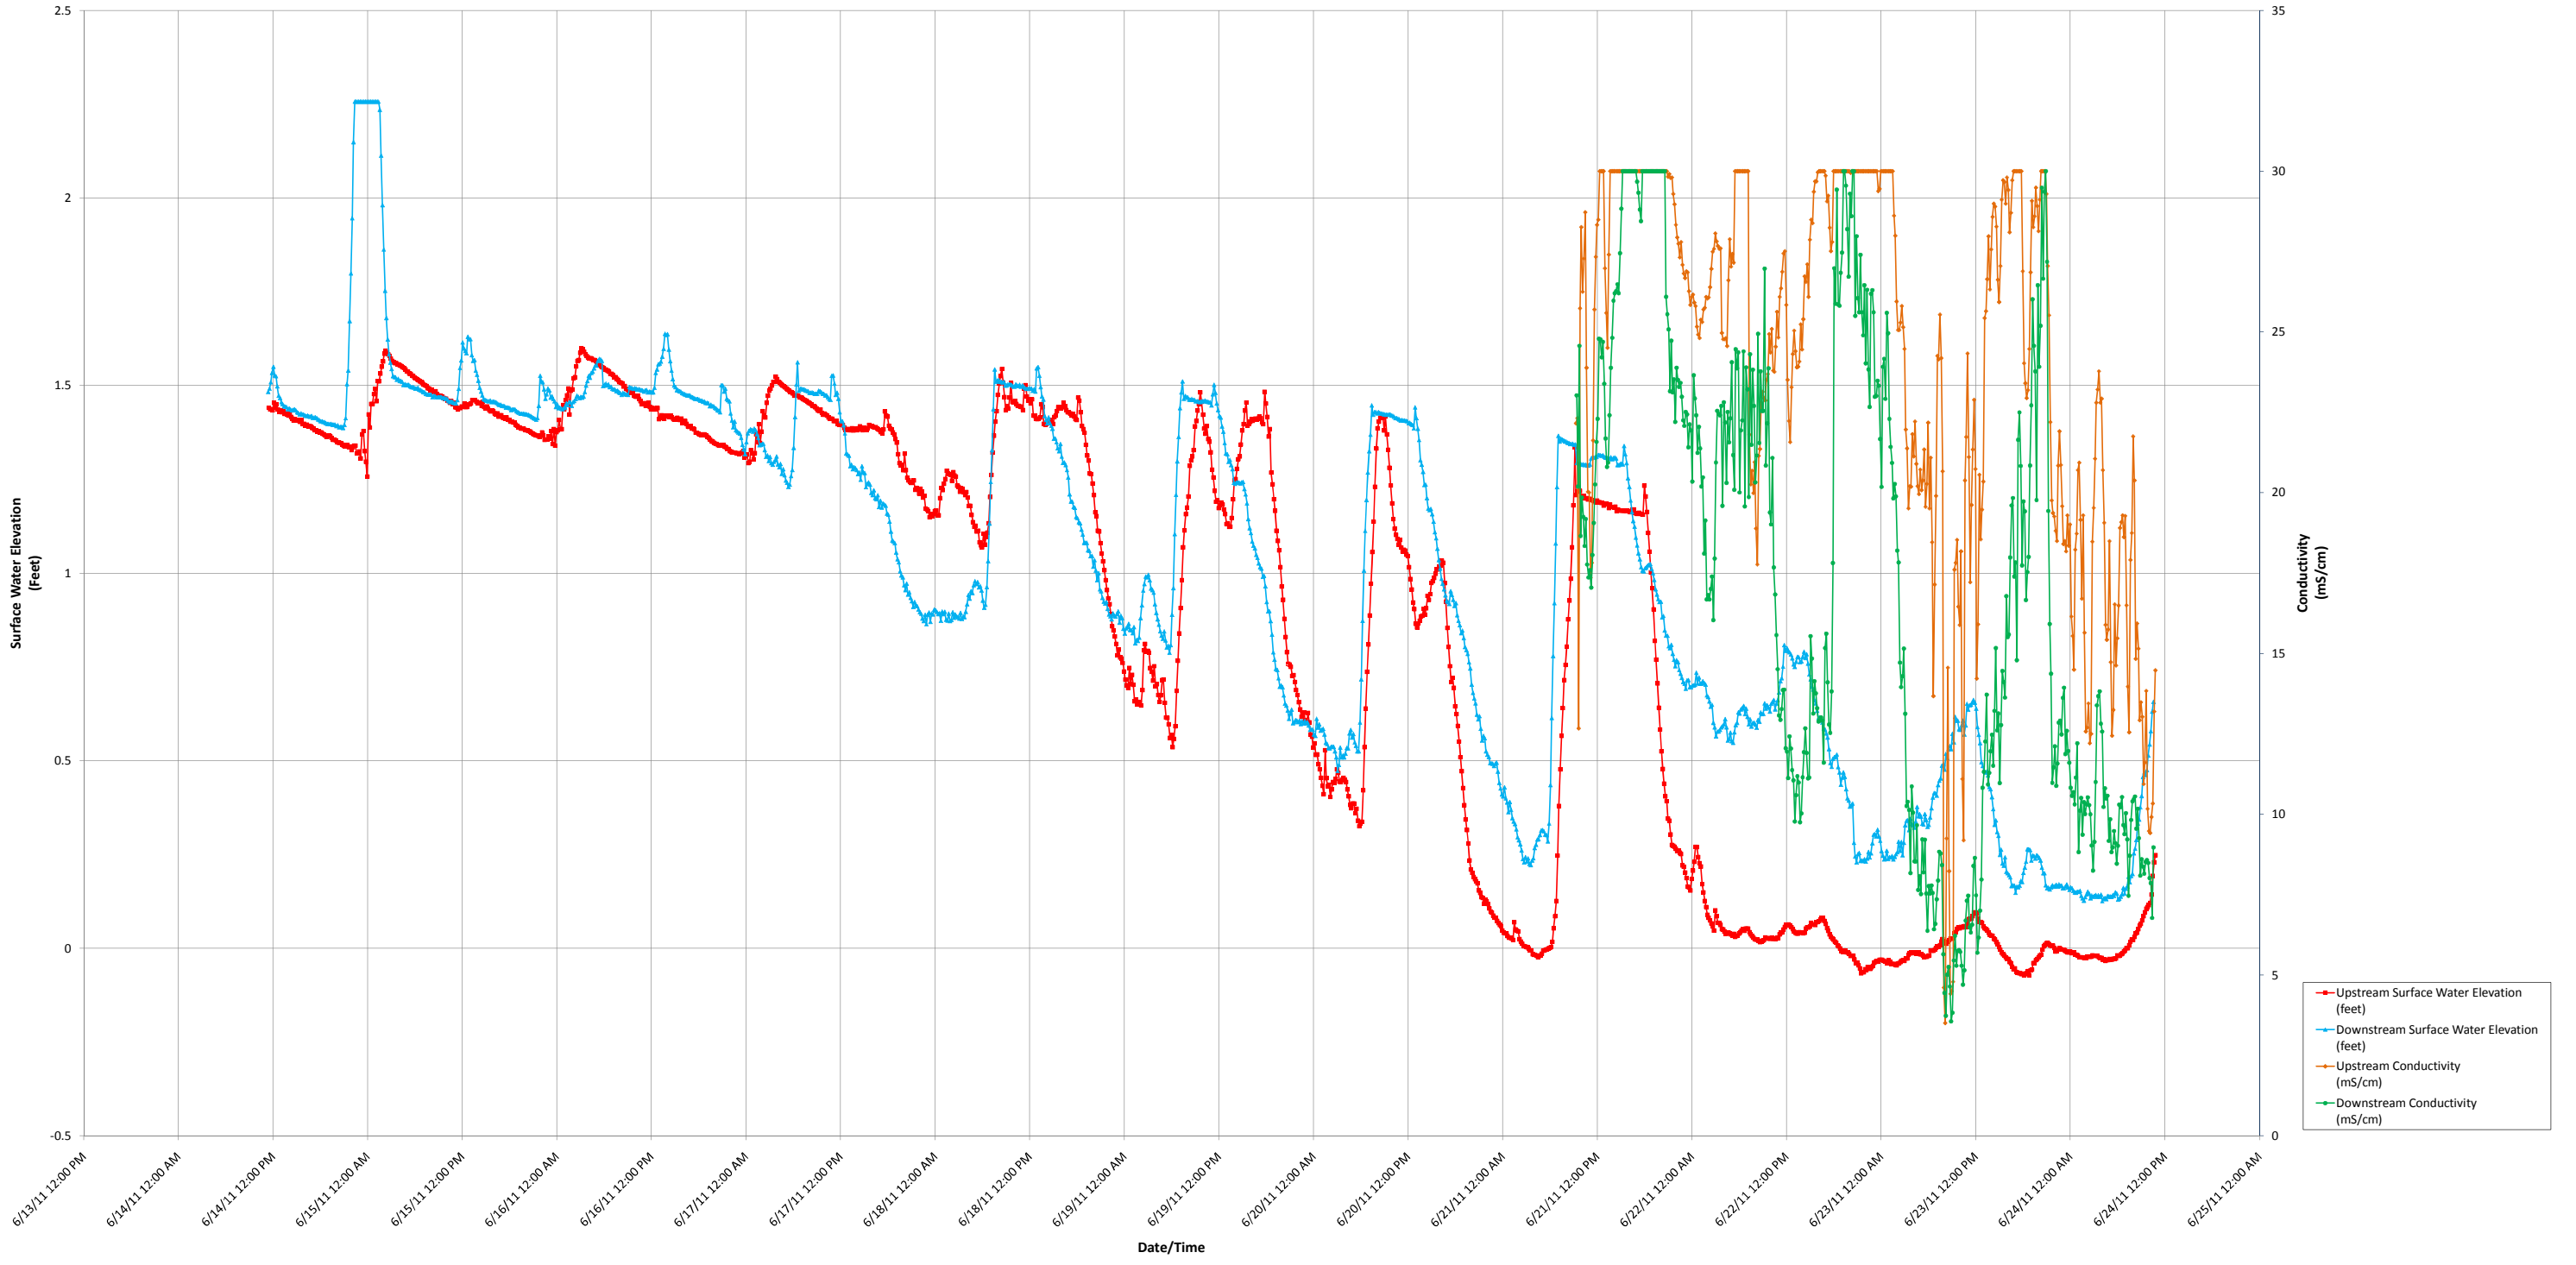
Snow's Creek Culvert  
Water Elevation and Conductivity

Water elevation data collected over the 10-day period show a correlation to available tidal predictions for Hyannis Port. While the data does show what appear to be some anomalies, the overall trends indicate that there were several cycles of consistent data showing the same trend around the middle of the data set. The upstream fluxes regularly peak with one daily high tide observed from the downstream location however regularly appear to lag significantly behind the second daily high tide indicating a restriction. Conductivity data shows significant spikes on the upstream side with a temperature gradient likely. Combined with the water elevation lag, these elements indicate the potential presence of a salinity lens with saltwater at lower depths with freshwater at the surface.

The weir wall at the Ocean Street culvert restricts flow through the culvert. At lower tides/flows, the restriction may have less influence as the restricted pipe capacity may be able to pass the full flows under these conditions. Under higher flows and tides, the influence will be greater as the restricted pipe may not be able to pass the full flows under these conditions. This could result in a shift in the trends from extreme high tides to extreme low tides.

The downstream data regularly show a peak followed by a sustained high tide with another small jump before subsiding. One explanation is that as the high tide peaks at the restriction it then reaches the top of bank along the inlet and plateaus accordingly. This would explain the sustained level at the culvert as the tide continues to rise while allowing the surrounding floodplain to absorb the incoming volume. As the tide turns the water elevation in the channel starts to drop. Another peak occurs with inflow and drainage of the floodplain and the increased flow out of Snow's Creek. Additional data will be needed to assess the long term trends of this influence as well as the impact relative to spring and neap tides.
