Covell's Beach and Bath House

ADA Transition Plan

October 2021

Institute for Human Centered Design

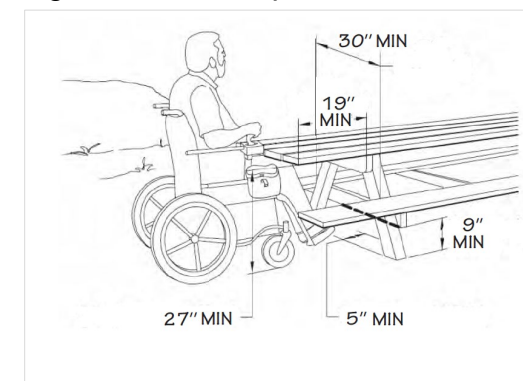
Fig. 1 Accessible picnic table

- Parking lot not maintained in operable working condition.
- Lack of designation signs with raised characters and braille at the toilet rooms.
- Picnic table, bench and bike racks not located on an accessible route.
- Lack of an accessible picnic table (near bathhouse).

Note: Ensure the picnic table has the required 19" knee clearance. See fig. below.

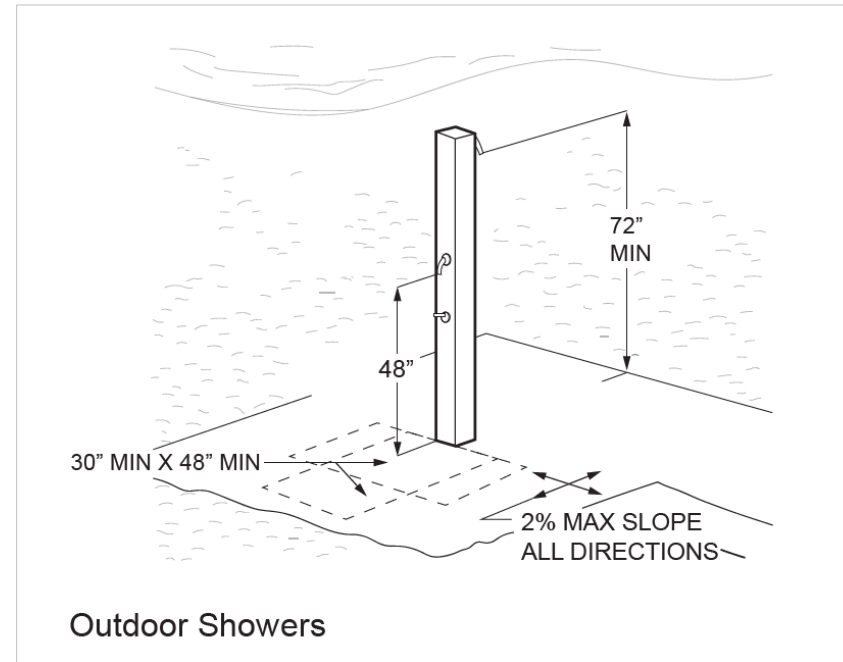
Fig.3: Accessible outdoor rinsing shower

The outdoor rinsing shower lacks a shower head located 48" above the ground and has controls that require tight grasping, pinching or twisting of the wrist. See Fig. 1 at the end of this report for an example of an accessible rinsing outdoor shower.
