Craigville Bathhouse and Beach

Town of Barnstable ADA Transition Plan

June 2021

**Town of Barnstable
Craigville Bathhouse and Beach**

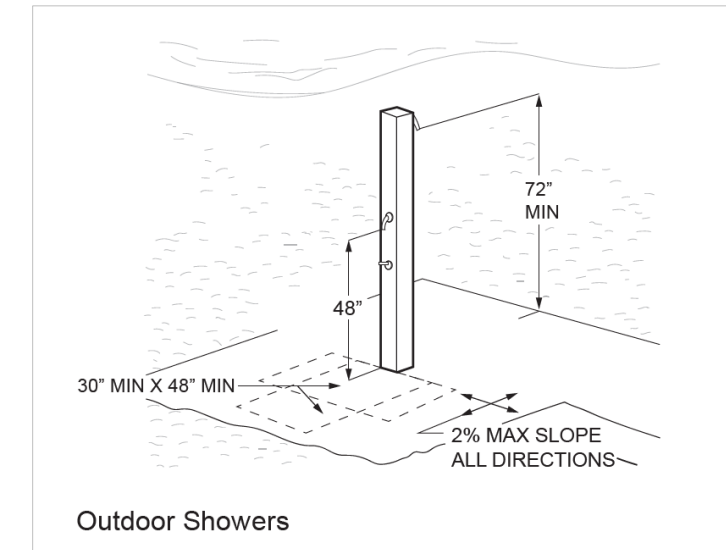
Outdoor Spray Shower

Accessibility issues include lack of a spray shower with a showerhead mounted 48” max. above the ground.

Note: In unmonitored facilities where vandalism is a consideration, a fixed shower head mounted at 48” above the shower floor may be used in lieu of a hand-held shower head.
