## Prince Cove Marina

## Town of Barnstable ADA Transition Plan

Institute for Human Centered Design

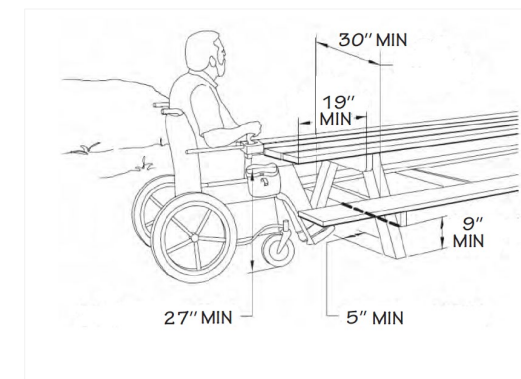
- Fire extinguisher, drop off box, and dog waste bags protrude into the circulation path
- Lack of designation van accessible sign at the accessible parking space.
- Lack of handrails at exterior stairs.
- Lack of an accessible picnic table.

**Note:** When picnic tables are provided ensure they have the required 19" knee clearance.
