## Barnstable Dog Park

## Town of Barnstable ADA Transition Plan

June 2021

Institute for Human Centered Design

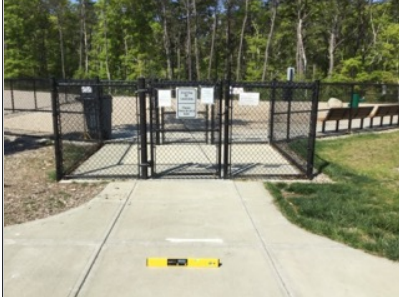
ID	Location	Floor	Room	Element	Type	Photo	Issues	Current Measure	Recommendations	Quantity	Price	Cost Estimation
<b>Approach and Entrance</b>												
<b>Exterior Access Route</b>												
1	Parking Lot to Dog Park Entrance North Side	Ext.		Exterior Access Route	Walkway

Cross slope > 1:50 (2.00%)	2.4%	Reduce cross slope to be no steeper than 1:50 (2.00%).	1	240	\$240
2	Route Near the Park	Ext.		Exterior Access Route	Walkway

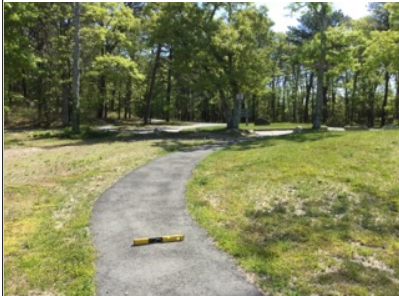
Cross slope > 1:50 (2.00%)	3.2%	Reduce cross slope to be no steeper than 1:50 (2.00%).	1	-	\$0
3	Route Near the Park	Ext.		Exterior Access Route	Walkway

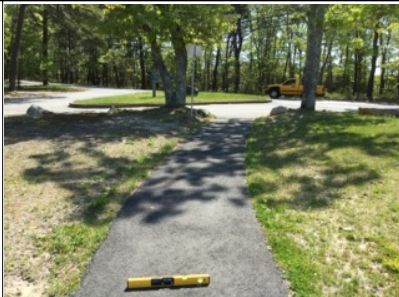
Cross slope > 1:50 (2.00%) Running slope > 1:20 (5%)	4.4% 6.6%	Reduce cross slope to be no steeper than 1:50 (2.00%). Reduce running slope to be no steeper than 1:20 (5.00%).	1	-	\$0
4	Route Near the Park	Ext.		Exterior Access Route	Walkway

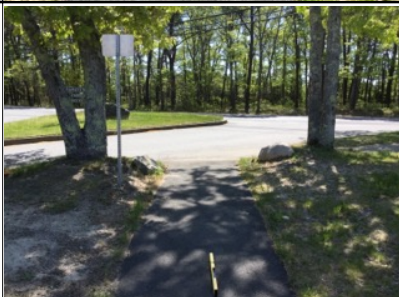
Cross slope > 1:50 (2.00%) Running slope > 1:20 (5%)	4.2% 6.3%	Reduce cross slope to be no steeper than 1:50 (2.00%). Reduce running slope to be no steeper than 1:20 (5.00%).	1	-	\$0

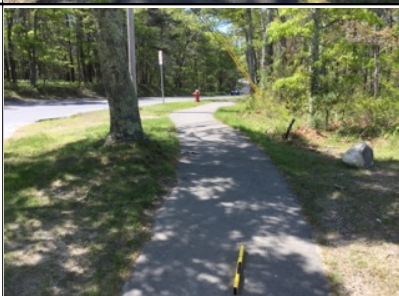
5	Route Near the Park	Ext.		Exterior Access Route	Walkway

Running slope > 1:20 (5%)	8.5%	Reduce running slope to be no steeper than 1:20 (5.00%).	1	-	\$0

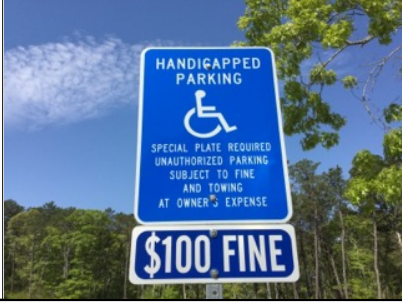
ID	Location	Floor	Room	Element	Type	Photo	Issues	Current Measure	Recommendations	Quantity	Price	Cost Estimation
<b>Off-Street Parking Lot or Garage</b>												
6	Parking Lot	Ext.		Off-Street Parking Lot or Garage	Visitor

Sign top > 96" above finished grade	-	Locate sign with the top of the sign 96" above the ground.	1	Labor	\$0
<b>Access to Goods and Services</b>												
<b>Dog Parks</b>												
7	Dog Park Entrance Between North and South Side	Ext.		Dog Parks	N/A

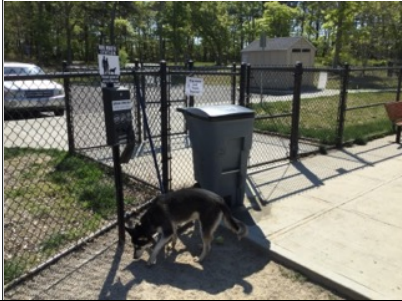
Accessible route not provided	-	Ensure an accessible route is provided to dog waste station.	1	240	\$240
8	Dog Park Entrance South Side	Ext.		Dog Parks	N/A

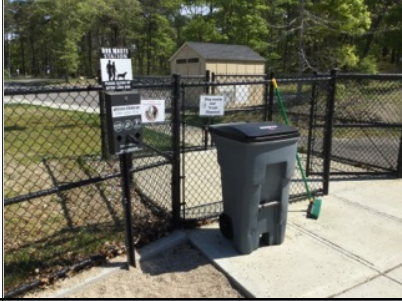
Accessible route not provided	-	Ensure an accessible route is provided to dog waste station.	1	240	\$240
<b>Additional Access</b>												
<b>Drinking Fountains</b>												
9	Dog Park Between North and South Side	Ext.		Drinking Fountains	Hi-Lo

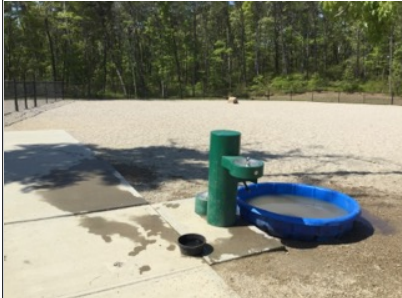
Clear floor space not provided No drinking fountain provided for standing users	- -	Provide a 30" by 48" clear floor space positioned for a forward approach. Provide an additional drinking fountain for standing users.	1	6056	\$6056

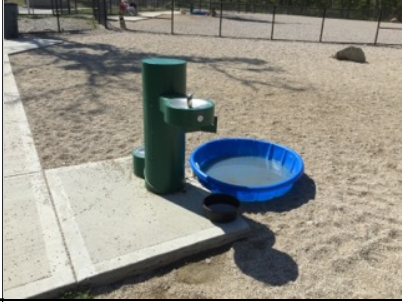
ID	Location	Floor	Room	Element	Type	Photo	Issues	Current Measure	Recommendations	Quantity	Price	Cost Estimation
10	Dog Park North Side	Ext.		Drinking Fountains	Hi-Lo

Clear floor space not provided No drinking fountain provided for seated users	- -	Provide a 30" by 48" clear floor space positioned for a forward approach. Provide an additional drinking fountain for seated users.	1	6056	\$6056
11	Dog Park 3 South Side	Ext.		Drinking Fountains	Hi-Lo

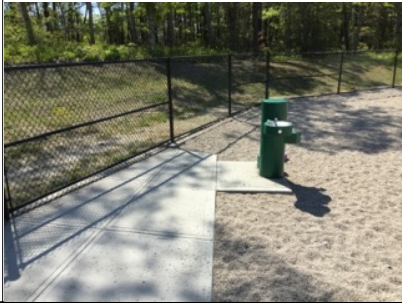
Clear floor space not provided No drinking fountain provided for seated users	- -	Provide a 30" by 48" clear floor space positioned for a forward approach. Provide an additional drinking fountain for seated users.	1	6056	\$6056
<b>Best Practice</b>												
12	Route Round the Park	Ext.			N/A

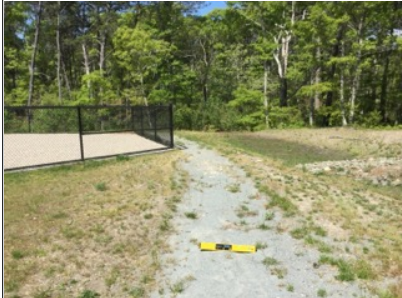
-	Recommend providing a stone dust stable surface around the dog park with no more than 1:50 (2.00%) cross slope and 1:20 (5.00%) run slope that is at least 48" wide and in operable working conditions.	1	-	\$0

- Recommend providing a stone dust stable surface around the dog park with no more than 1:50 (2.00%) cross slope and 1:20 (5.00%) run slope that is at least 48" wide and in operable working conditions.
